U.S. NUCLEAR REGULATORY COMMISSION

Docket/Report Nos.: 50-220/98-14  
50-410/98-14

Facility: Nine Mile Point, Units 1 and 2

Dates: August 16 - September 26, 1998

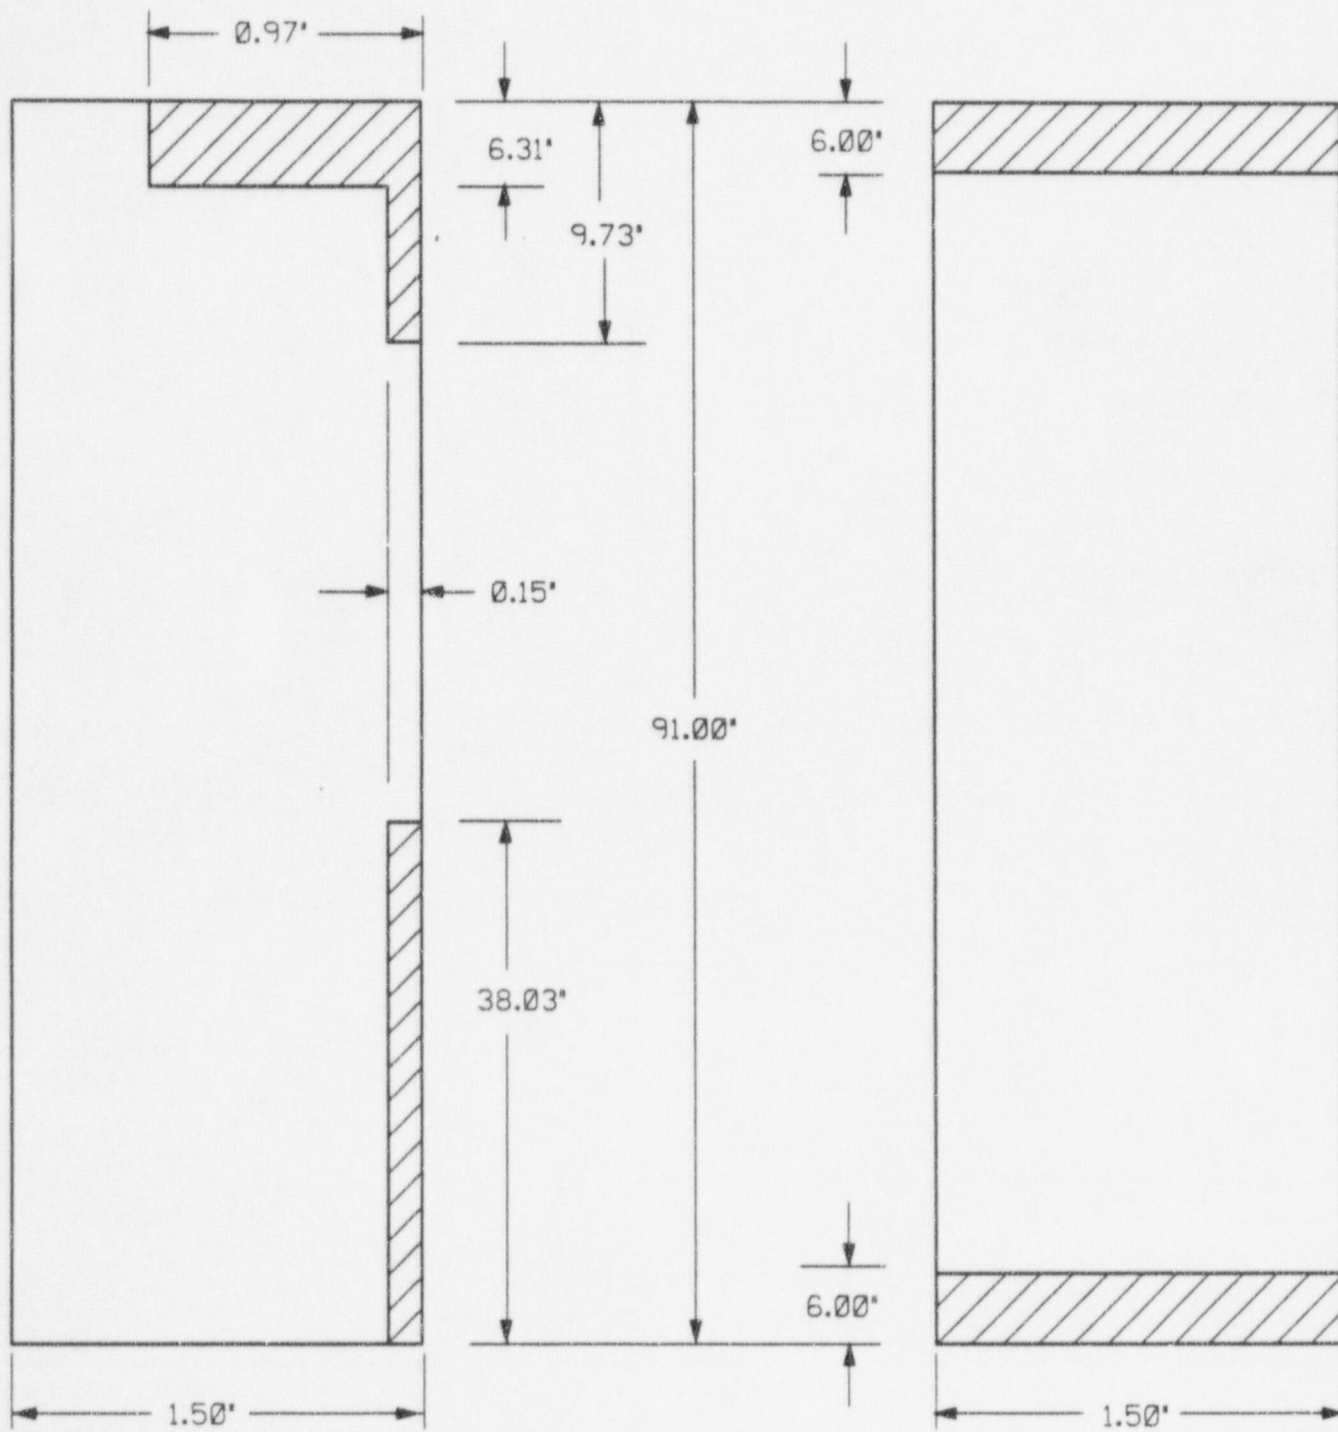
# EVALUATED CRACK GEOMETRIES

- The follow-up supplemental fracture mechanics analysis, demonstrates that the required ASME code required margins are maintained, for more than 14,500 hours, even assuming a CGR of  $5 \times 10^{-5} \text{ in/hr}$ 
  - Analysis consistent with BWRVIP-01 guidelines
  - Credit taken for uncracked locations confirmed by both volumetric inspections (UT) and visual inspections (EVT-1) for V9 and V10
  - Credit taken for far side detection capability of UT as qualified by BWRVIP-03 for V4 weld
  - V4, V9 and V10 limit load evaluations show significant margin
