Commonwealth Edison
One First National Plaza, Chicago, Illinois
Address Reply to: Post Office Box 767
Chicago, Illinois 60690 - 0767

May 31, 1988

Subject: Quad Cities Station Unit 1
Response to Request for Additional
Information (RAI) Regarding Fall
1987 Unit 1 Intergranular Stress
Corrosion Cracking (IGSCC) Inspection
NRC Docket No. 50-254

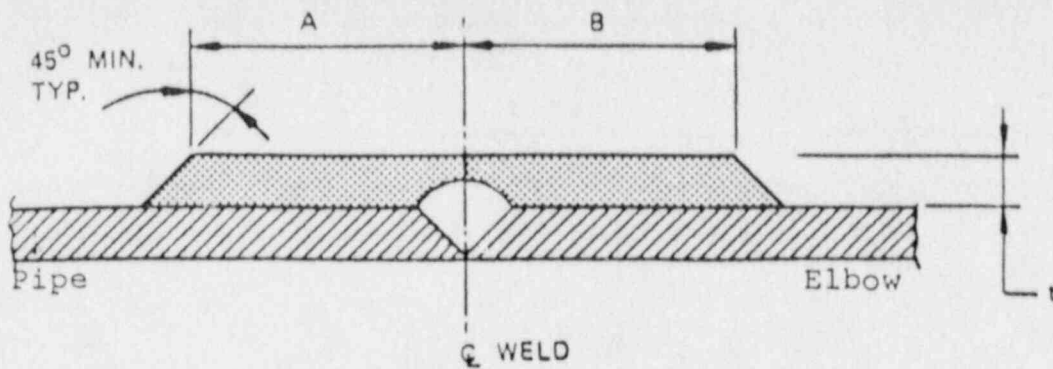
WELD OVERLAY REPAIR DETAILS

Item 6: The corrections in Table 5.2-1 and 5.2-2 result in Weld O2G-S3 having a final overlay repair thickness slightly below a NUREG-0313, Revision 2 "standard" overlay thickness. As shown in attached NUTECH Drawing CEC073.0133 and its associated Weld Overlay Data Sheet, the surface conditioning grinding of Weld O2G-S3 resulted in a final overlay thickness (0.229") below NUTECH's requested full-structural (standard) thickness (0.24"). Due to the heavy outage duration pressures caused by unplanned overlays during the Quad Cities Unit 1 1987 outage, this overlay was left as-is eventhough it was clearly below NUTECH's requested design thickness. During the rush to support an expedited final report submittal date, the data entry errors made in Tables 5.2-1 and 5.2-2 hid the fact that Weld O2G-S3 did not meet "standard" overlay criteria.

It should also be noted that NUTECH's requested design thickness for weld O2G-S3 of 0.24" provides a "standard" thickness over a low delta ferrite first layer with a "normal" average thickness of 0.10" instead of the actual first layer thickness of 0.15". As demomnstrated by the first layer thicknesses for Welds O2C-S4, O2F-S4, and O2B-S7 in Table 5.2-1, 0.10" is a reasonable assumption for a first layer thickness, but did not provide for a conservative "standard" thickness for Weld O2G-S3 in spite of the 0.229" thickness provided by the welding contractor.

As stated in Section 5.2 of the revised flaw disposition report, the decision to leave the overlay is appropriate for the following reasons:

- a. The predicted flaw depth ratio of 0.77 can be shown to meet "standard overlay repair thickness criteria using the alternate flaw evaluation requirements of ASME Section XI Paragraph IWB-3642,

- b. Because only 0.03" of additional thickness is required to meet the arbitrary maximum allowable flaw depth ratio of 0.75 in Table IWB-3641-1, the man-REM exposure that would be expended to build up, surface condition, and reinspect the overlay cannot be justified, and

- c. Because the predicted flaw depth ratio is based upon the assumption that an IGSCC indication could eventually propagate through the 0.15" thick low delta ferrite first layer, but actual observed circumferential flaws have not been detected in the outer 25% of the original pipe wall and axial flaws have not been detected in the overlay, the inspection frequency associated with a "standard" overlay in NUREG-0313, Revision 2 Category E is sufficient.

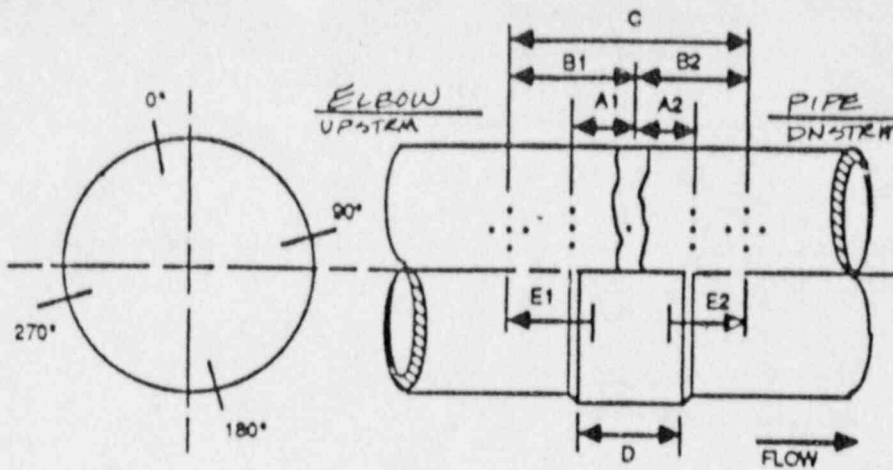
WELD OVERLAY DATA SHEET REV. 1

DATA IS FROM ORIGINAL OVERLAY DATA SHEET.
 NOTE: 1ST LAYER OF ORIGINAL OVERLAY FAILED THE DELTA FERRITE CRITERIA. *WJW/1/3/87*

AVERAGE THICKNESS UPSTREAM	AVERAGE THICKNESS DWNSTREAM
0.274	0.229

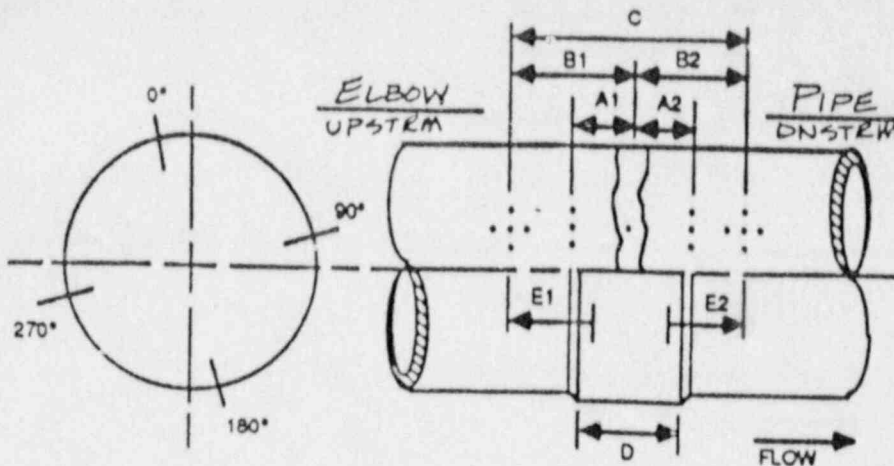
DATA IS FROM ORIGINAL OVERLAY DATA SHEET.
 NOTE: 1ST LAYER OF ORIGINAL OVERLAY FAILED DELTA FERRITE' JW 11/3/87

* DUE TO 1977 OVERLAY
 ** See Weld Overlay Data Sheet, Rev. 1

ADDITIONAL GRINDING REQ'D SEE MAINT/MOD. PROCEDURE REV. 1. JW 11/3/87

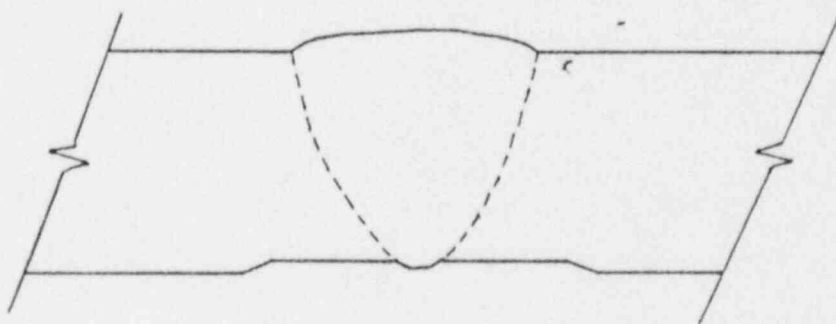
- The weld joint was fit-up and welded in the normal manner from the outside of the component.

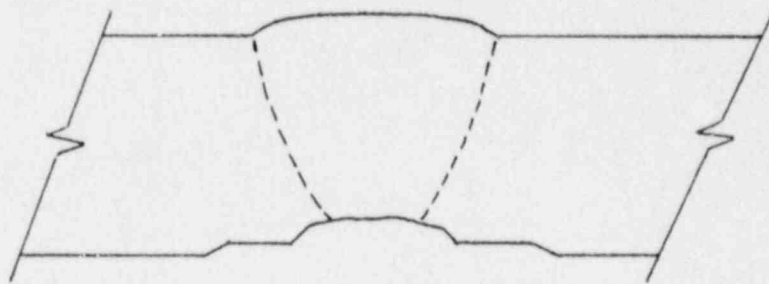
- The weld root was excavated from the component ID.

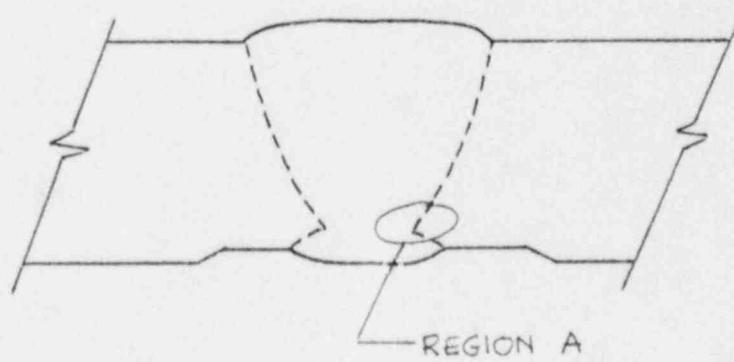
- The excavation was then re-welded from the inside and ground in preparation for examination.

The "corner" created in Region A of the above sketch provides the conditions necessary to produce an ultrasonic reflector or signal (similar to a crack tip) in a region of the weldment (heat affected zone) where IGSCC is commonly seen during typical shear wave examinations.
