SUBJECT: STEAM GENERATOR INSPECTION RESULTS, OCTOBER 1998, SOUTH TEXAS PROJECT, UNIT 2

Docket No. 50-499

NRC PHONE DISCUSSION – 2RE06 STEAM GENERATOR TUBE INSPECTION RESULTS OCTOBER 1998

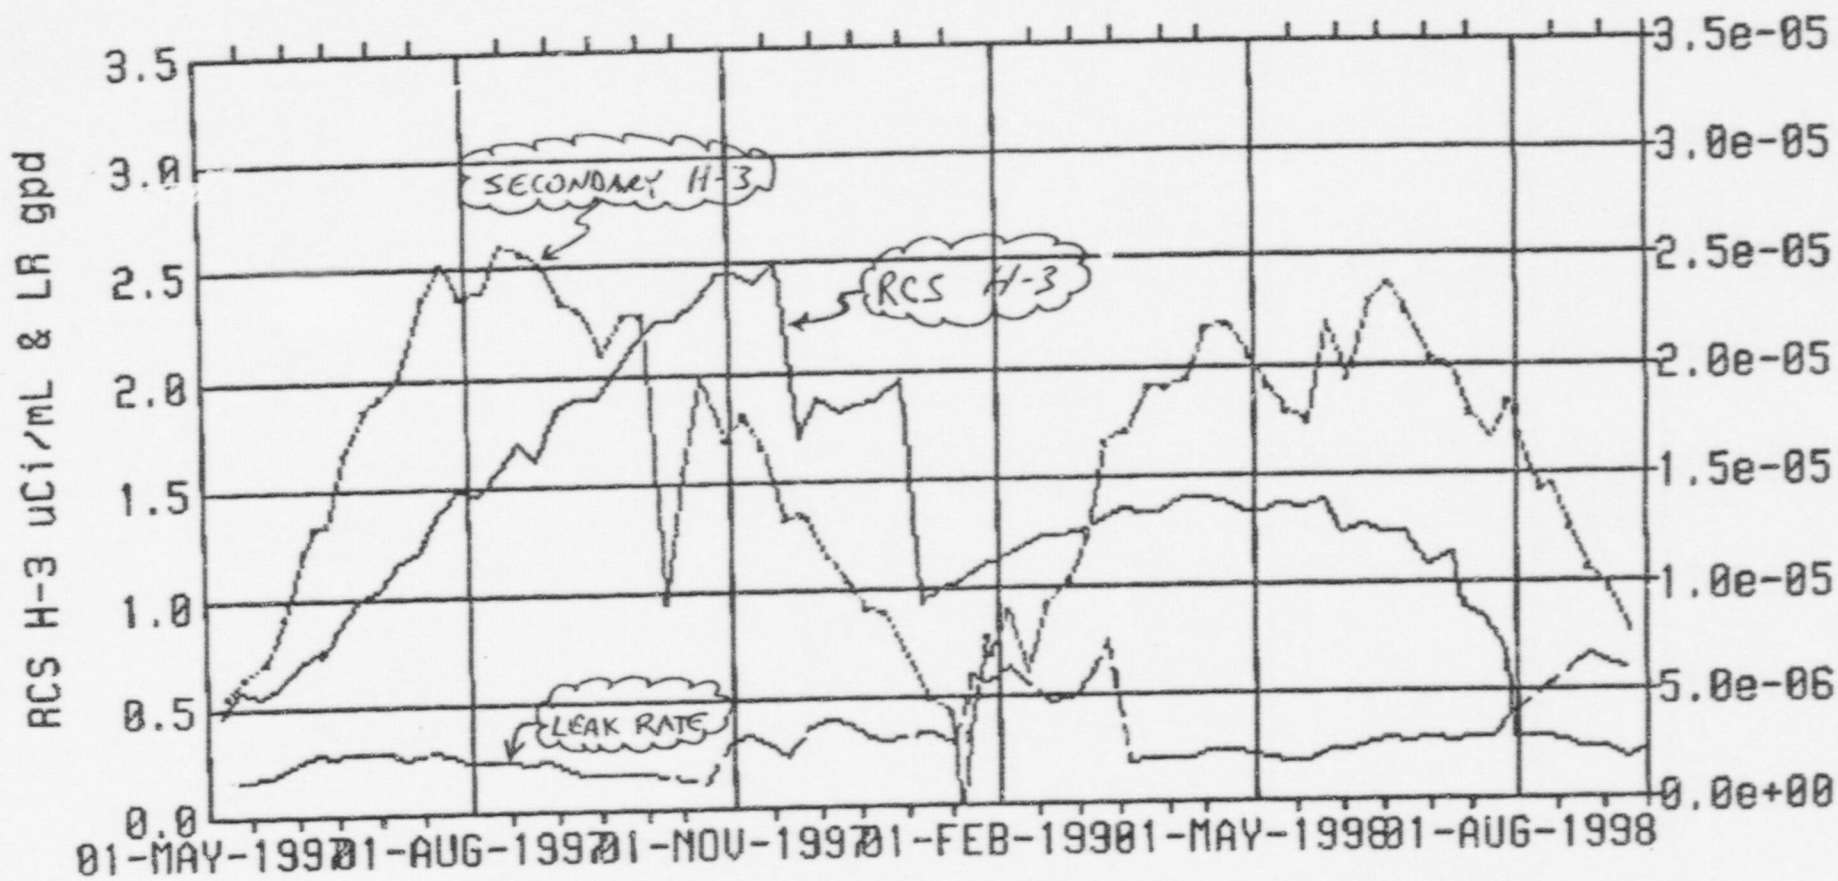
Unit Two Primary and Secondary Tritium and Leak Rate

STP 2RE06 – Leak rate prior to shutdown was a fraction of a gallon per day. Calculated leak rate with with stable tritium concentration in the primary was ~0.25 gpd, but never exceeded ~0.8 gpd during the cycle. See attached graph.
