Detroit
Edison

Subject: Response to CAL on Reactor Recirculation
Pump B Discharge Valve

ACTION PLAN STATUS

VIEWGRAPHS FROM SEPTEMBER 27, 1988
PRESENTATION AT NRC REGION III HEADQUARTERS

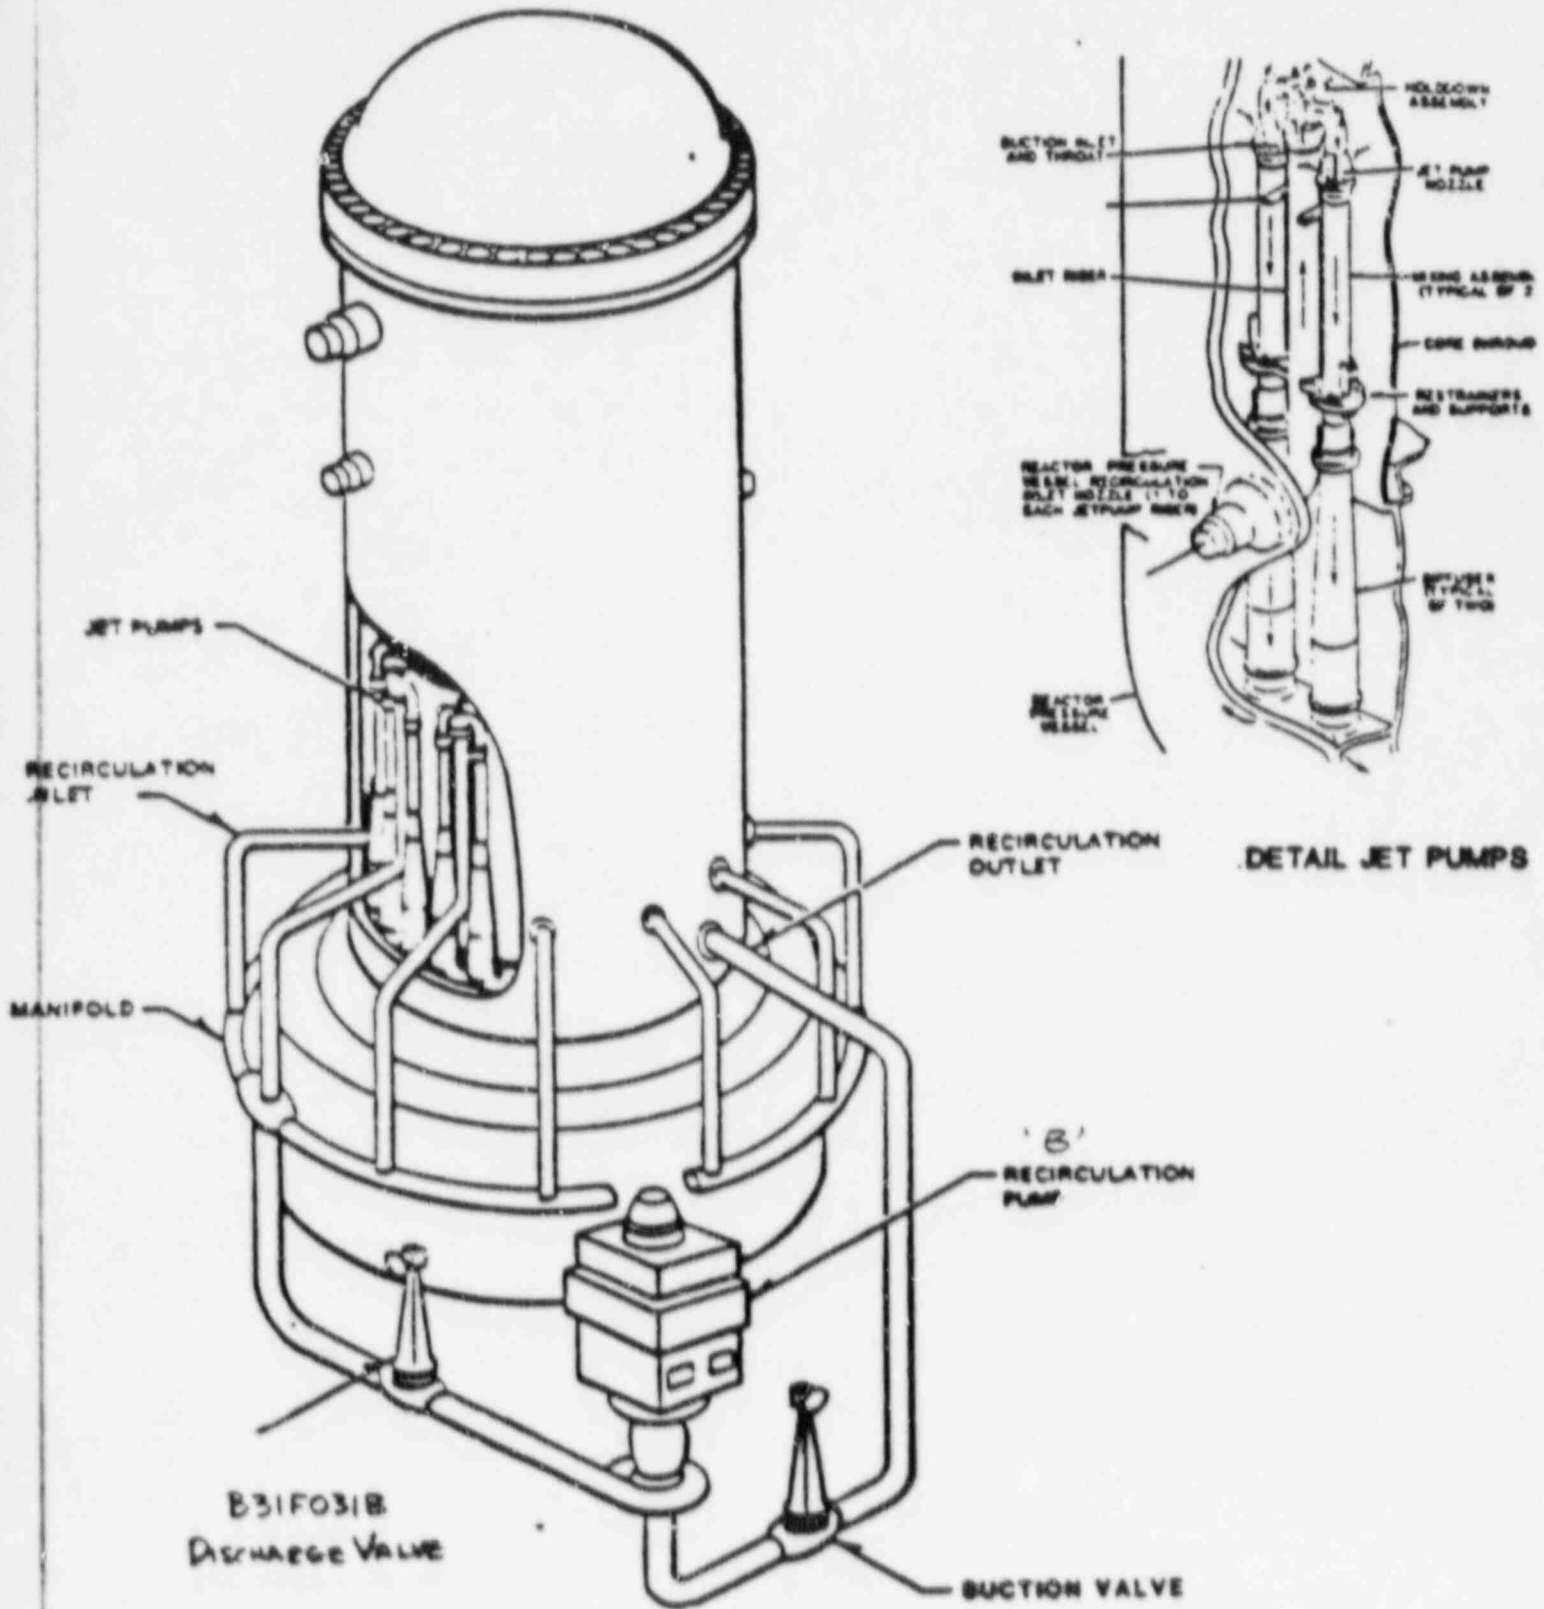
FIGURE 2-4 JET PUMPS AND RECIRCULATION PUMP SYSTEM

Single Loop Flow with Recirc Pump B Shutdown
 Attempted to close B31F031E To Allow
 Pump Restart ~ Would not close

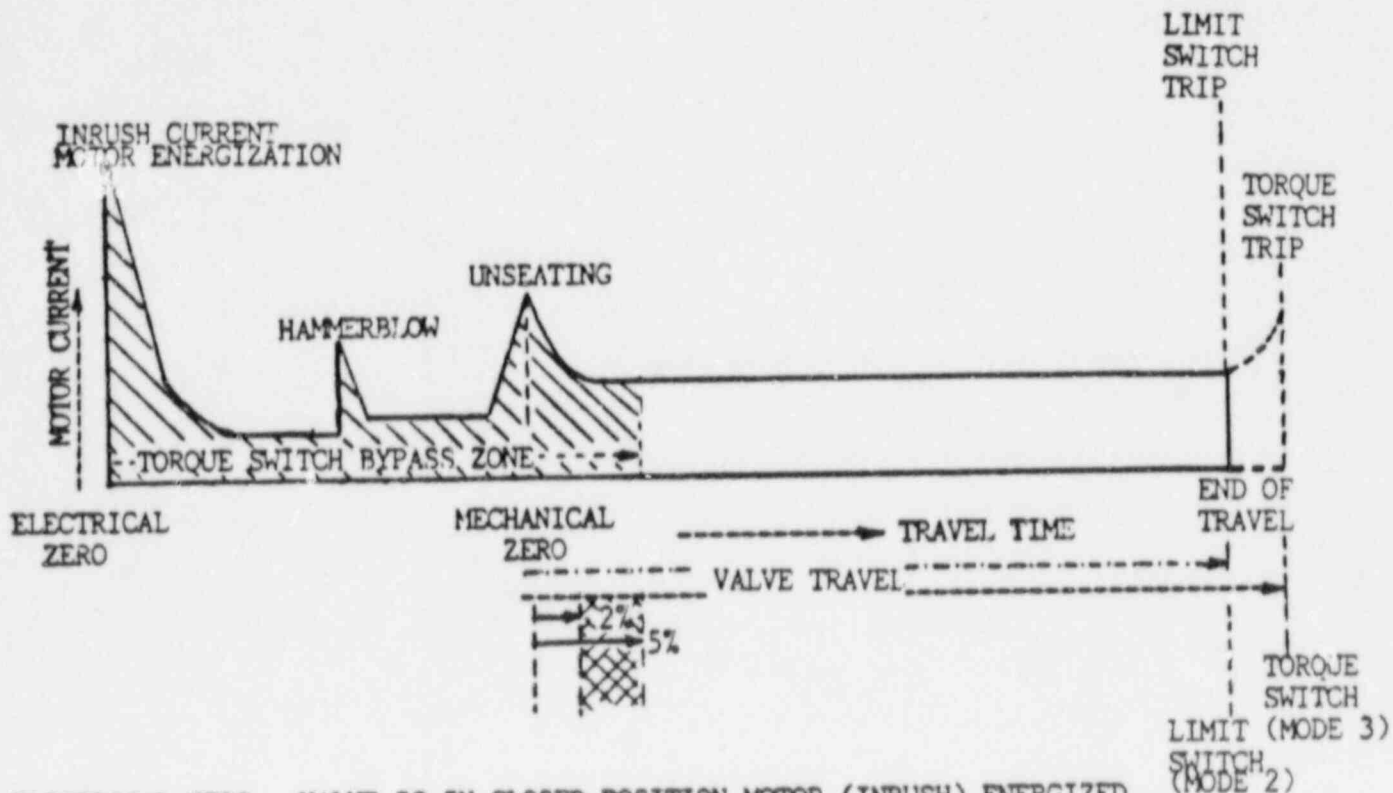
VALVE CLOSE-TO-OPEN CYCLE
DIAGRAM

HAMMERBLOW: DOGS ON THE WORM WHEEL CONTACT THE DRIVE KEYS IN THE CLUTCH RING WITH CONSIDERABLE IMPACT.

Note: Hammerblow could cause spring-pack deflection and vibrate the torque switch contact open momentarily.
