**LICENSEE EVENT REPORT (LER)**

FACILITY NAME (1) Millstone Nuclear Power Station Unit 3	DOCKET NUMBER (2) 05000423	PAGE (3) 1 of 6
---	-------------------------------	--------------------

TITLE (4)  
Potential Air/Gas Intrusion in Chemical and Volume Control System

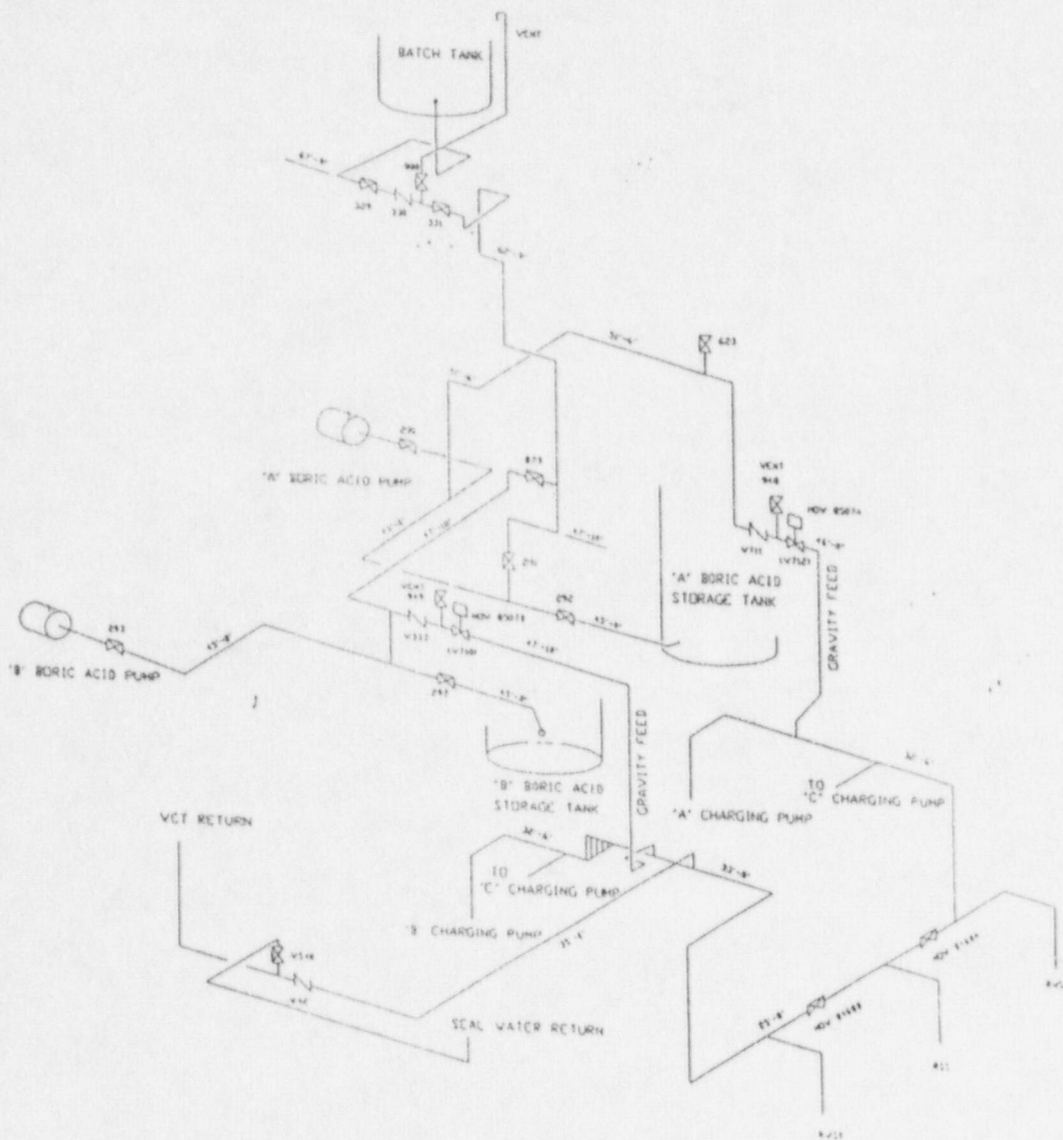
#### BORIC ACID BATCHING SYSTEM GRAVITY FEED SYSTEM (Not to Scale)

The boric acid batching process has led to air intrusion because the air filled space in the vertical section of piping below the Boric Acid Batch Tank is swept into either the "A" or "B" Train when the batch tank drain valve is opened for filling and the respective train's pump is running for mixing during batching operations. Air binding of the Boric Acid Pumps could prevent the flow of boric acid from the system when called upon. Also, both pumps tie into a common header to the charging pumps. Sufficient air within the system could lead to air binding of one or more charging pumps as they take suction from a common header. These conditions are reportable pursuant to 10 CFR 50.73 (a)(2)(vii) as "any event where a single cause or condition caused at least one independent train or channel to become inoperable in multiple systems or two independent trains or channels to become inoperable in a single system designed to: (A) Shut down the reactor and maintain it in a safe shutdown condition; [and] (D) Mitigate the consequences of an accident." This condition is being dispositioned in accordance with the Millstone Corrective Action Program.

The Boric Acid System consists of two separate trains, each containing a Boric Acid Storage Tank (BAST), Boric Acid Pump (to transfer borated water from the storage tank to either the Volume Control Tank (VCT), the RWST, or the suction of the charging pumps), and associated piping and valves. The Boric Acid Batch Tank is located on the floor level above the two trains. There is a long vertical drop in the piping from the batch tank to a connection with each system. During a batching operation a slug of air is trapped in this line and is swept into the operating Boric Acid Pump as it circulates the boric acid solution for mixing. A vent valve was installed on this section of piping during this outage.

The physical configuration of the "A" Boric Acid System Gravity Boration lines contains a high point segment of piping which is at a much higher elevation (51 feet - 6 inches) than the elevation of the line running from the "A" Boric Acid Storage Tank to the suction of the "A" Boric Acid Pump (45 feet - 0 inches). This section of piping is a dead leg (only opened if gravity boration is needed) and provides a large volume to trap gas/air once introduced into the system.

On the "B" Boric Acid System suction piping the vertical line from the Boric Acid Batch Tank contains a short horizontal segment at an elevation of 47 feet - 10 inches, which connects a short vertical segment that leads down to the horizontal suction line between the "B" Boric Acid Storage Tank and the suction of the "B" Boric Acid Pump (elevation of 45 feet - 0 inches). This short horizontal section of piping at elevation 47 feet - 10 inches can also trap air during batching

This condition is historical. The cause for air intrusion into the Boric Acid Pumps is inadequate initial design of the Boric Acid system piping configuration. Inadequacies in the design of the piping layouts and the lack of vents in some locations resulted in trapped air in the system. Contributing factors were inadequate batching and venting procedures. The boric acid batching process used introduced air into the System. The large amount of maintenance performed during this outage on portions of the Chemical and Volume Control and the Boric Acid Systems could have introduced air pockets into the Boric Acid System which may not have been adequately vented.

1. Troubleshooting of the Boric Acid System to determine the source(s) of air intrusion into the system and corrective actions have been identified.
2. Procedures have been revised to incorporate lessons learned from the troubleshooting effort to avoid air entrainment during Boric Acid batching operation to address deficiencies in the design of the system.

3. Vent valves have been added to the high points in the gravity boration pathways.
4. The effectiveness of Boric Acid batching procedure was validated and the procedure was revised as a result
