CATAWBA UNIT 2

DIESEL GENERATOR 2B #7 MAIN BEARING FAILURE REPORT
LOW POWER LICENSE CONDITION NO. 13, ATTACHMENT 1, ITEM 9

Prepared by
Duke Power Company

April 1986

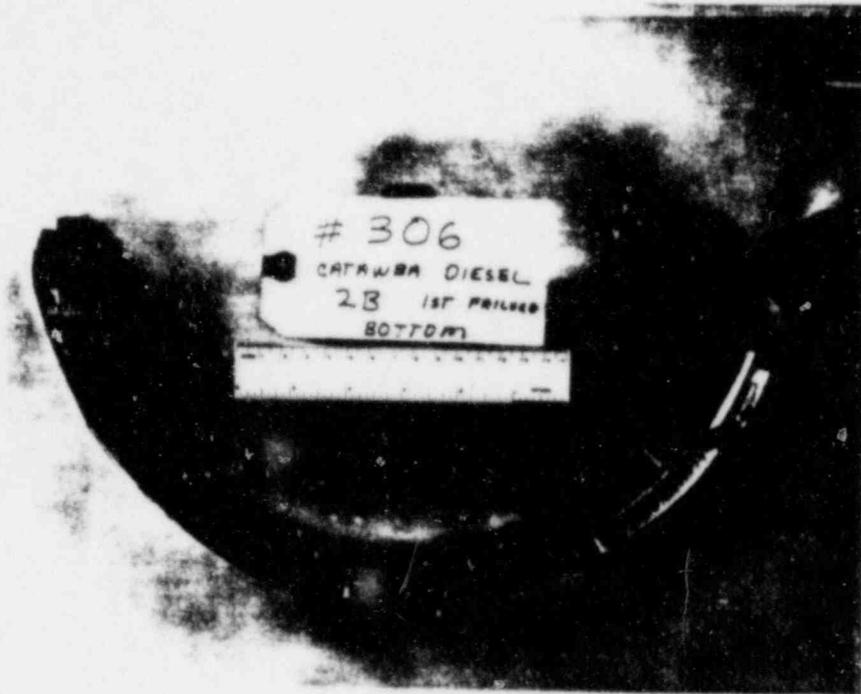
Figure 1 - Fractured #7 lower bearing from 1st failure. Fracture is believed to have initiated at left side, in the annular groove. Ma-451.

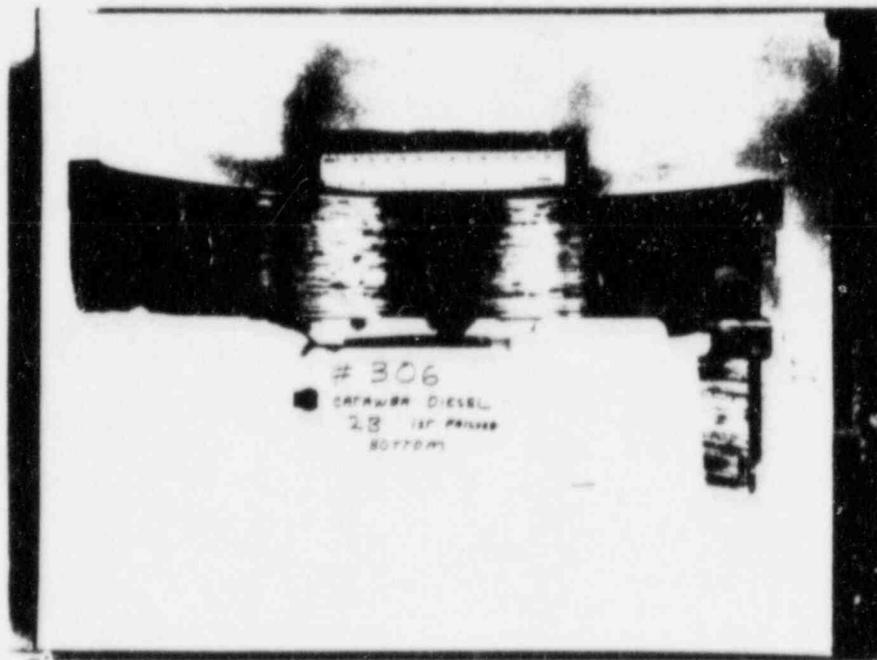
Figure 2 - Top view of #7 lower bearing first failure. Note fracture of the keyslot, which is not considered the primary fracture, secondary cracks in the webbing parallel to the primary fracture, and the change of direction of the fracture at right. Ma-453.

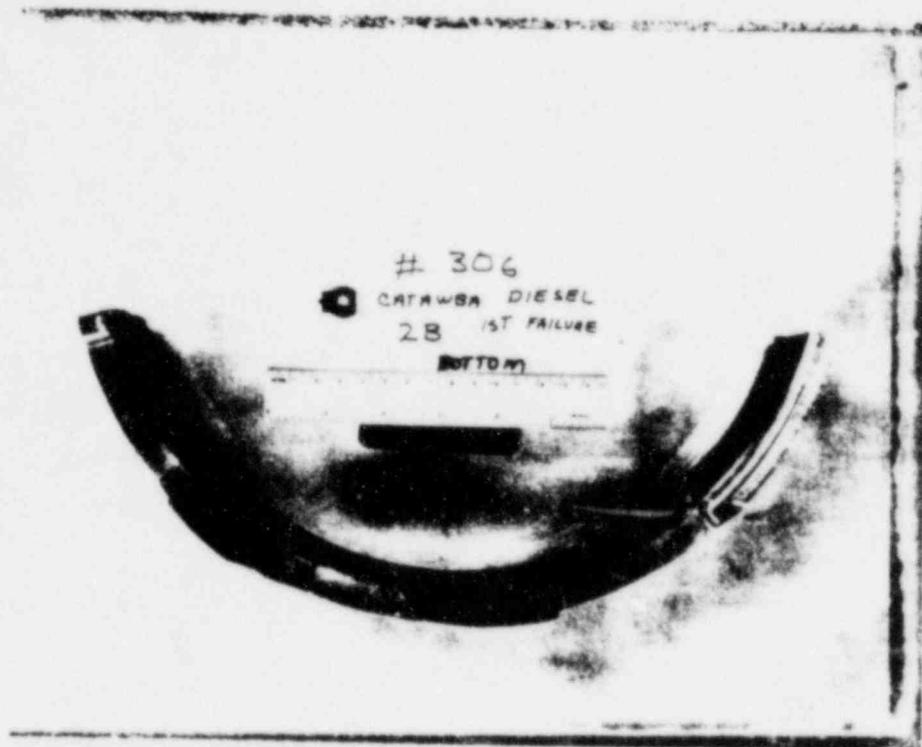
Figure 3 - Remaining portion of #7 lower bearing, first failure. Fracture face on right web was removed for examination by FaAA. Ma-450.

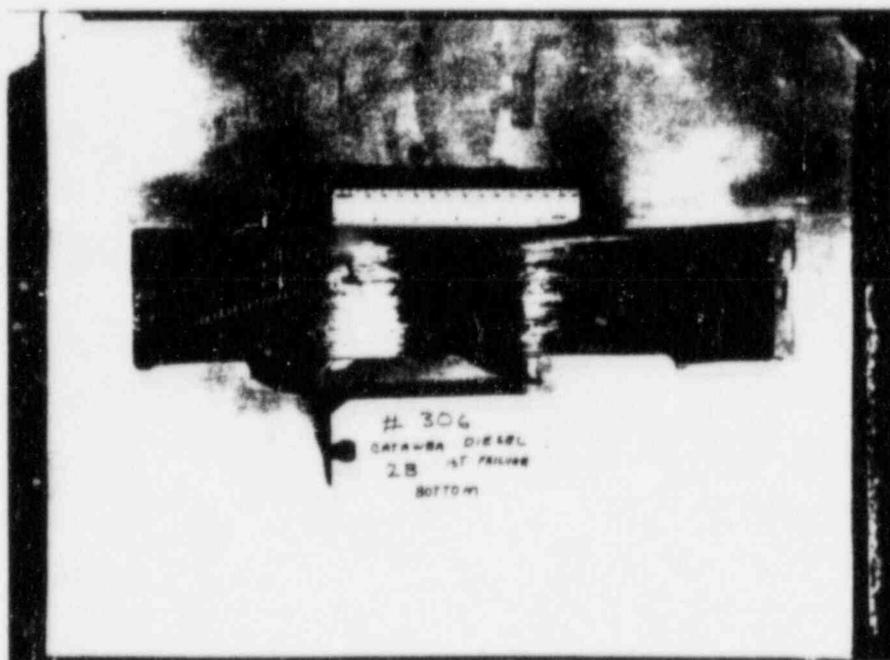
Figure 4 - Top view of above bearing. Babbitt overlay is completely worn away and aluminum surface is heavily abraded. Crack changed directions and fractured perpendicular to annular groove. Ma-452.

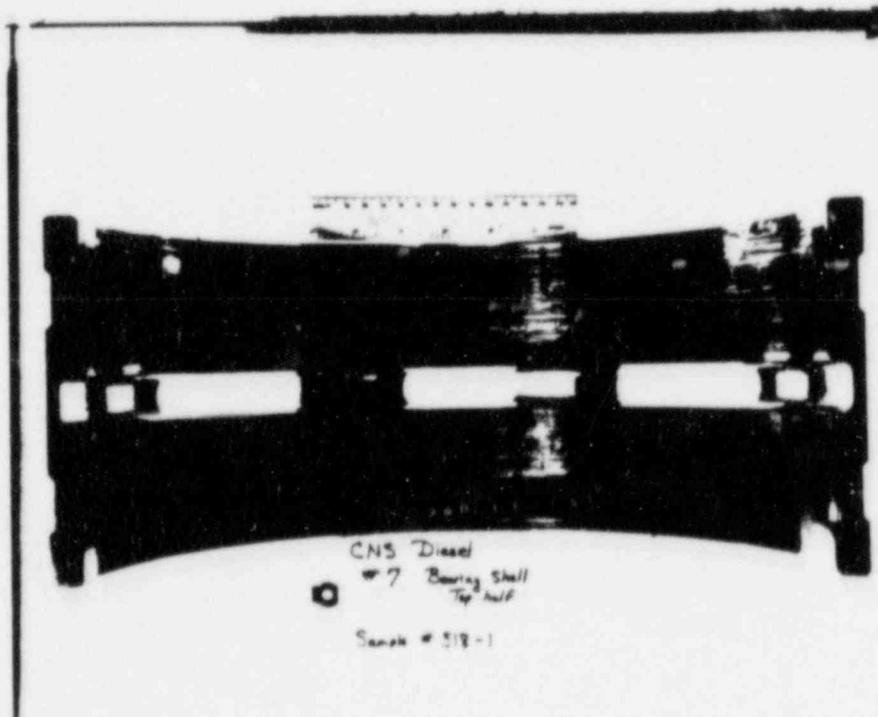
Figure 6 - Lower #7 bearing, 2nd failure. Upper portion of bearing is heavily abraded while Pb based babbitt is still intact at outer edge of lower portion, suggesting non-uniform loading. Ma-444.

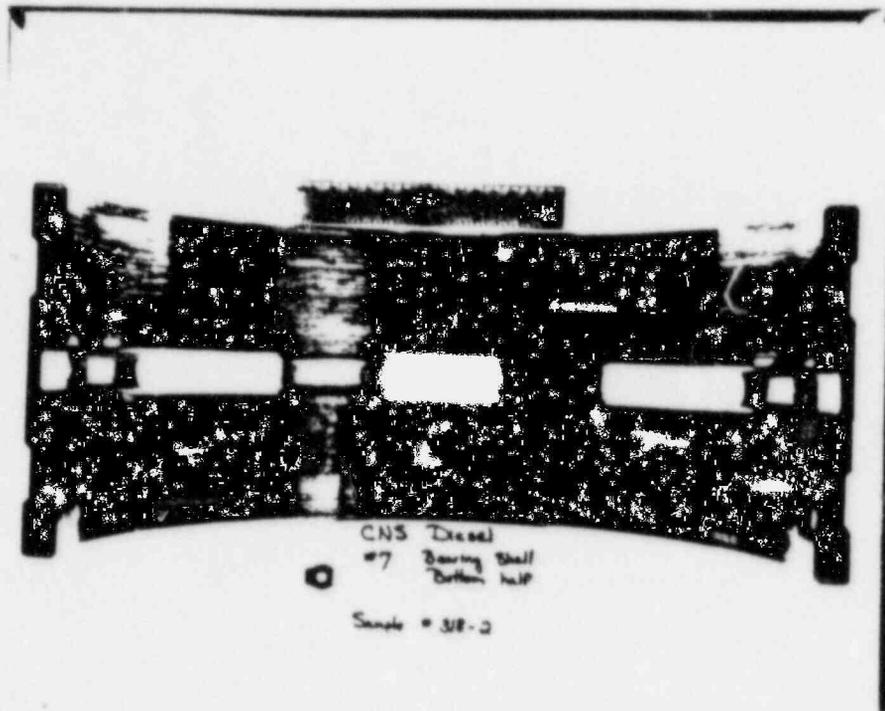
Lower #7 bearing, 2nd failure, exhibiting non-uniform wear previously mentioned. Crack can be seen at lower right corner of annular groove. Ma-446.

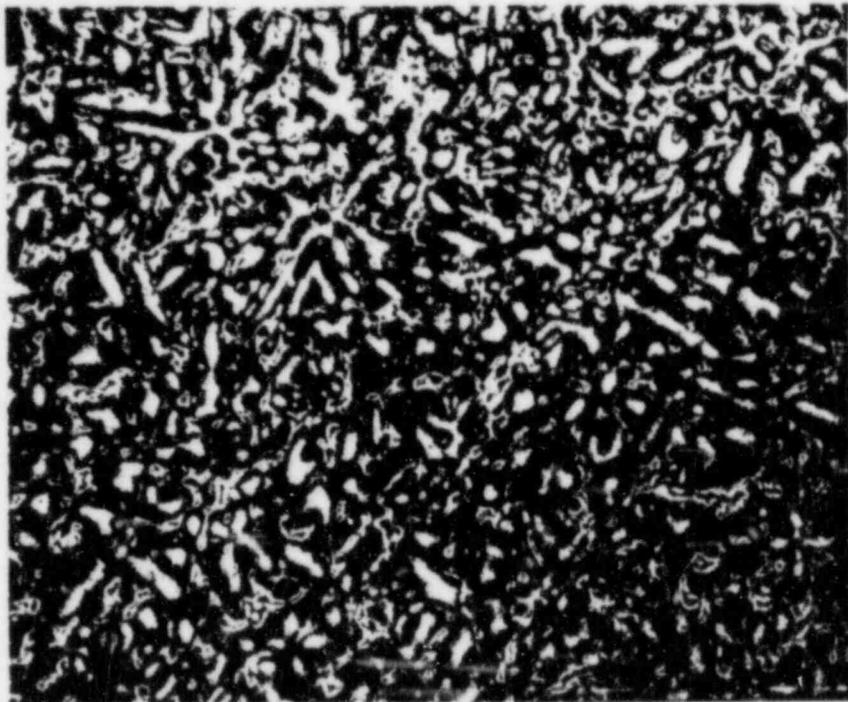
Figure 15 - Microstructure of bearing material. The material is reported to be B850 aluminum alloy. (100x) MI-685.

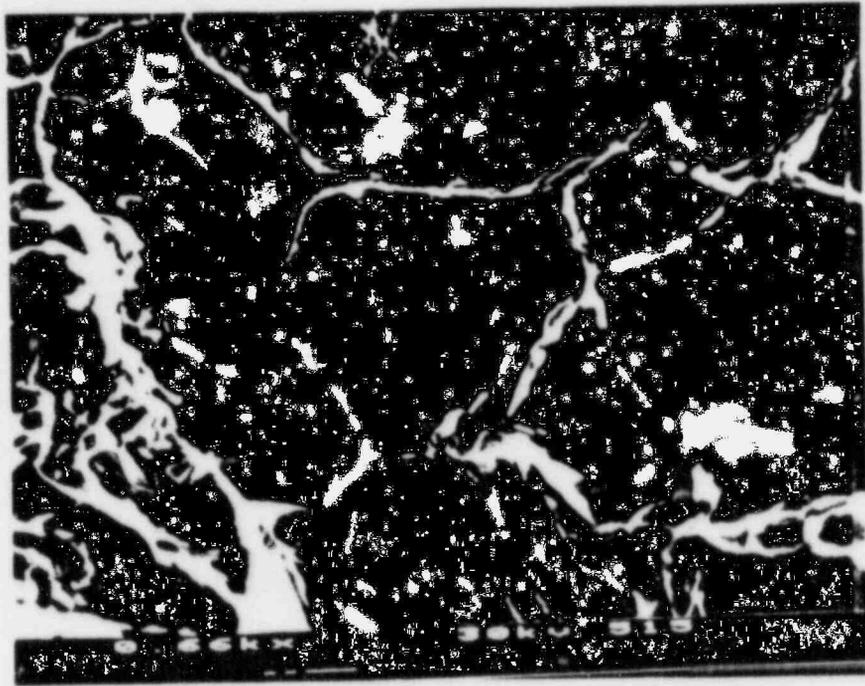
Figure 19 - Intergranular appearance of fracture of tensile specimen. (660x) S-345.

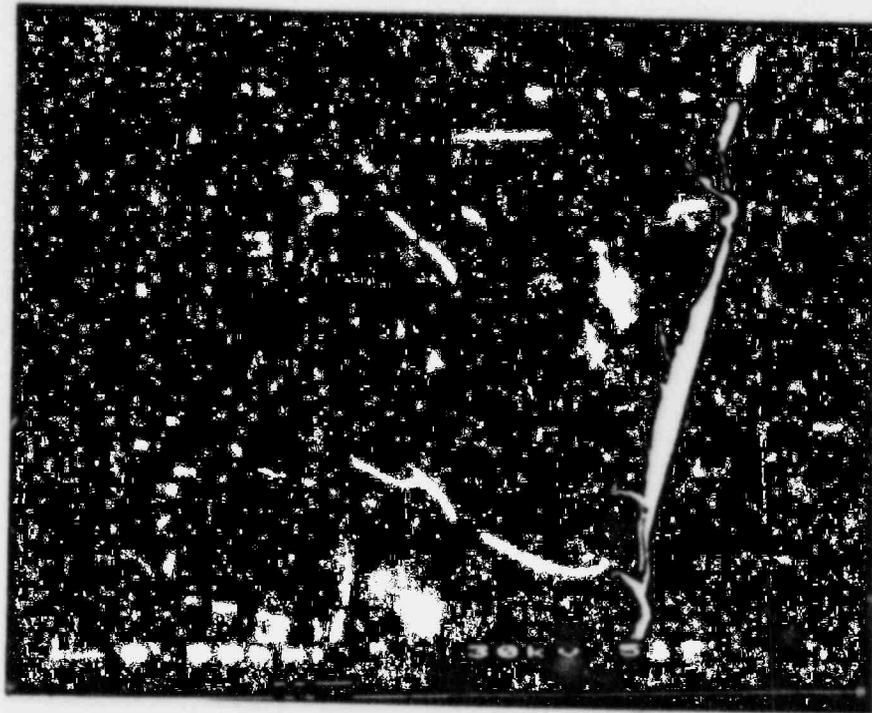
Figure 21 - Additional voids at surface of bearing casting. Voids are numerous and are found throughout the fracture surface. (500x) S-347.

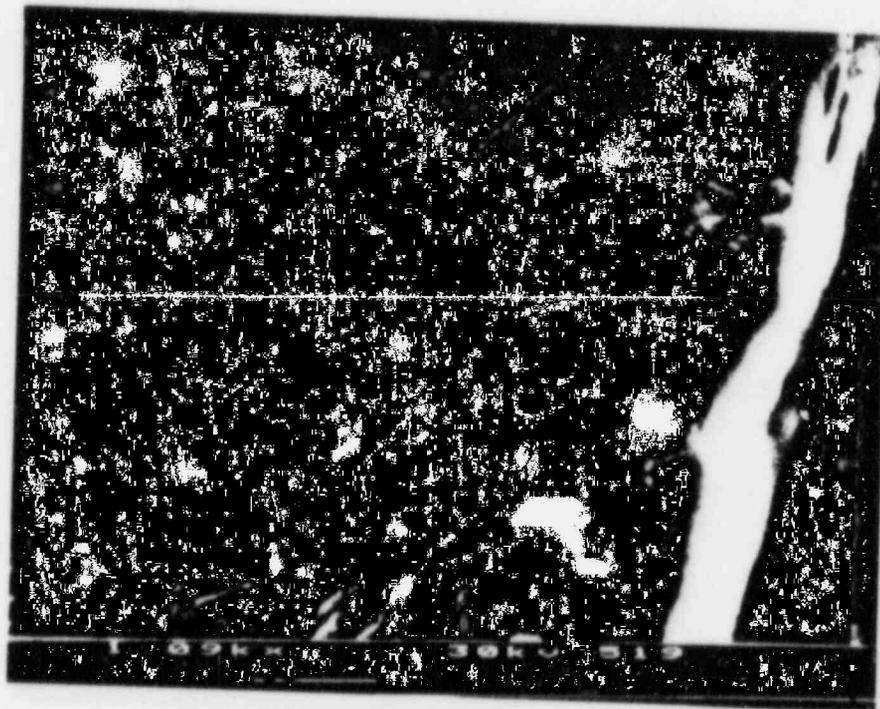
Figure 22 - Apparent fatigue striations can be seen in immediate center of photograph. This area is located just above void shown in Fig. 21 (1090x) S-350.
