FaAA-DC-R-86-04-02
QRDUK/LAS4/R-QRDUK

DRAFT REPORT

**MAIN BEARING SHELL ANALYSIS
#2B EMERGENCY DIESEL GENERATOR
DUKE POWER COMPANY - CATAWBA UNIT #2**

April 1986

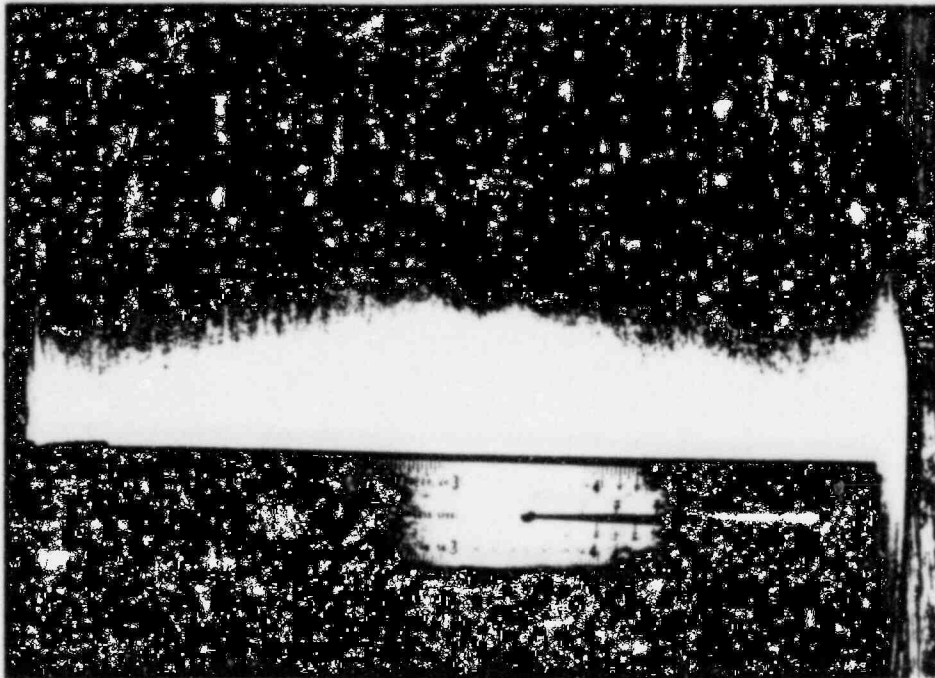
Examination of the lower bearing shell O.D. disclosed non-uniform contact between the shell and the bearing saddle in the engine base. Figures 1A and 1B show the range of contact evidence, from almost no contact (Fig. 1A) to normal contact (Fig. 1B), the latter characterized by the normal embedding of ferrous oxide in the aluminum.

The fatigue crack appears to have had two contributing causes: The non-uniform O.D. contact pattern on the lower bearing shows that it was not seated perfectly in the bearing saddle and, thus, was not installed in its design condition. This would cause normal operating loads to develop higher than normal cyclic stresses in the bearing shell due to concentrated reaction loads and induced bending. Secondly, the large amount of embedded debris in the bearing I.D. also caused local stresses to be higher than normal. Embedded dirt particles displace bearing material, some of which is forced inward toward the crankshaft. These areas then support more of the operating loads than the nearby unaffected areas, raising local cyclic stresses. Due to the destruction of the surface details during the wiping incident, and lack of any way to characterize quantitatively the effect of the non-uniform O.D. support, it is now impossible to assign degrees of contribution among the two fundamental causes of the failure, minor misalignment and major particulate embedding.

FIGURE 1A. Lower bearing shell O.D. showing minimal contact with engine base bearing saddle.
(QRDUK, Roll 3, Exp. 7)

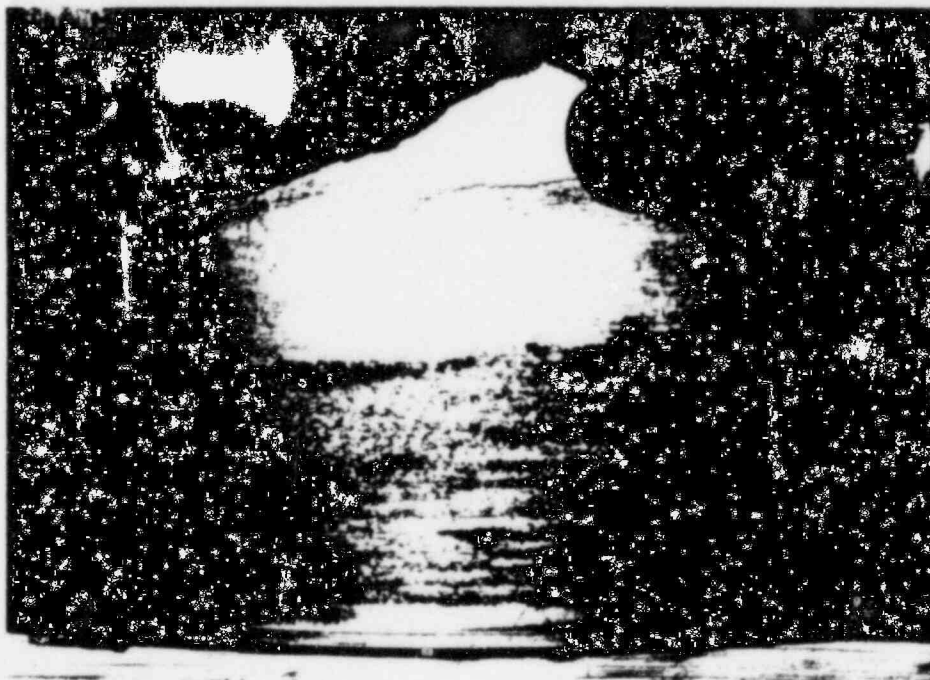
FIGURE 1B. Lower bearing shell O.D. exhibiting normal contact pattern.
(QRDUK, Roll 3, Exp. 16)

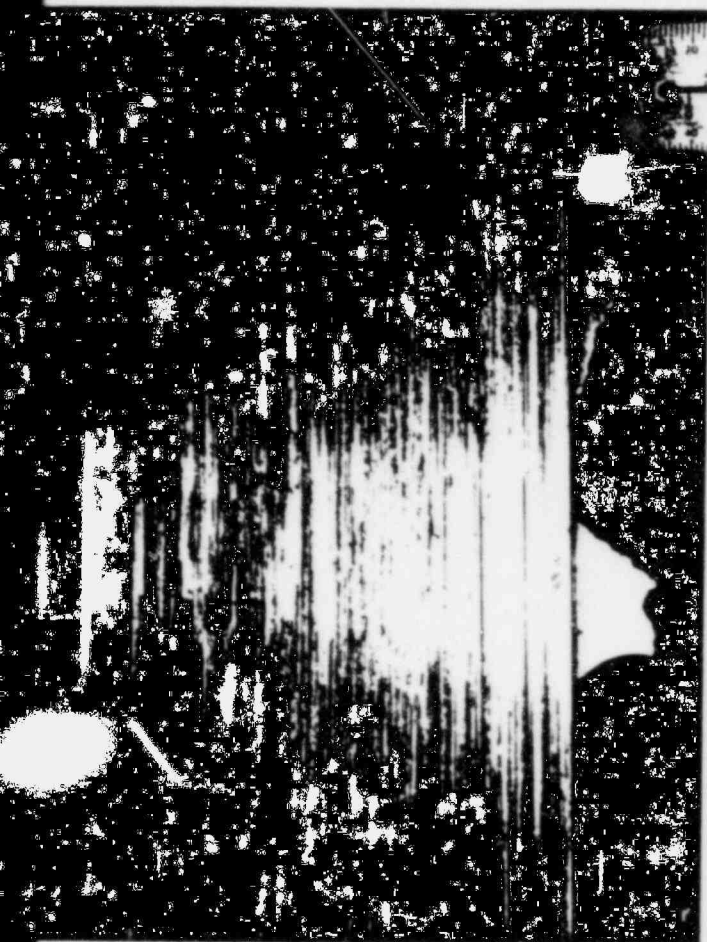
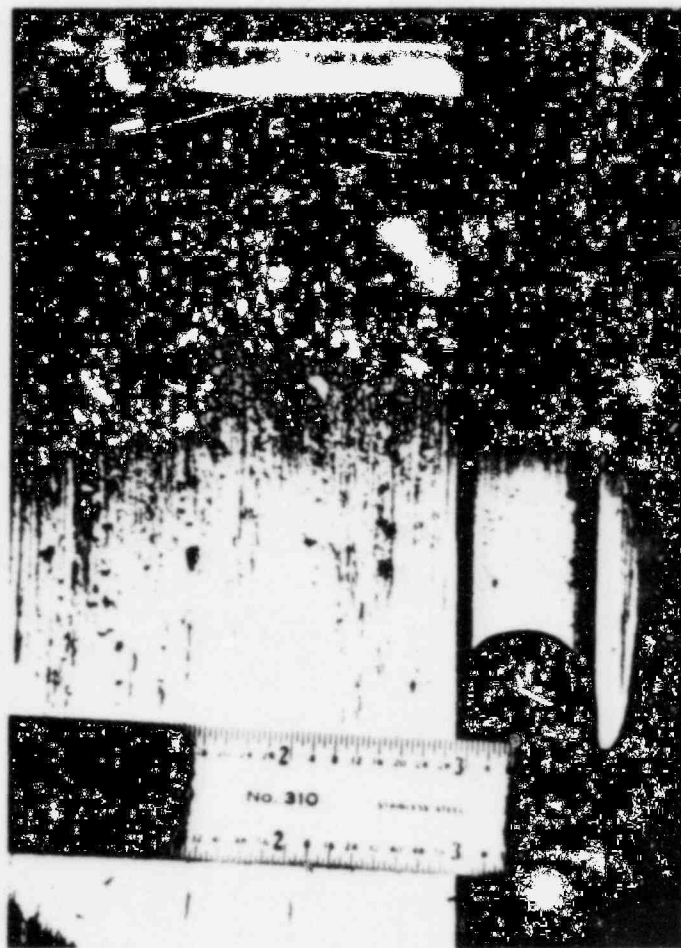
The primary feature of note is the evidence of severe scoring by foreign particles on the bearing shell I.D. Figures 2A, 2B, and 2C show the degree of scoring on the lower bearing shell in which hard particles significantly larger than the overlay thickness abraded the surface and embedded themselves in the aluminum. Figures 3A and 3B document scoring of the upper (unloaded) bearing shell by relatively large particles. In addition, Duke Power Company engineers reported that the No. 7 main journal had been scored by large (many thousandths of an inch) hard particles, and that other, unfailed main bearing shells, e.g., Nos. 4 and 6, had high levels of dirt scoring and embedded particles. This is consistent with the reported history of Engine 2B's suffering contamination from grit-blasting media during the construction activities at Catawba Nuclear Station.

FIGURES 2A, 2B, 2C: Lower bearing shell I.D. with severely scored surface.

compliance of the bearing increased to the point where it could no longer support operational loads and failed catastrophically. Subsequent to these failures, Duke Power Company representatives have reported that thorough engine flushing and careful bearing installation procedures have prevented recurrence of any problems in the No. 7 bearing during more than 100 hours of additional engine operation.

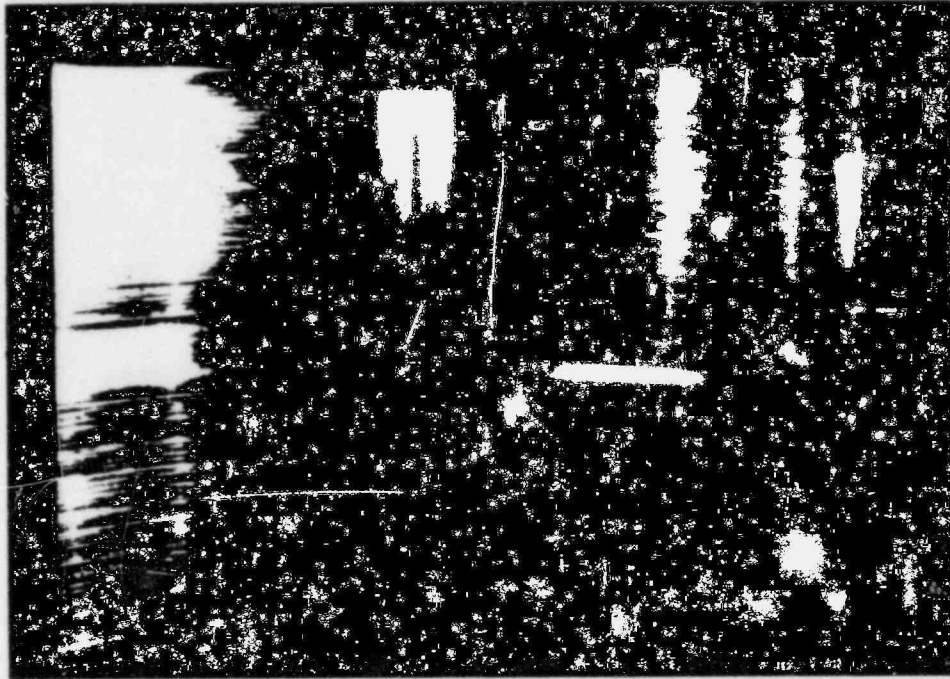
FIGURE 3A. Scoring of upper bearing shell I.D.
(QRDUK, Roll 6, Exp. 5)

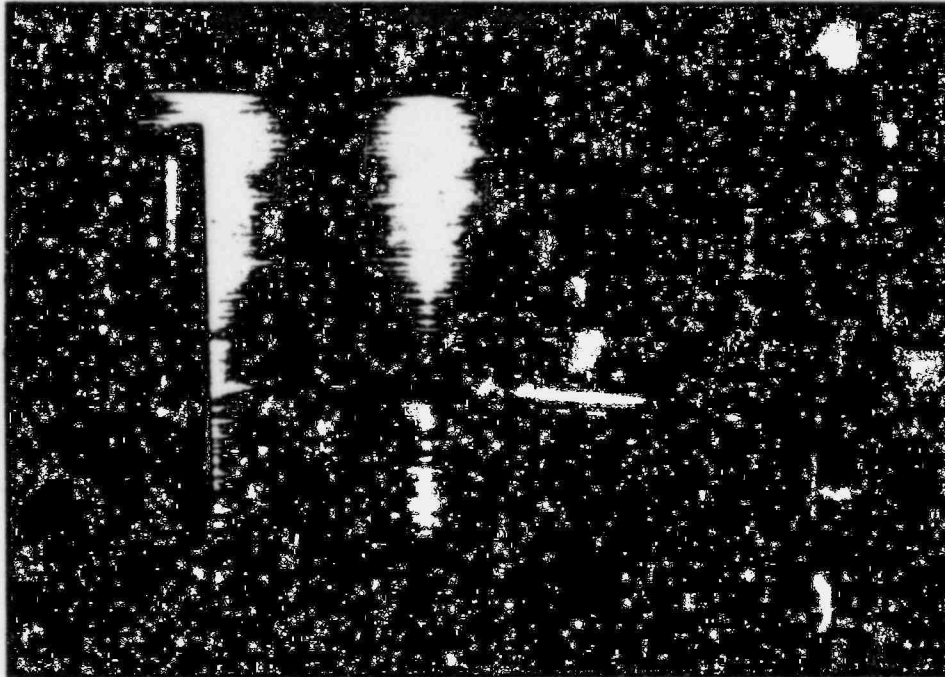
FIGURE 3B. Scoring of upper bearing shell I.D.
(QRDUK, Roll 6, Exp. 6)
