INDEPENDENT SAFETY EVALUATION SERVICES

PROJECT REPORT 3-96

Investigation of E Diesel Generator In-operability Event

Report Date: 7/24/96

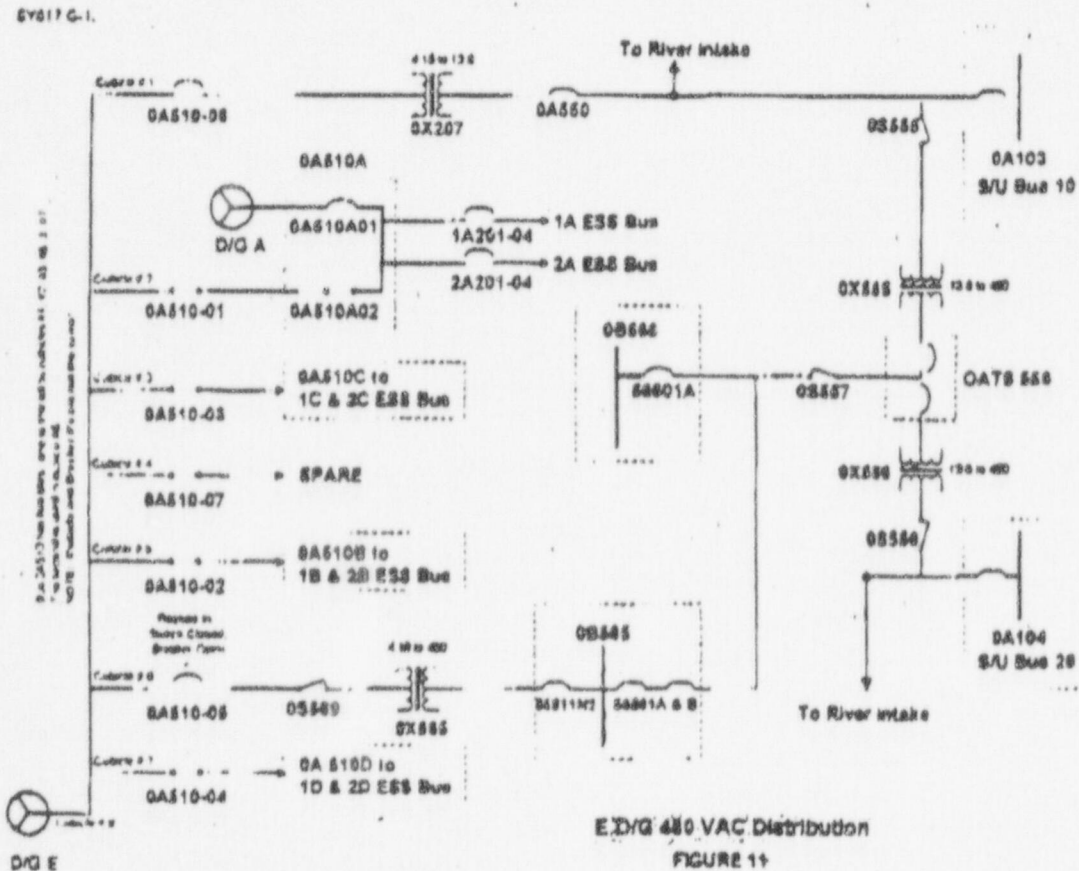
FIGURE 1

Figure 1 shows the breaker configuration used to connect the E DG to the various buses.

The design makes it impossible to connect two diesel generators to the same bus at the same time. This is done by physically moving the transfer breakers of the affected diesel and of DG E. Consider Figure 1. In order to align the E DG to the A ESS buses, the transfer breaker of the A DG (0A510A01) must be moved from the output of the A DG to position 0510A02 and the transfer breaker of the E DG must be moved from the test position (0A510-06) to position 0A510-01. When the alignment is made the above breakers are closed. They establish the current path. Electricity can now flow from the E DG to the 1A and 2A ESS buses via 0A510-01 and 0A510A02. The actual output breakers, which close to connect the diesels to the ESS buses, are located on the ESS buses downstream of panels 0A510 and 0A510A through D. The only time that the transfer breaker on panel 0A510 serves as the E DG output breaker is when the E DG is being tested by supplying power to transformer 0X207.

Notice that buses 0B565 and 0B566, the E DG auxiliary power buses are normally supplied by offsite power from Transformer T-10 or T-20. If offsite power were lost, auxiliary power would come from the E DG via breaker 0A510-05, which would shut.

Notice also that the transfer breaker of the E DG changes number from 05A10-06, to 01, 02, 03, or 04 depending upon which bus is being supplied. In the normal configuration where the E DG is not in service the E DG output breaker is in the test position and is numbered 0A510-06.

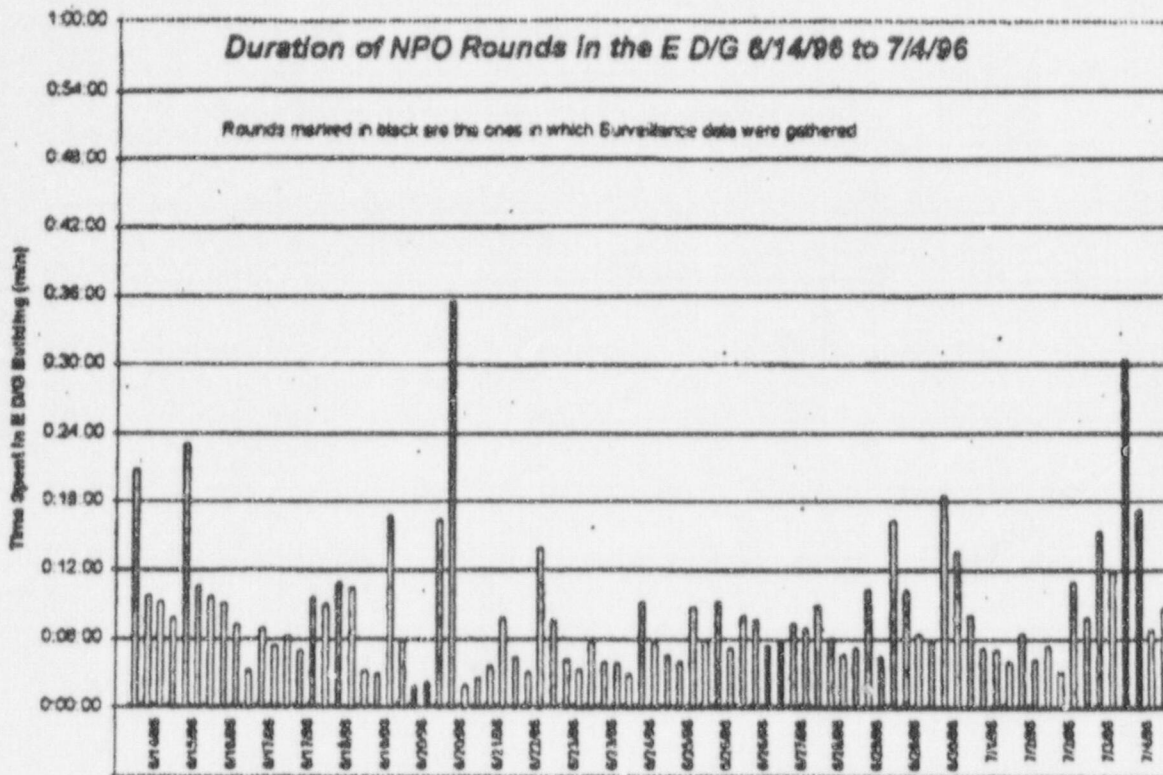
The fact that 15 operators over the course of 82 rounds failed to detect the E DG misalignment raises questions as to the quality of operator rounds. As noted above, ISES reviewed the time spent in the E DG building by the NPOs performing operator rounds. The data are plotted on Figure 3.

Times ranged between 1 minute 49 seconds and 35 minutes 33 seconds. The average was 8 minutes 28 seconds. Eleven rounds were completed in less than 3 minutes and 30 seconds.

The above figures raise serious doubts about the quality of rounds being performed by some nuclear plant operators. ISES recommends that the specific performance of Operators 3, 4 and 5 be evaluated. ISES also recommends that significantly more management attention be paid to the performance of operator rounds in general.
