AEOD SPECIAL REPORT

UNIT: LaSalle 2 SPECIAL REPORT NO.: AEOD/S803
DOCKET NO.: 50-374 DATE: June 7, 1988
LICENSEE: Commonwealth Edison EVALUATOR/CONTACT: J. Kauffman/G. Lanik

SUBJECT: AEOD CONCERNS REGARDING THE POWER OSCILLATION EVENT
AT LASALLE 2 (BWR-5)

EVENT DATE: March 9, 1988

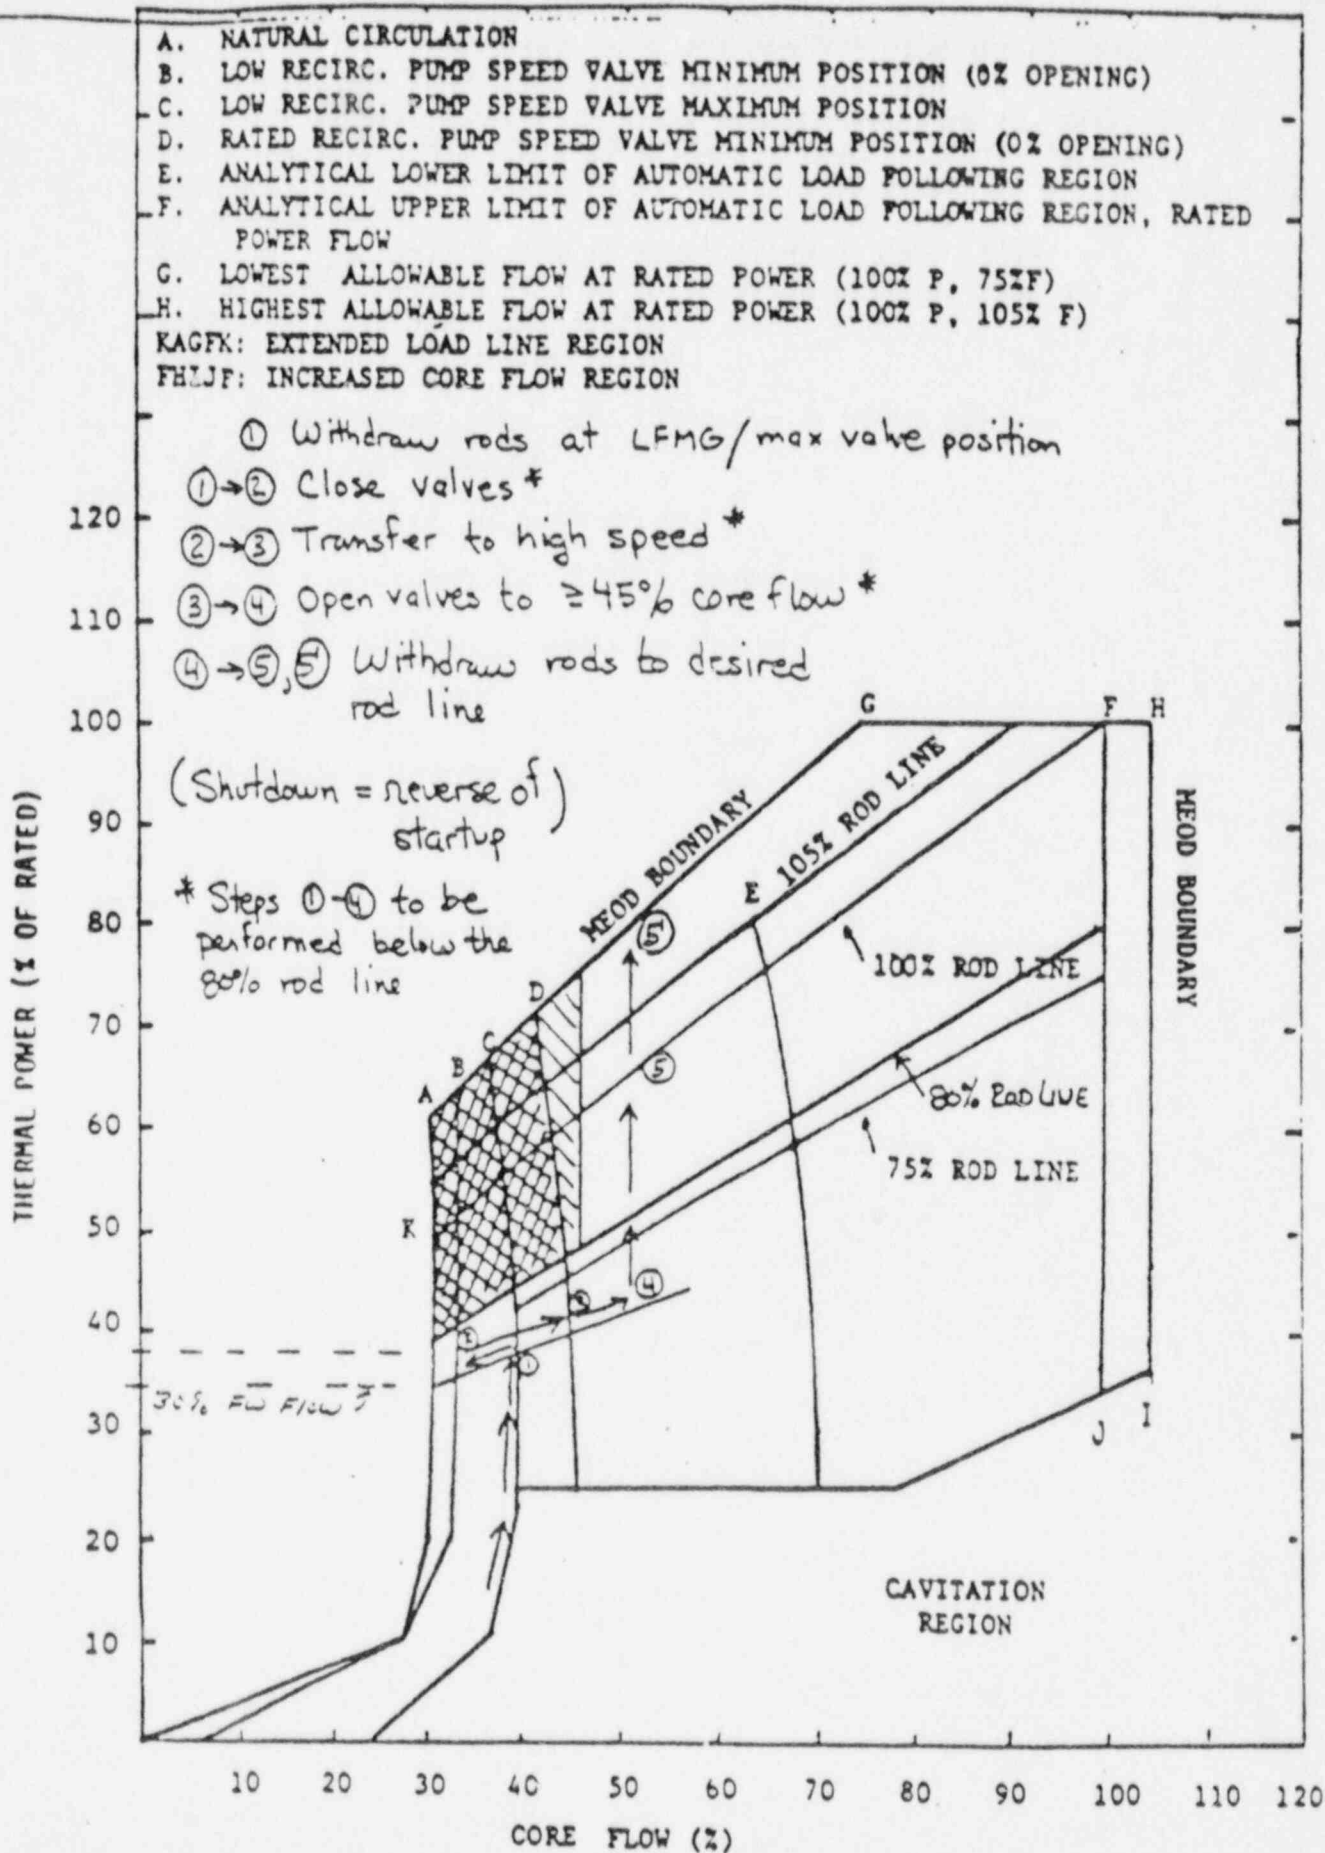
to prevent routine entry into potentially unstable areas. In particular, guidance was developed to prevent routine entry into these areas during reactor startups and shutdowns, to require increased monitoring of APRMs and LPRMs in potentially unstable areas, and to provide guidance for operator response to certain transients such as loss of feedwater heaters and recirculation pump trips and restarts. In summary, these foreign plants have taken action to restrict or prohibit operation in areas of instability. Figure 1 is an example of operating restrictions during startup and shutdown in place at one foreign BWR.

Figure 1. Example of Methods to Avoid Unstable Regions

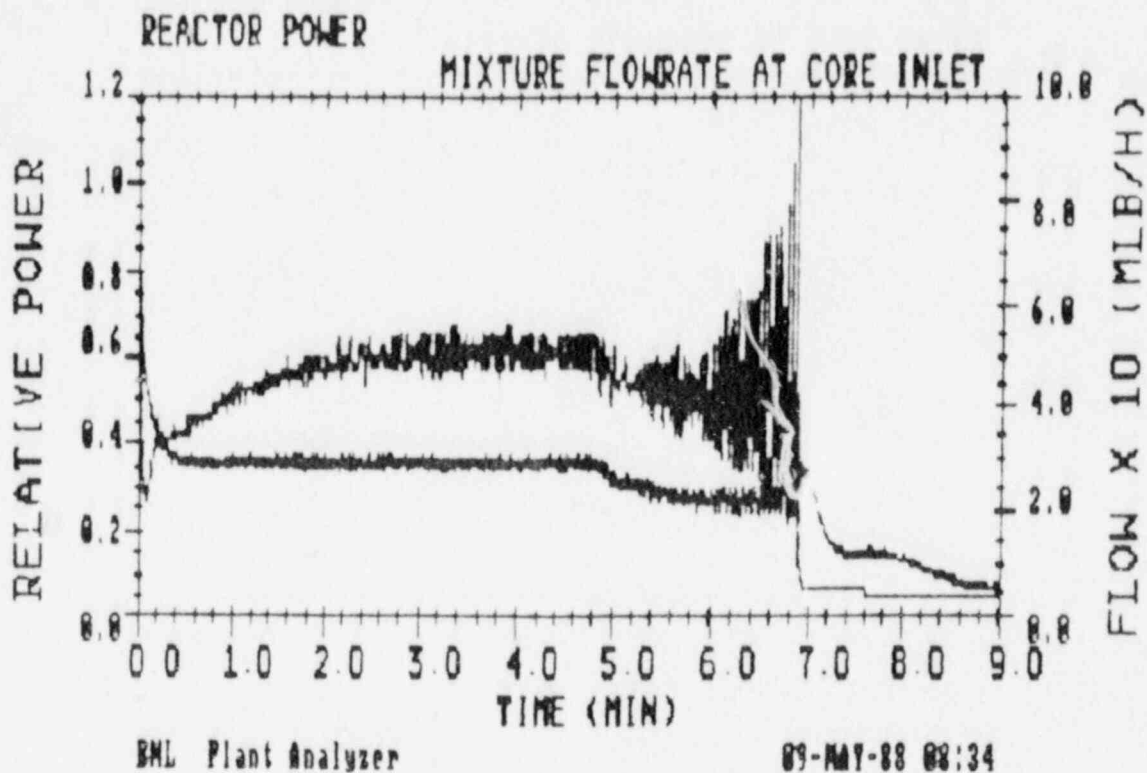
Figure 2

Several calculations using the BWR Nuclear Plant Analyzer were performed by Brookhaven at AEOD request. The simulation of the LaSalle event is shown in Figures 2 through 5. By parametrically increasing loop flow resistances, it was possible to generate power oscillations similar to those experienced at LaSalle. Preliminary results from these runs indicate that large reactivity changes occur during these events. The power oscillations experienced at LaSalle are cyclic interactions of core void formation, flow, and neutron power. The period of the oscillations is about 2.5 seconds while the thermal time constant of the fuel is 5 to 7 seconds; and consequently, direct gamma heating of the coolant is the likely energy feedback mechanism. This phenomena apparently begins with thermal-hydraulic instabilities arising due to relatively large two-phase resistance in the core, while the driving head and flow rate are

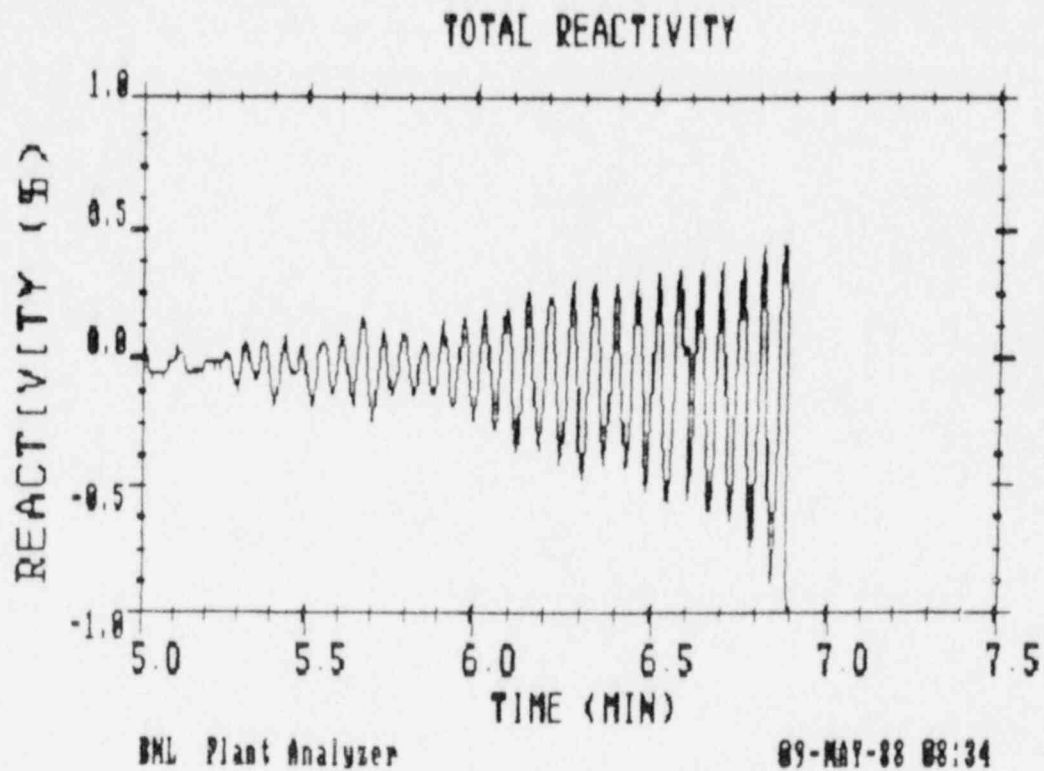
Figure 4

Preliminary results from the Brookhaven analyzer indicate that large reactivity changes occur during these events. Figure 4, for example, represents the LaSalle base case, where the analyzer calculated 0.5 dollars total reactivity inserted just prior to the reactor trip.
