LICENSEE EVENT REPORT (LER)

FACILITY NAME (1)	DOCKET NUMBER (2)	PAGE (3)
Sequoyah, Unit 1	0 5 0 0 0 3 2 7 1	OF 0 7

Improper Valve Alignment Caused By Poor Communications Results In A Loss Of Reactor Coolant Water Inventory, RHR Pump Cavitation, And Loss Of RHR Cooling

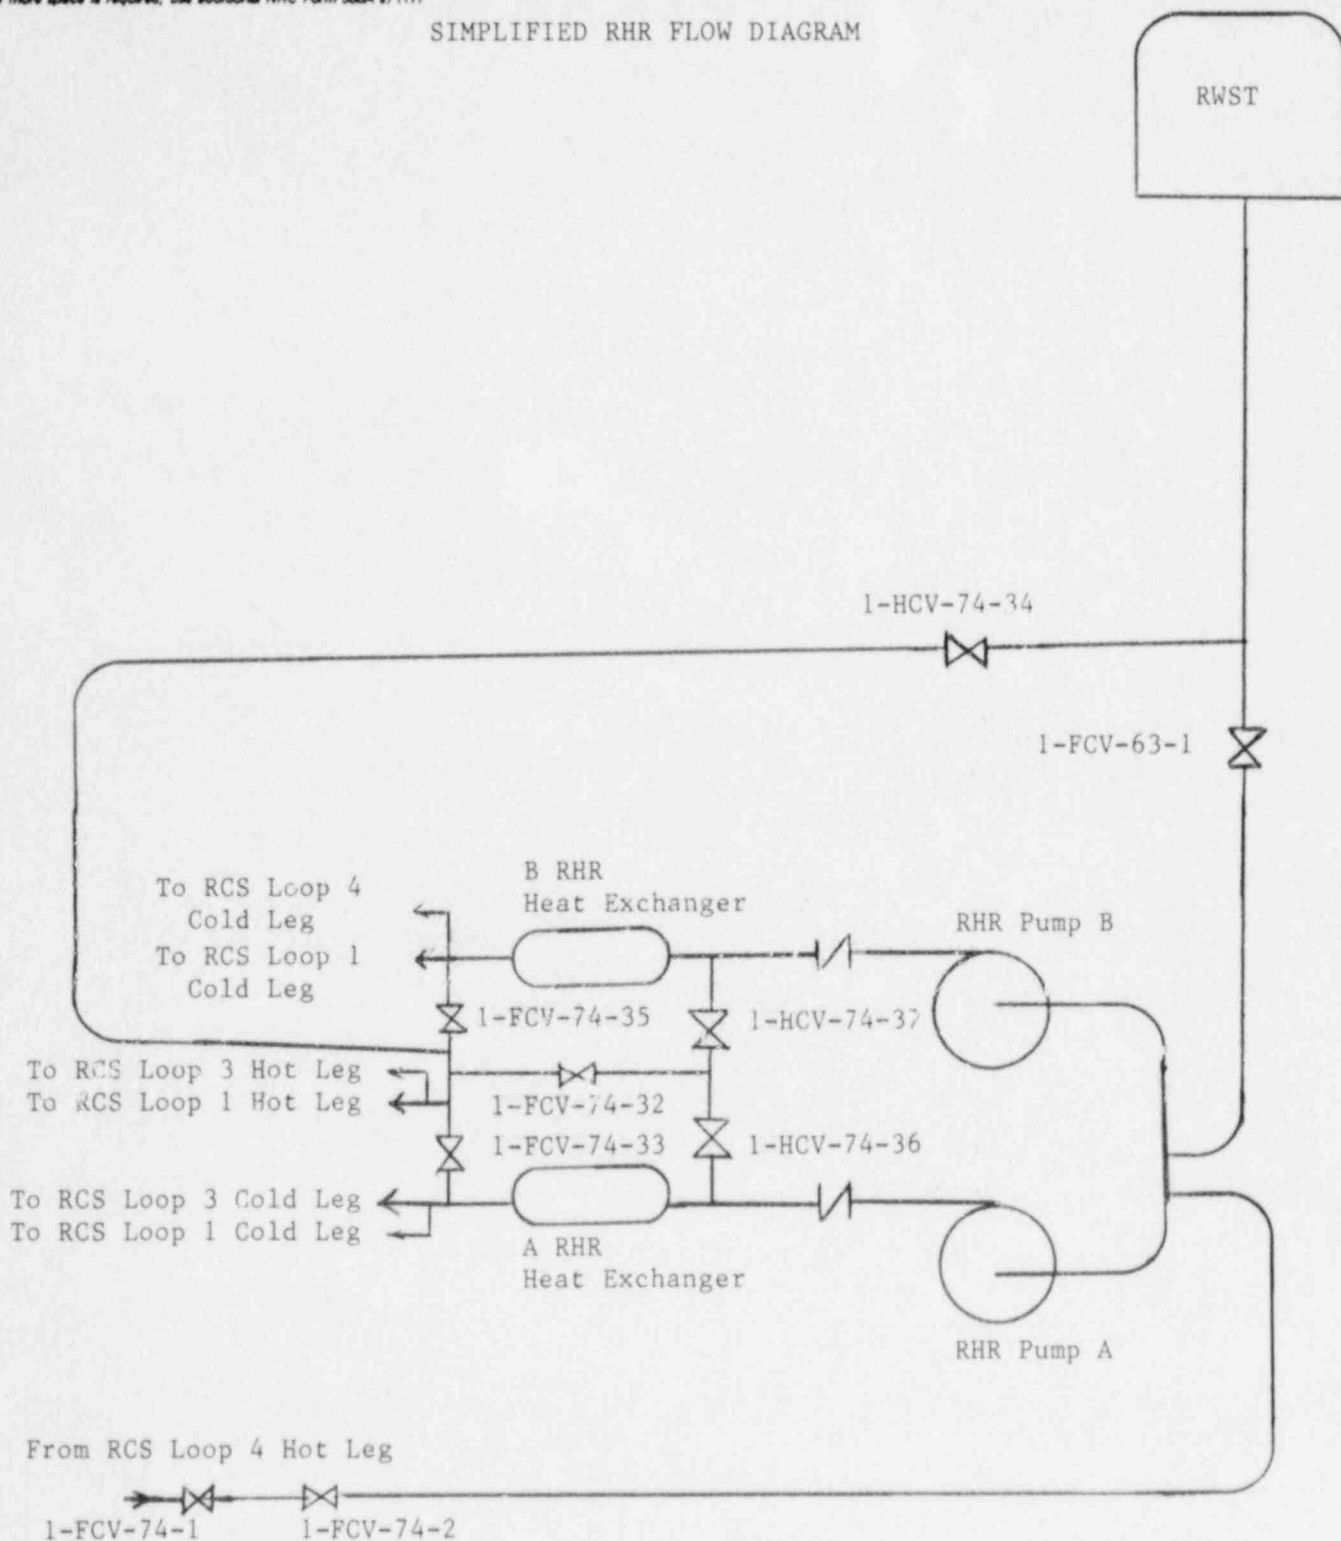
SIMPLIFIED RHR FLOW DIAGRAM

Initial Conditions Train "B" residual heat removal (RHR) (EIIS Code BP) loop was in service to provide decay heat removal. Train "A" RHR loop was out of service due to a recently completed train "A" RHR outage. Both "A" train and "B" train centrifugal charging pumps were tagged out of service to support work being performed on the chemical and volume control system (CVCS) (EIIS Code CB). The reactor coolant system (RCS) (EIIS Code AB) was partially drained to a point below the reactor coolant pump seals while seal flow was secured to support the CVCS outage. The water level in the RCS loop was being monitored in the control room through the use of a closed circuit camera focused on a sight glass connected to the RCS loop 1 cross under piping and via a recorded level (PR-68-69) from the output of a temporary transmitter located on the loop 1 hot leg. The RCS water level was being maintained above the top of the RCS loops. The top of the RCS hot leg is at elevation 696 feet 2.5 inches. The hot leg center line is at elevation 695 feet 0 inch. RHR pump cavitation is known to occur at the 695 feet 2 inch elevation. The sight glass visible scale ranges from the 694 feet 6 inch elevation to the 699 feet 5 inch elevation and requires camera scanning for full scale viewing. Surveillance of the RCS water level was being conducted every 30 minutes in accordance with Surveillance Instruction (SI)-673, "Reactor Coolant System Level Verification Using Sight Glass or Tygon Hose." A figure is attached to this report to provide a simplified RHR flow diagram for reference.

The immediate cause of the loss of RHR capability was the opening of manual isolation valve 1-HCV-74-34. This action established a flow path that pumped water from the RCS hot leg into the RWST. This resulted in depleting the RCS inventory and the net positive suction head to the RHR pump. Pump cavitation and the concomitant oscillations in RHR flow resulted.
