LICENSEE EVENT REPORT (LER)

FACILITY NAME (1) Sequoyah, Unit 2	DOCKET NUMBER (2) 0 5 0 0 0 3 2 8	PAGE (3) 1 OF 07
--	---	----------------------------

Single Failure Criteria Not Being Considered Completely In The Initial System Design Results In Inoperability Of Both Trains Of Emergency Gas Treatment System (EGTS)

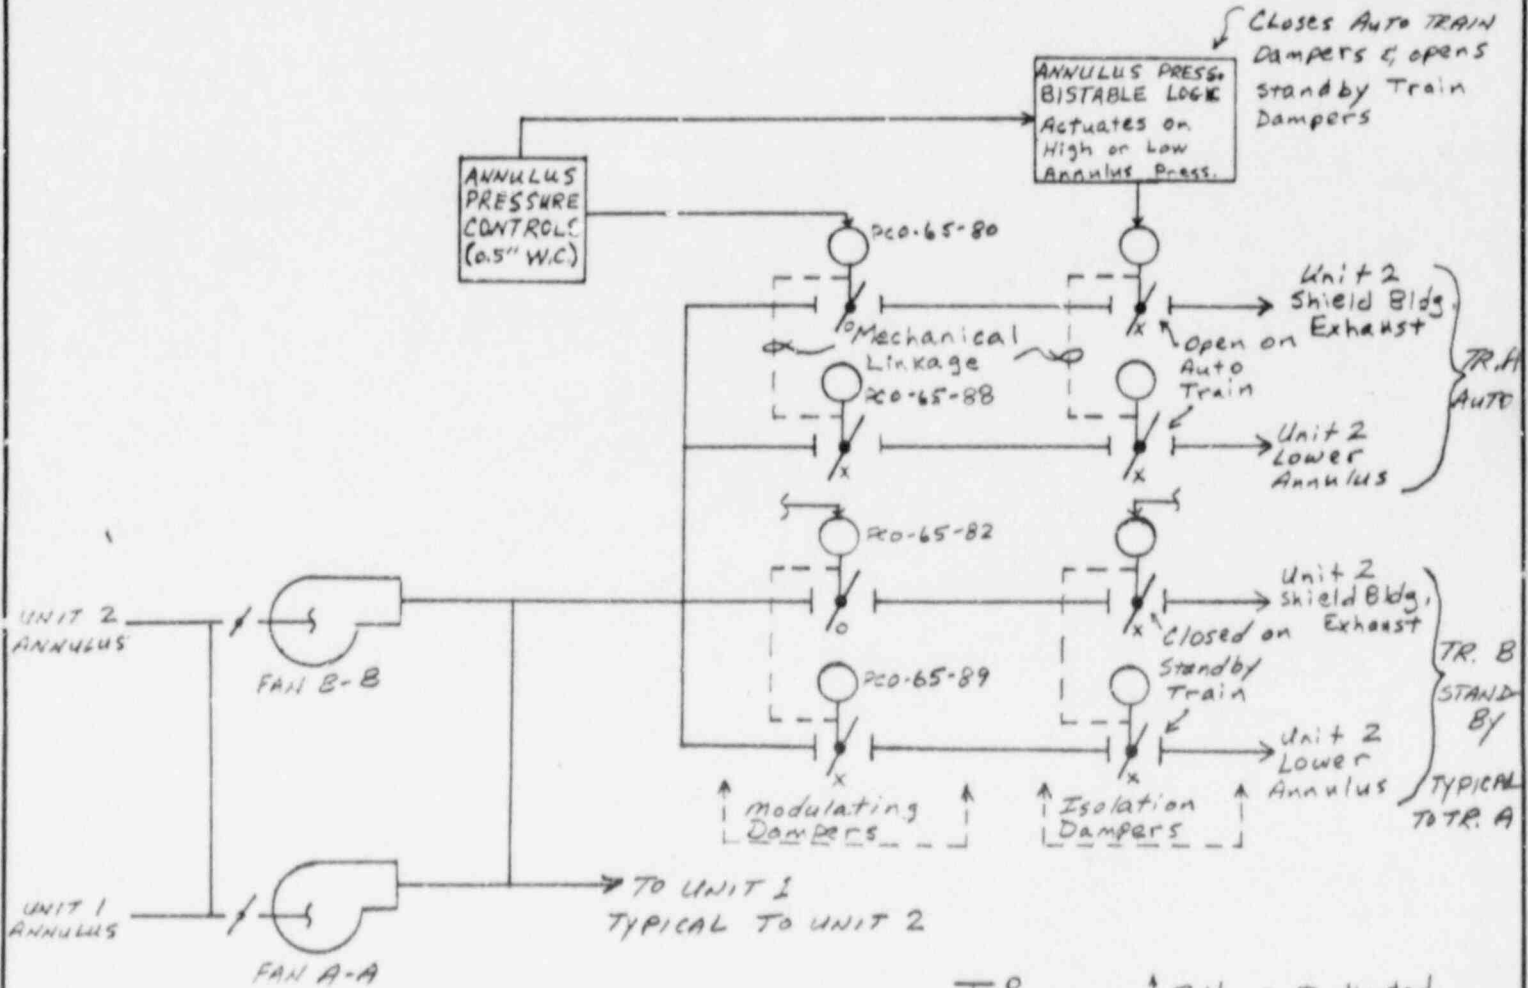
ATTACHMENT 1

However, it was discovered that if a single failure occurred in the operating train at the time of a initiating accident or any point prior to the annulus DP reaching the -0.7 inches water arming setpoint, such that the modulating damper to the shield building stack failed open, the bistable logic would not allow automatic swapover to the standby train. If this failure occurred as described, the annulus DP would not reduce to the -0.5 inches water control point as designed, but would continue to discharge full flow (rated at 4000 CFM) out the shield building exhaust stack. With this condition present, preliminary results from Quality Information Release (QIR) NTBSQN80222 indicate that the site boundary whole body gamma dose could exceed the 10 CFR 100.11 limits of 25 Rem. The results of this QIR show that because of this failure condition, the site boundary whole body gamma dose rate could possibly reach 27.3 Rem approximately two hours after initiation of a Loss of Coolant Accident (LOCA).

- 0.2 --- ↑ Failure Indicated
- 0.5 --- Accident Control Point
- 0.7 --- ↑ Arms Susceptor Logic
- 1.2 --- ↓ Failure Indicated
- 4.0 --- ↓ Arms Swapper Logic
- 5.0 --- Normal Control Point

As long-term corrective action to preclude the deficiency described in this report, the Sequoyah Electrical Engineering Branch (EEB) is evaluating a hardware modification to replace the existing pressure bistable arming logic. Initial design review indicates that this design change will involve replacing the existing pressure bistable arming signals (-4.0 and -0.7 inches water) with time delay circuitry, such that the standby train will be automatically armed after a predetermined time of operation. This time delay will ensure that upon initiation of the air cleanup system on an accident signal, there will be sufficient time to reduce the annulus DP to -0.5 inches water before arming the standby train.
