NRC DOCKET 50-321
OPERATING LICENSE DPR-57
EDWIN I. HATCH NUCLEAR PLANT UNIT 1
REPORT CLARIFICATION AND SUBMITTAL OF REVISED
DESIGN REPORT FOR CLASS 1 STAINLESS STEEL PIPING
AND COMPONENTS - 1985 MAINTENANCE/REFUELING OUTAGE

FIGURE 7.1

"A" Loop - Recirculation & Attached Systems

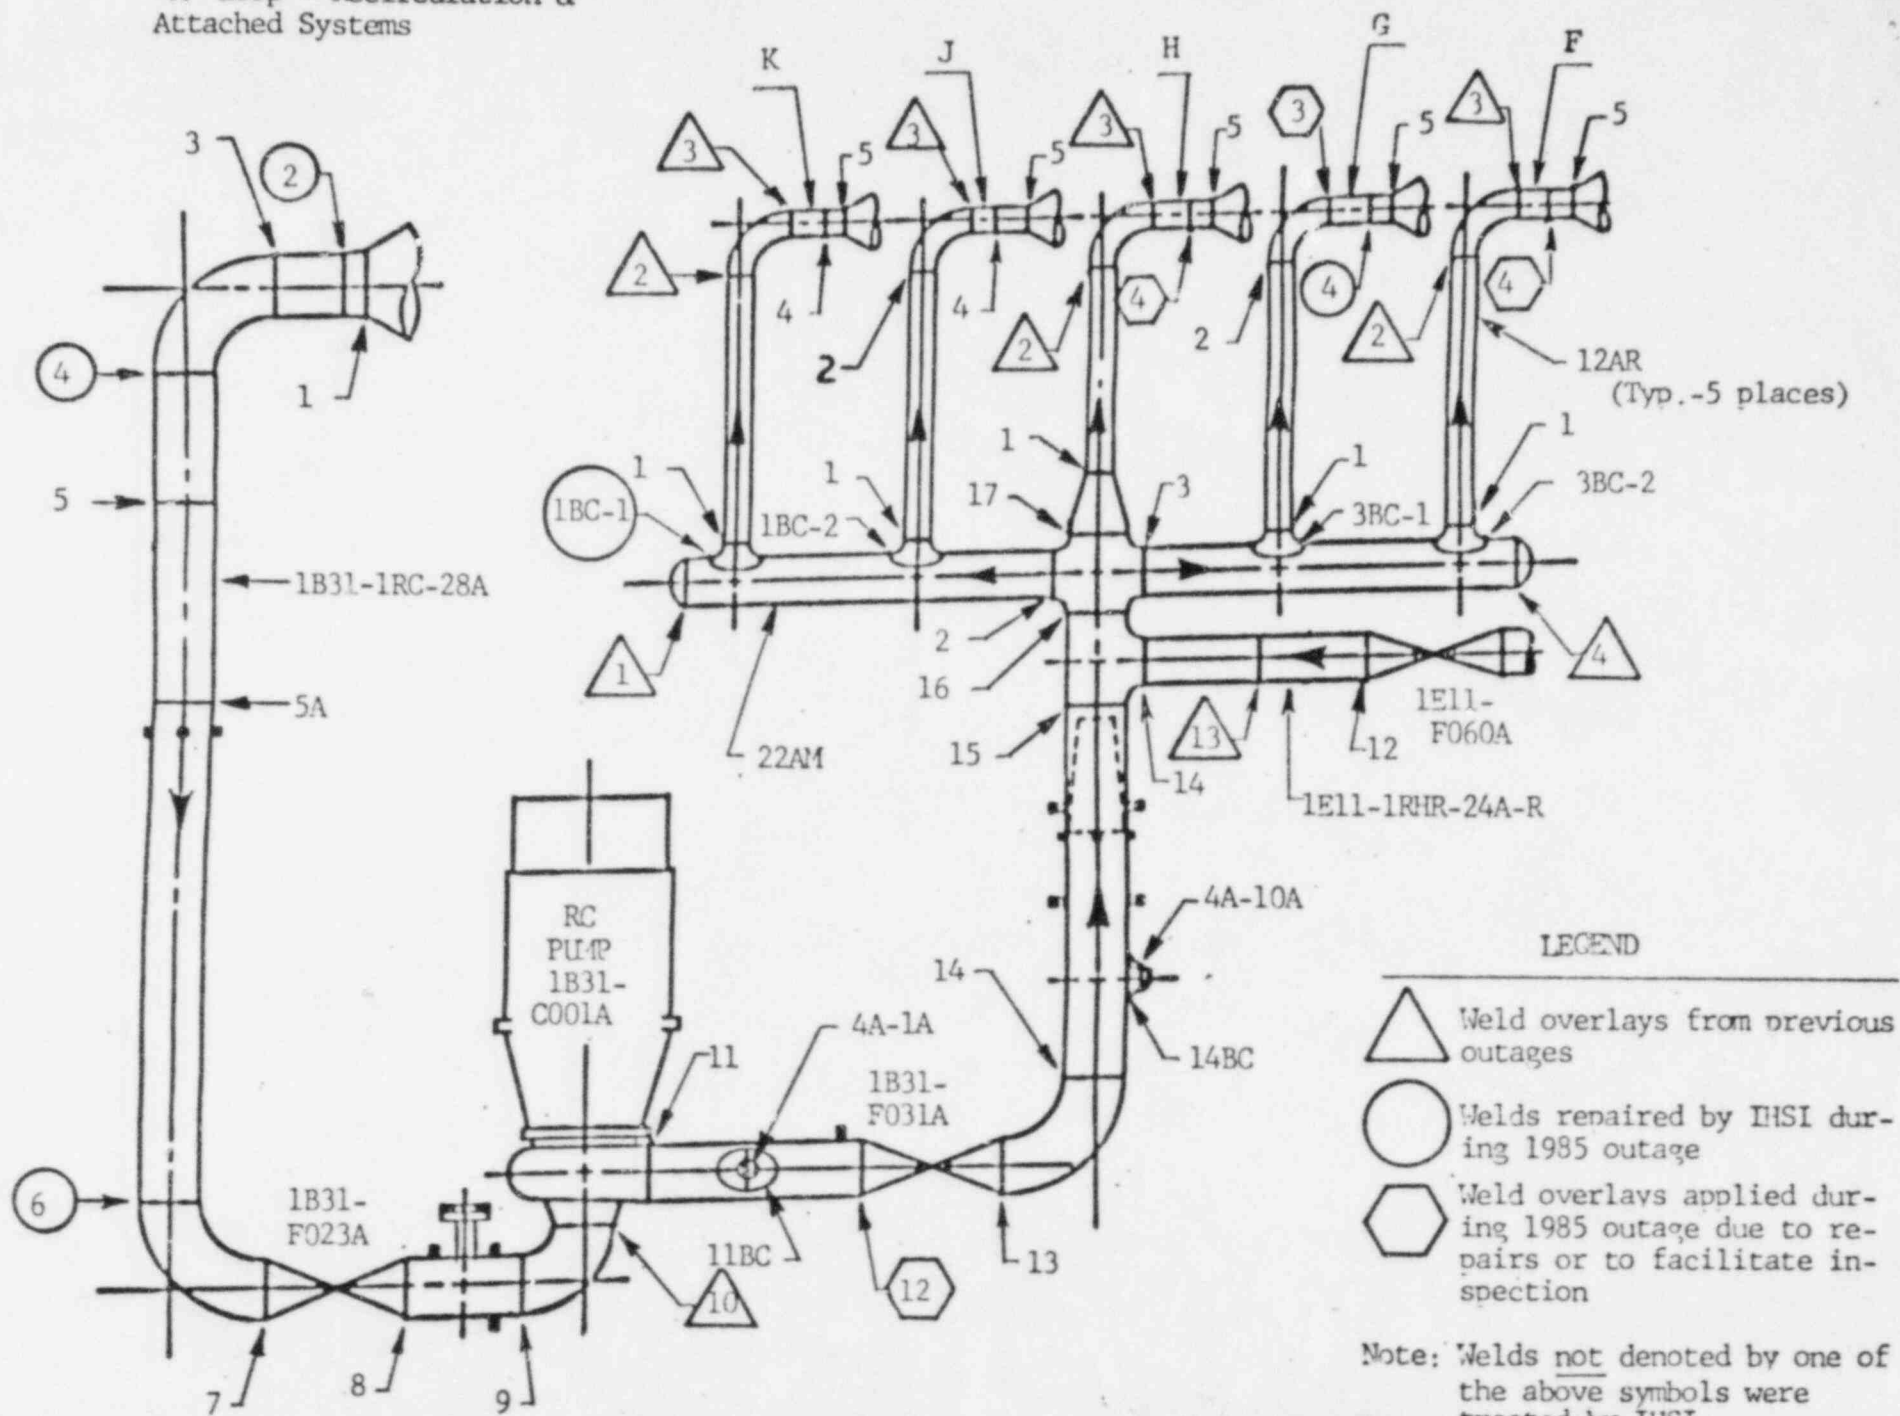
In addition to the submittal of Revision 2 of the SIA design report, enclosed is revised Figure 7.1 which supercedes the subject figure included in our March 10, 1986, submittal. Figure 7.1 depicts the "A" loop of the Recirculation and RHR systems. The notation for weld number 2 on Recirculation riser 12AR-J was inadvertently omitted from the subject figure in the aforementioned submittal. Please be advised that weld 12AR-J-2 was treated with IHSI during the outage. The post-IHSI ultrasonic examination indicated that the weld was free of reportable indications.
