LICENSEE EVENT REPORT (LER)

FACILITY NAME (1) Waterford Steam Electric Station Unit 3	DOCKET NUMBER (2) 0 5 0 0 0 3 1 8 2	PAGE (3) 1 OF 0 9
--	--	----------------------

TITLE (4)  
Missed Penetrant Test on Two Welds Due to Personnel Error

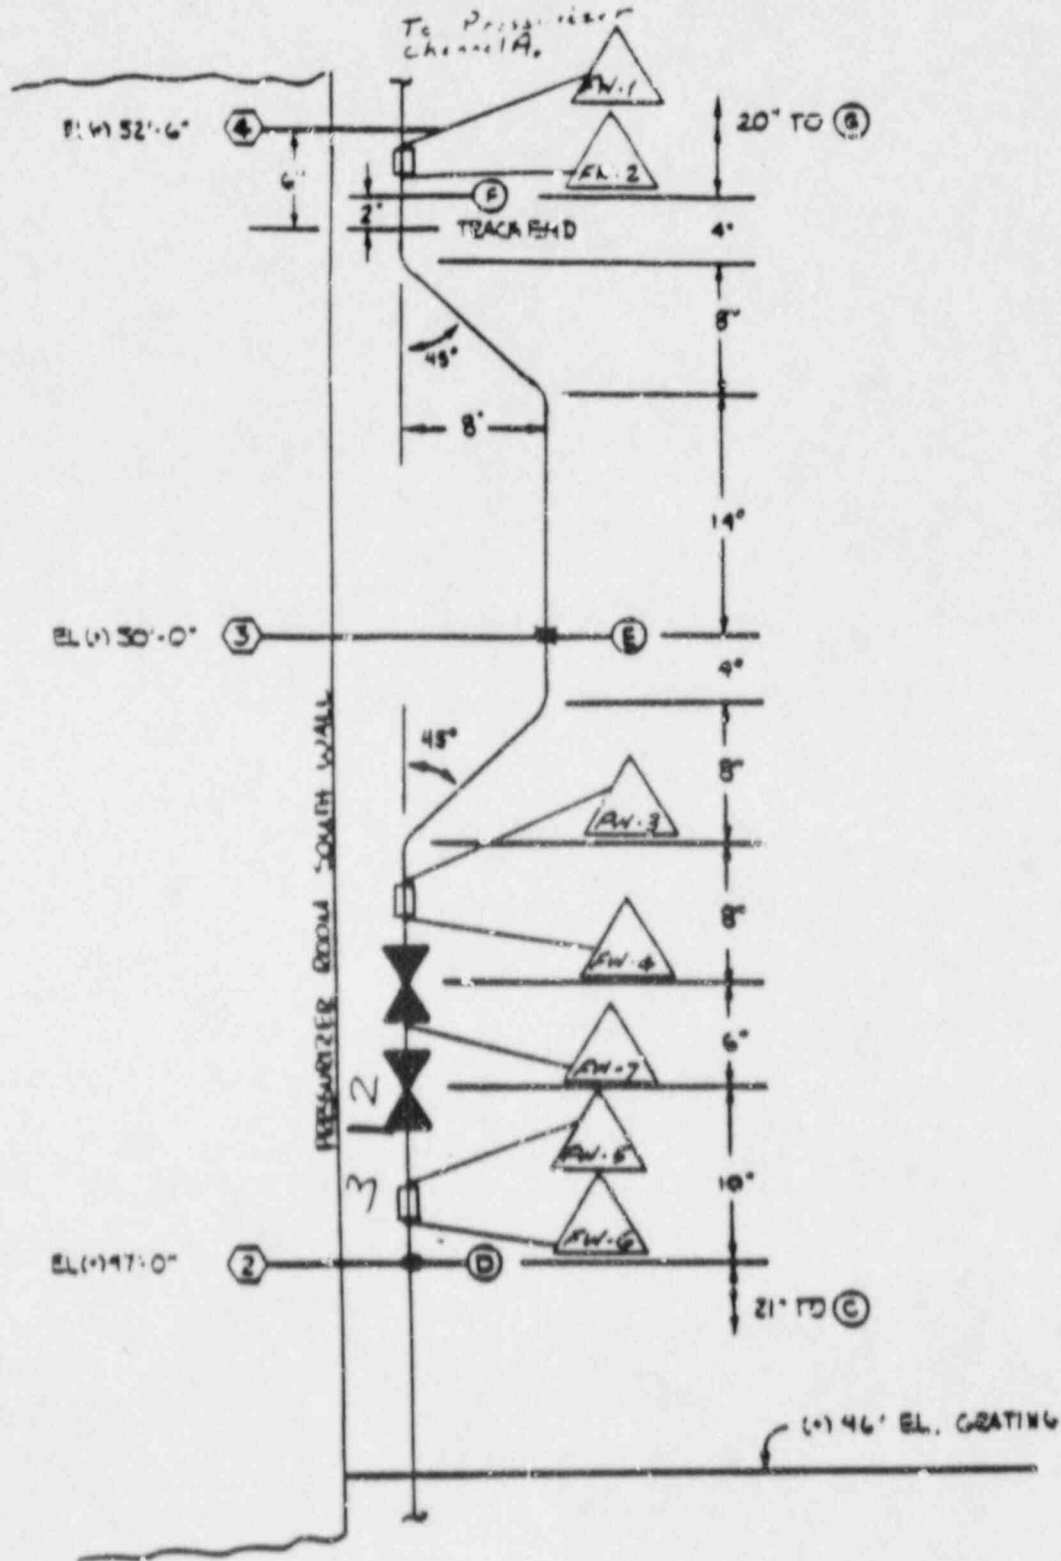
Figure 1

QS 88-062 identified a failure to perform non-destructive evaluation (NDE) dye penetrant testing (PT) on five safety class 2 socket welds. The five welds are located on stainless steel tubing which connects to a pressurizer condensate pot. Four of the welds, Field Welds (FWs) 1, 2, 3, and 4, experience RCS normal operating pressure and the fifth weld, FW 7, is isolated from the RCS by a single valve (See Figure 1).
