LICENSEE EVENT REPORT (LER)

Facility Name (1) Byron, Unit 1 Docket Number (2) 0 | 5 | 0 | 0 | 0 | 4 | 5 | 4 Page (3) 1 | of | 0 | 7

Title (4) Loss of Shutdown Cooling During Reactor Cavity Level Lowering Evolution Due to Unexpected Flow Phenomenon

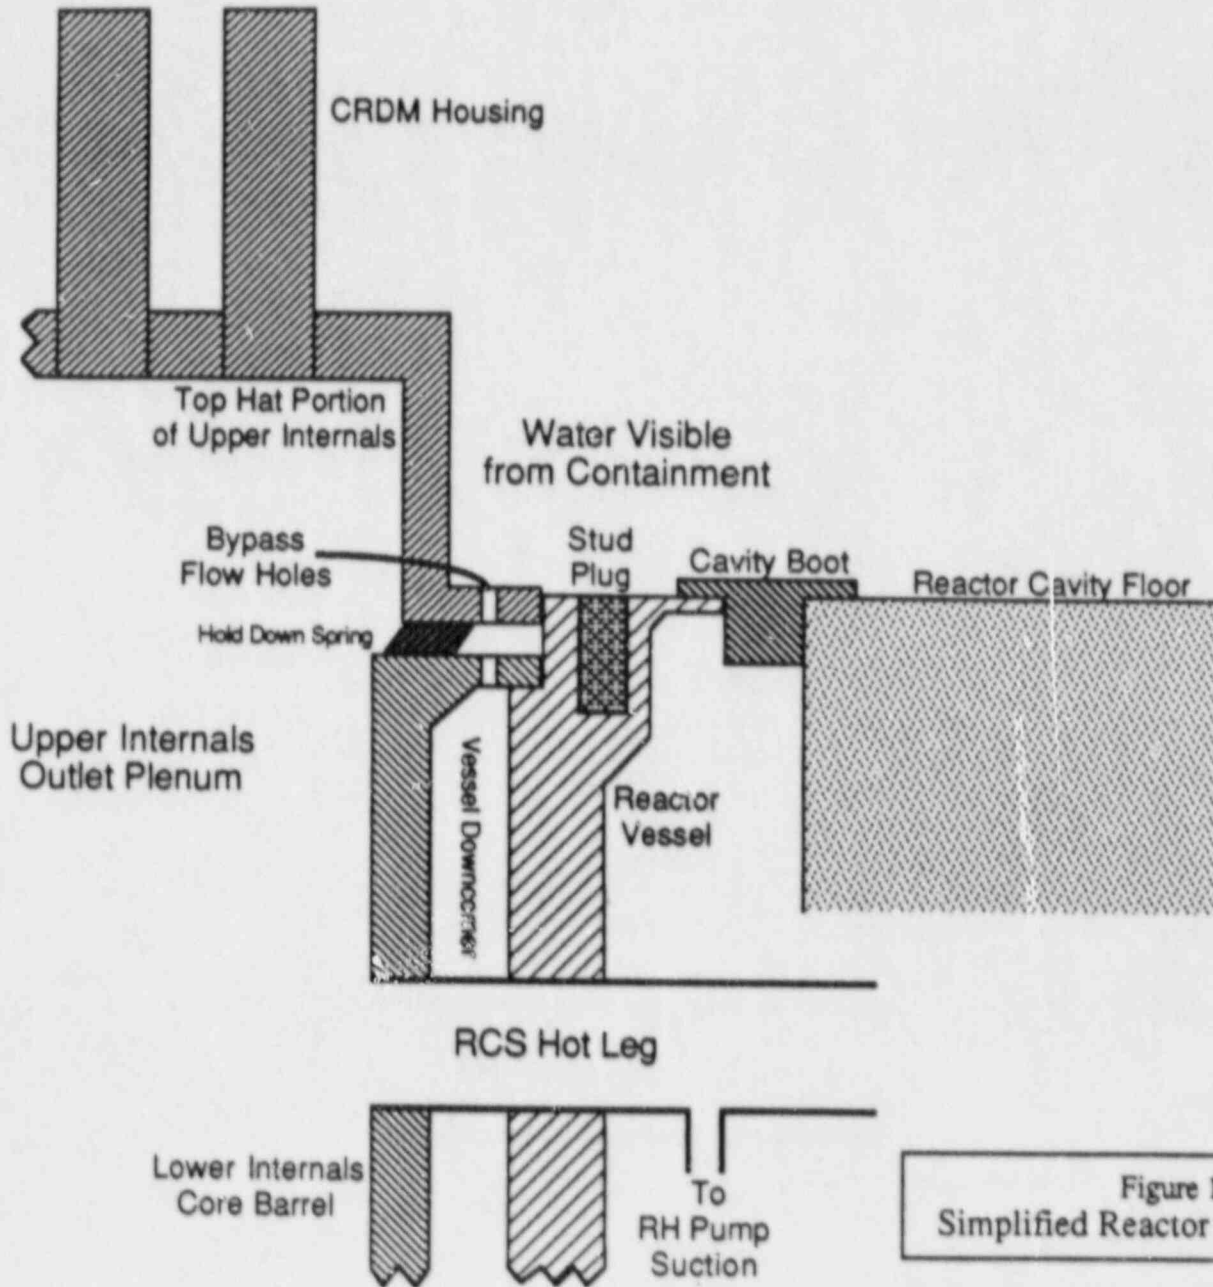
Figure 1  
Simplified Reactor Construction

internals assembly. However, the design of the upper internals assembly (top hat design) precluded adequate hydraulic coupling of reactor vessel water level and reactor cavity water level, when cavity water level was below the top of the upper internals assembly and the upper internals are fully seated on the hold down spring. In this condition with cavity water level below the top of the upper internals, hydraulic coupling with reactor vessel level occurred via bypass flow holes in the lower internals flange to the vessel downcomer region (cold leg side of core barrel). When the 1B RHR pump was used to lower cavity water level, it actually took suction from a reactor coolant hot leg, which was hydraulically coupled to the upper internals outlet plenum. This acted to lower water level in the reactor vessel beneath the upper internals by direct coolant removal. The cavity water level dropped at a slower rate due to restricted flow through the bypass flow holes in the flange. Therefore cavity water level was held artificially high by the limited capacity of the bypass flow holes, while the actual reactor vessel water level beneath the upper internals assembly lowered according to 1B RHR pump flow rate. As the maintenance personnel in Containment observed cavity water level, the actual, concealed reactor vessel water level dropped to a level where vortexing to the 1A RHR Pump suction occurred.
