James A. FitzPatrick
Nuclear Power Plant
P.O. Box 41
Lycoming, New York 13093
315 342-3840

October 21, 1988
JAFF-88-0965

Subject: Additional Information on Internal Vessel Core Spray
Pipe Crack

TO: US NRC
FROM: R. J. CONVERSE
SUBJECT: ADDITIONAL INFORMATION ON
INTERNAL VESSEL CORE SPRAY
PIPE CRACK

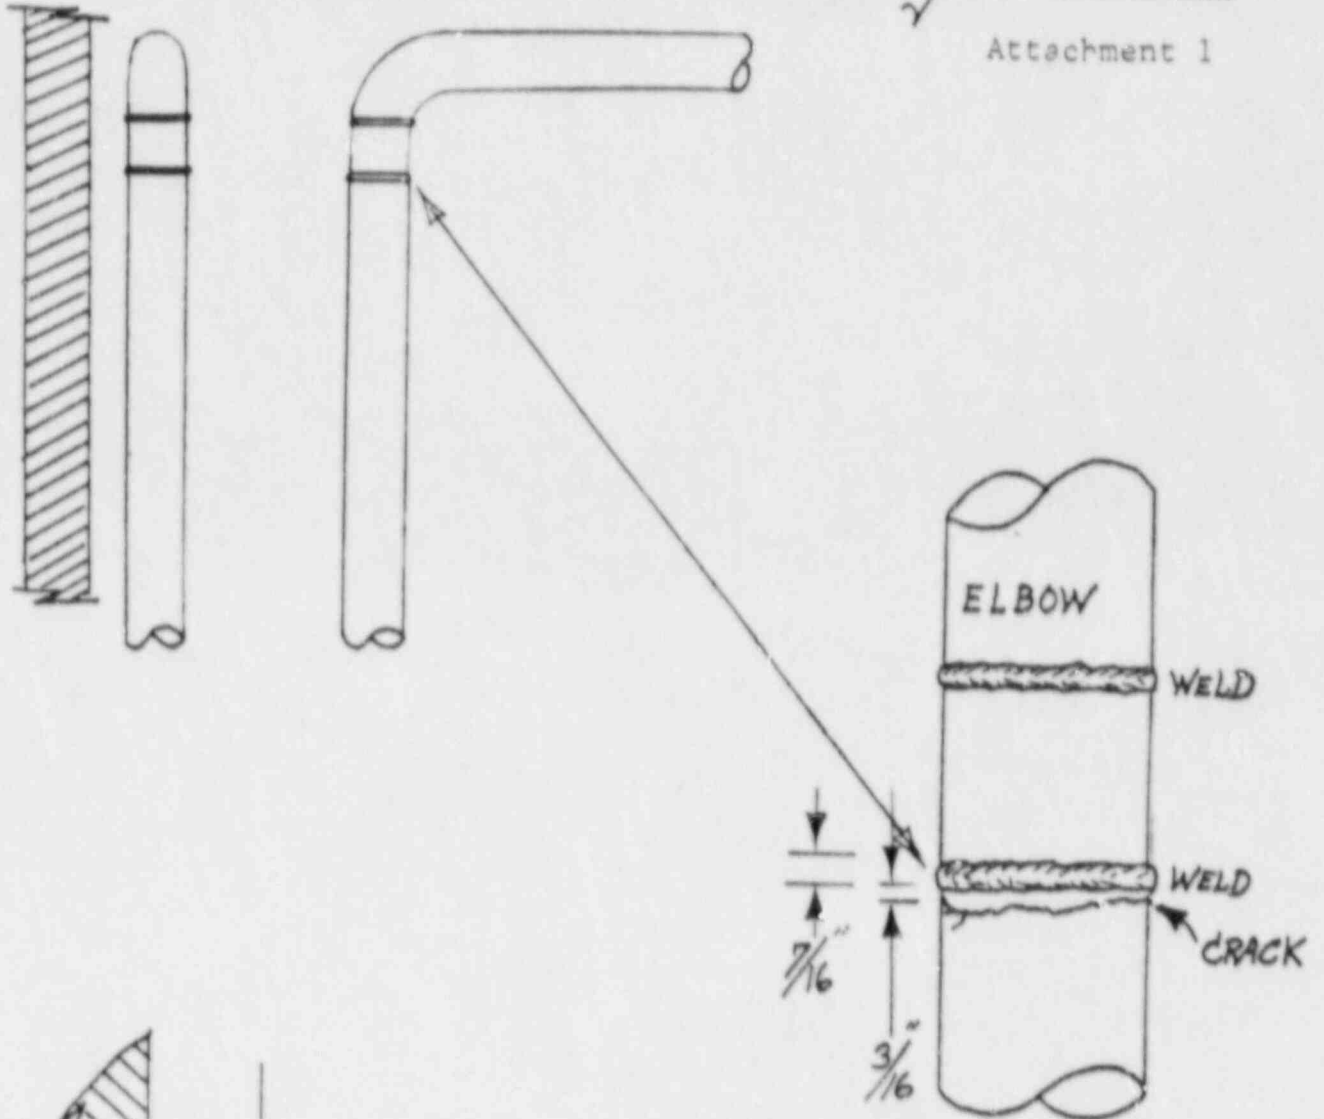
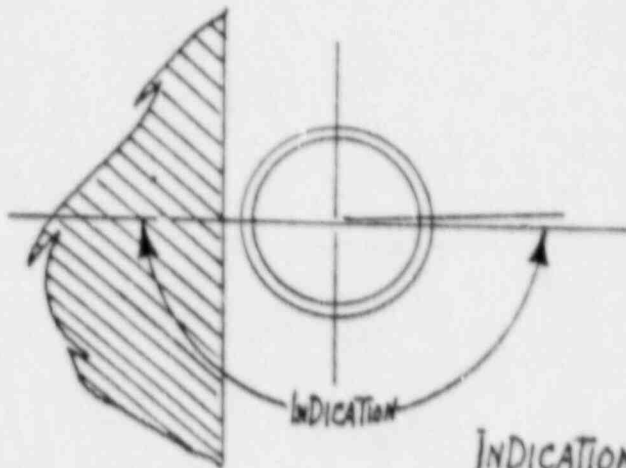
This letter formally transmits the originally requested stress information and the revised information concerning this crack. Attachment 1 is a revised drawing which shows the actual location of the crack based on the initial visual exam. Attachment 2 provides a drawing which shows the actual crack orientation based on ultrasonic inspection performed October 16, 1988, prior to repair. Attachment 3 summarizes how the original identification error was made. Attachment 4 provides a summary of the revised repair program. Attachment 5 provides a drawing of the revised repair. Attachment 6 provides a summary of the results of other inspections performed in-vessel. Attachment 7 provides the stress information on the original and repaired piping. Attachment 8 provides a copy of the repair safety evaluation.

190° AZIMUTH CORE SPRAY RISER

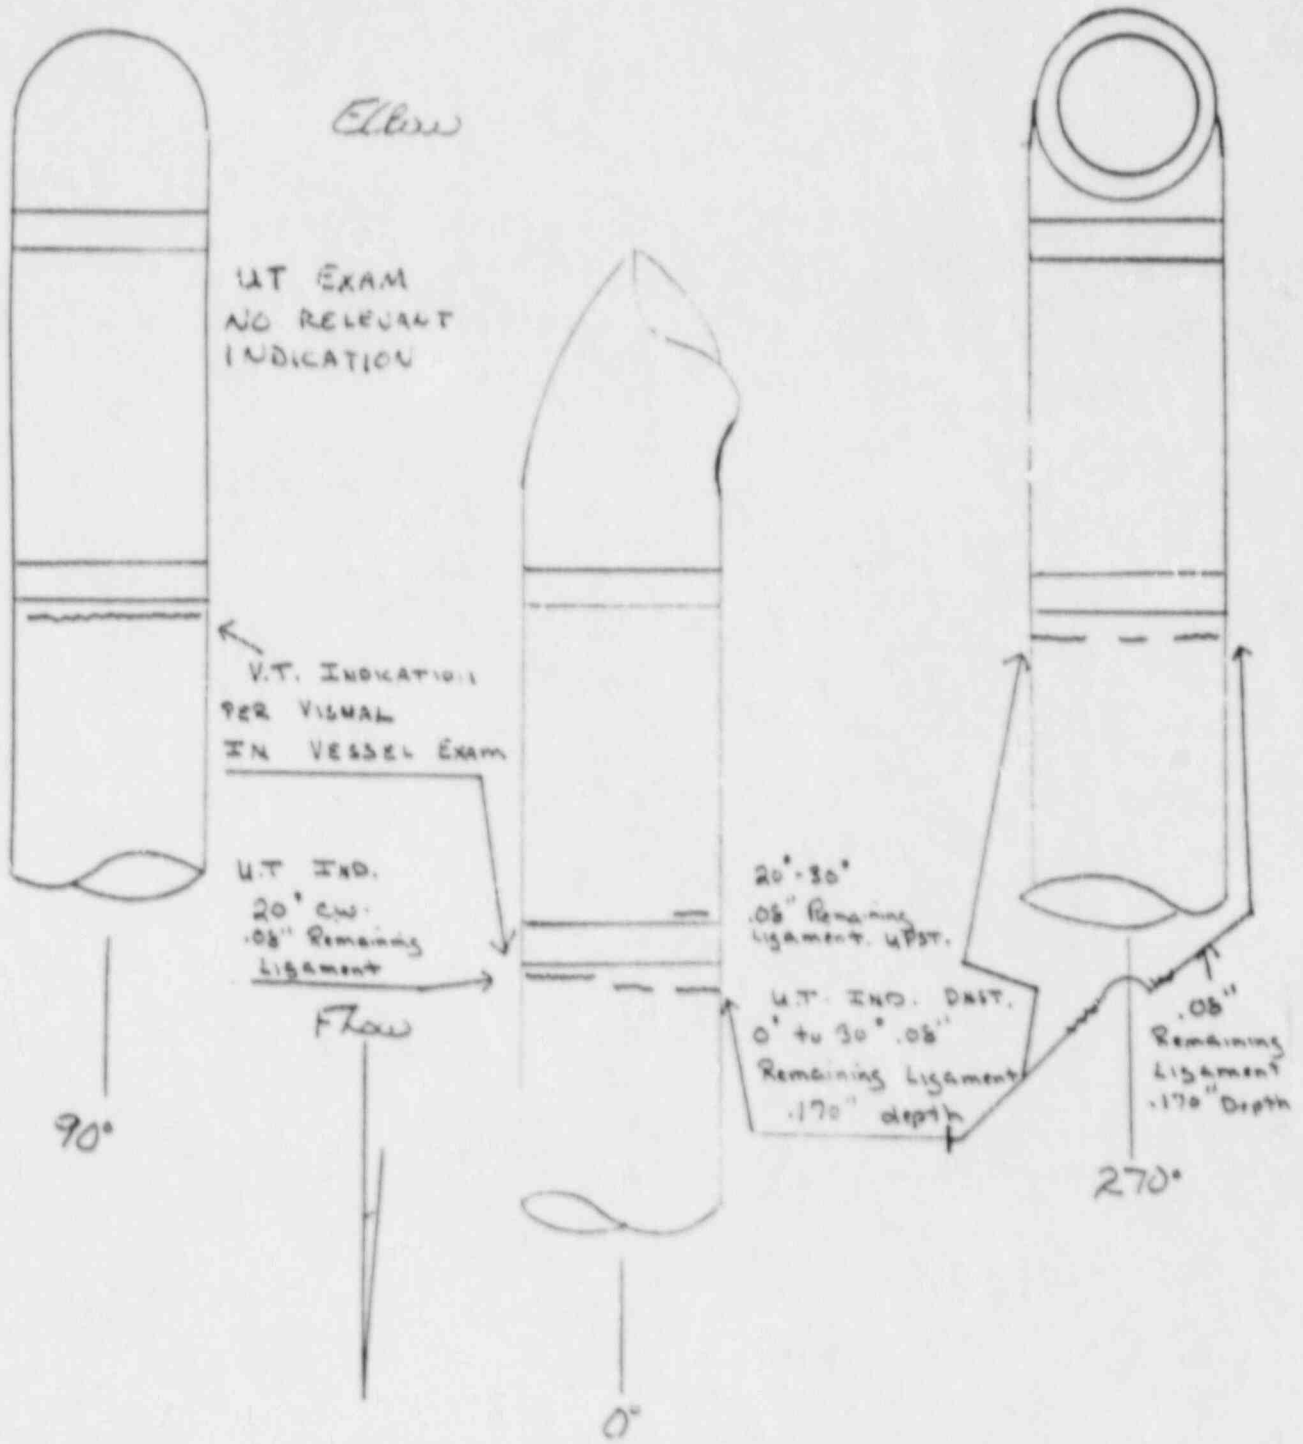
ATTACHMENT 2

INDICATION IS APPROX. 180°
OF CIRCUMFERENCE

JAF Core Spray 190° - Azimuth
of the Reactor Vessel

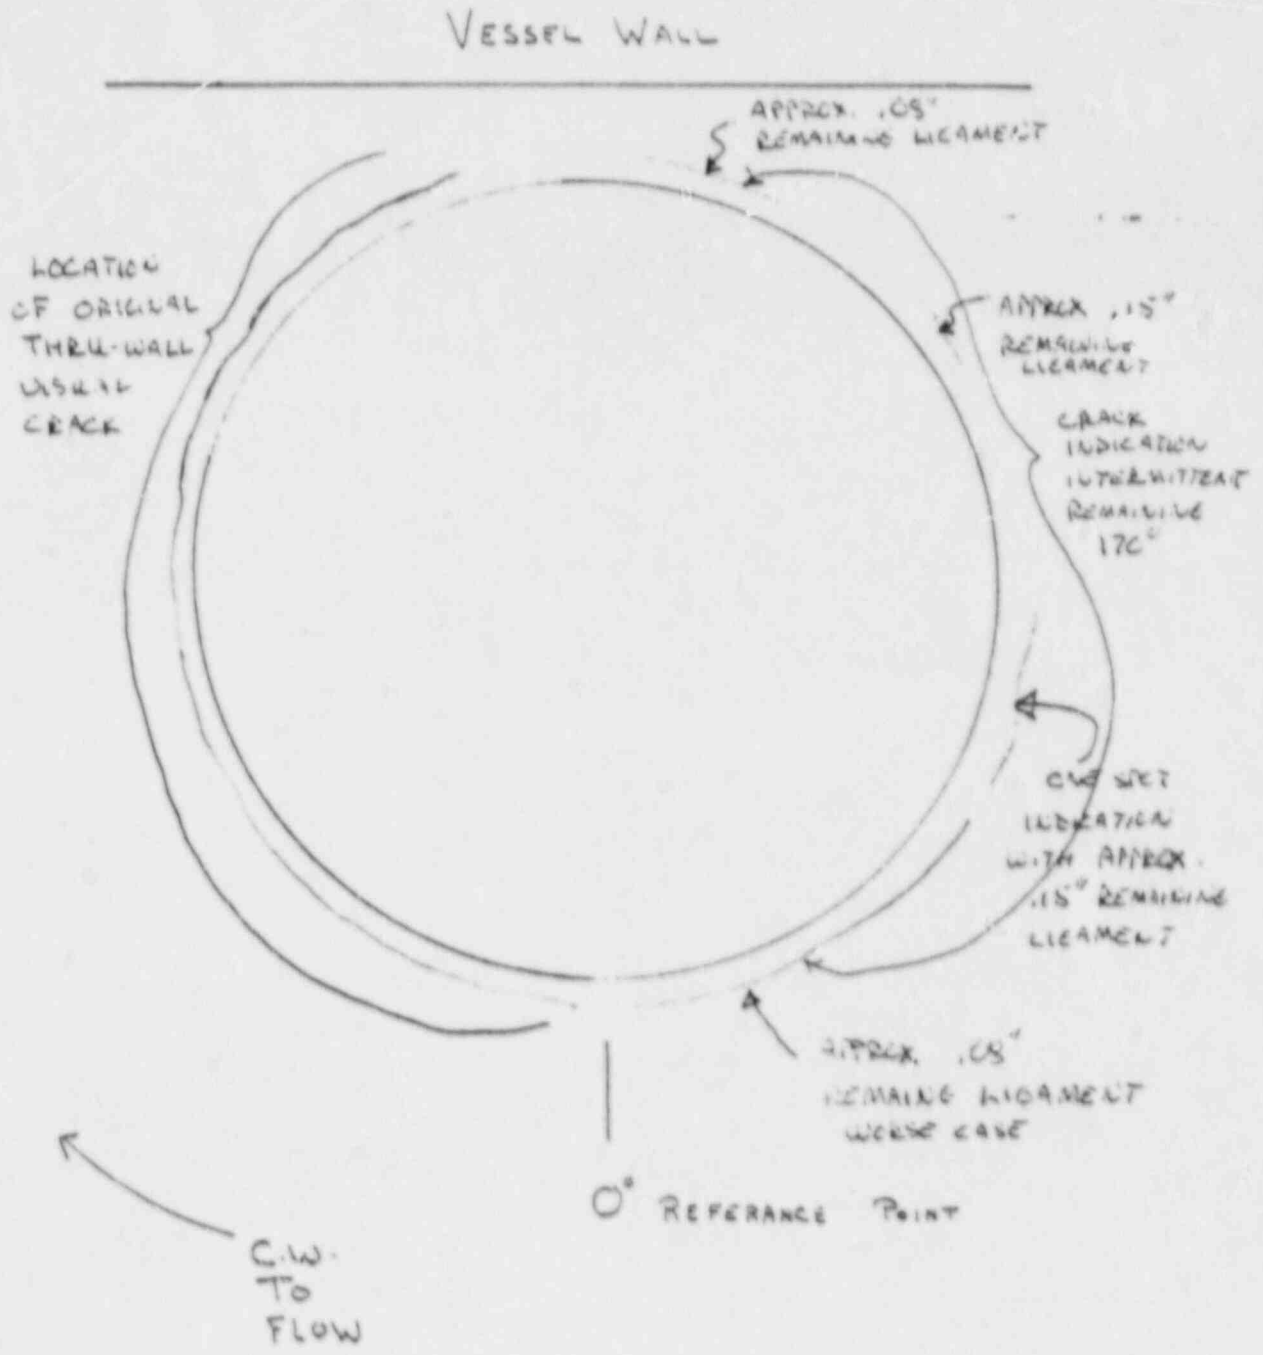
ATTACHMENT 2 (Cont'd.)

ALL DEPTHS CALCULATED FROM : (T) = .250"

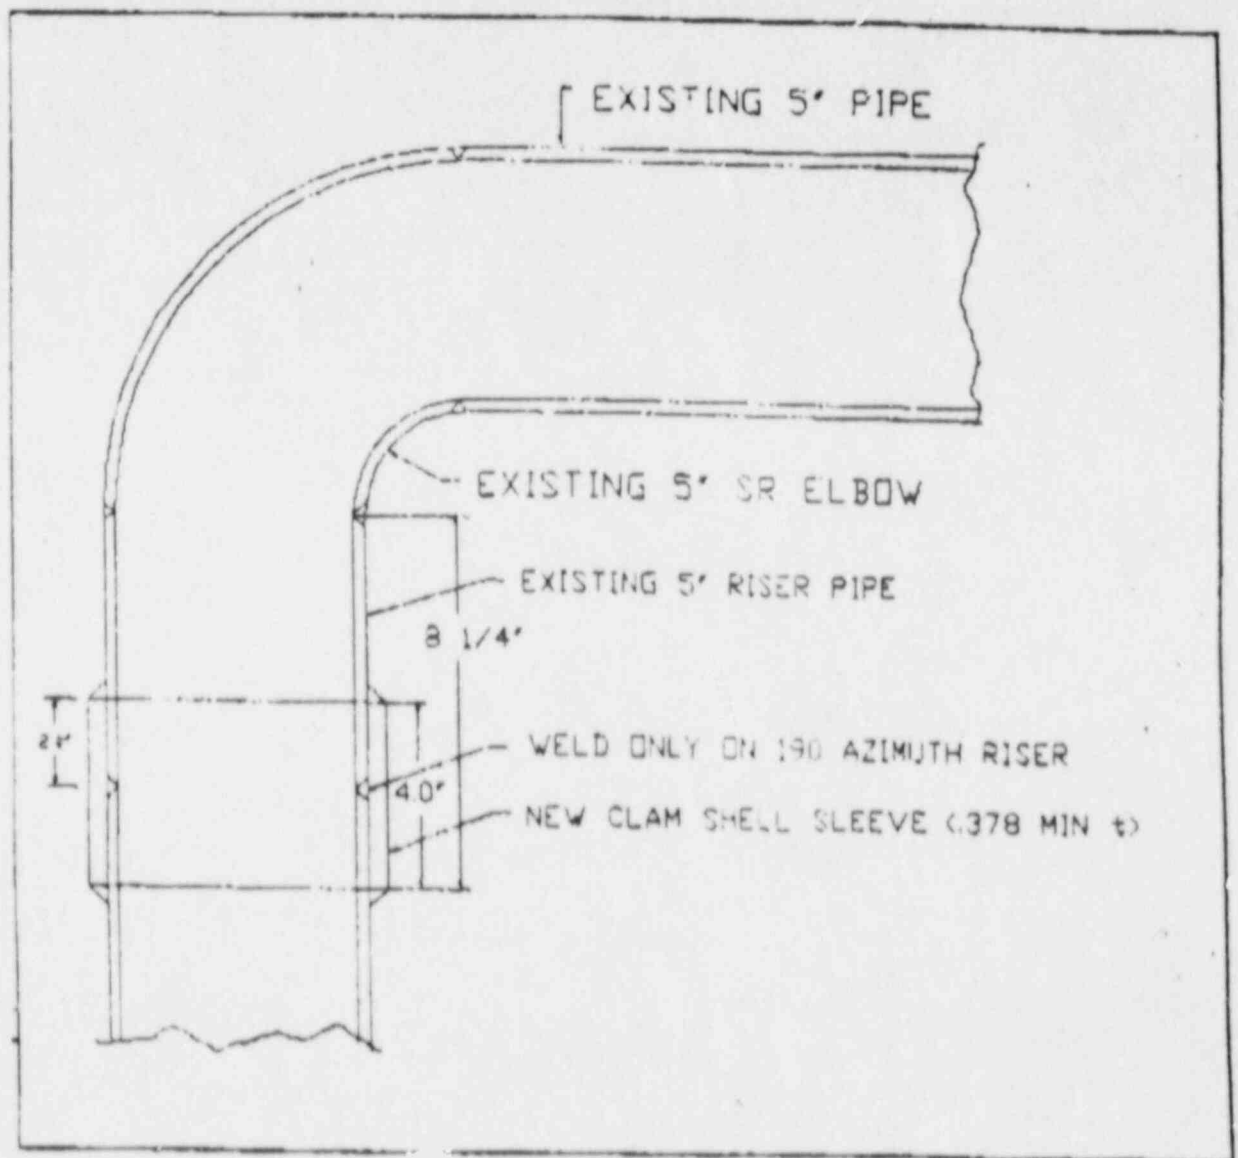
Attachment 5

The crack in the pipe was visually noted to be approximately 180°-190° circumferential in the heat affected zone on the lower side of the pipe-to-pipe weld located approximately 6 inches below the elbow-to-pipe weld on the 190° azimuth riser. Subsequent ultrasonic examination revealed that the crack intermittently extended the remaining 180° on the I.D. with worse case remaining ligaments of .08"-.15" (refer to Attachment 2). Ultrasonic examination on the other side of the weld revealed a 20-30 degree internal crack with .08" remaining ligament. In both cases, the cracks revealed IGSCC ultrasonic signal characteristics.

The repair consisted of a "clamshell" arrangement composed of 6 inch, schedule 80 pipe (0.432 inch wall), 4 inches long. The material is ASTM A-312, Type 316L. The clamshell was cut in two, approximately 180° halves, and was positioned on the existing 5 inch, schedule 40 pipe with the affected weld in the middle of the 4 inch long clamshell. Both cracks were completely covered by the clamshell. The inside diameter of the clamshell was approximately 0.2 inches larger than the outside diameter of the 5 inch Schedule 40 pipe, thus providing sufficient clearance for fit-up.

Repair of Core Spray Pipe with Clamshell Sleeve

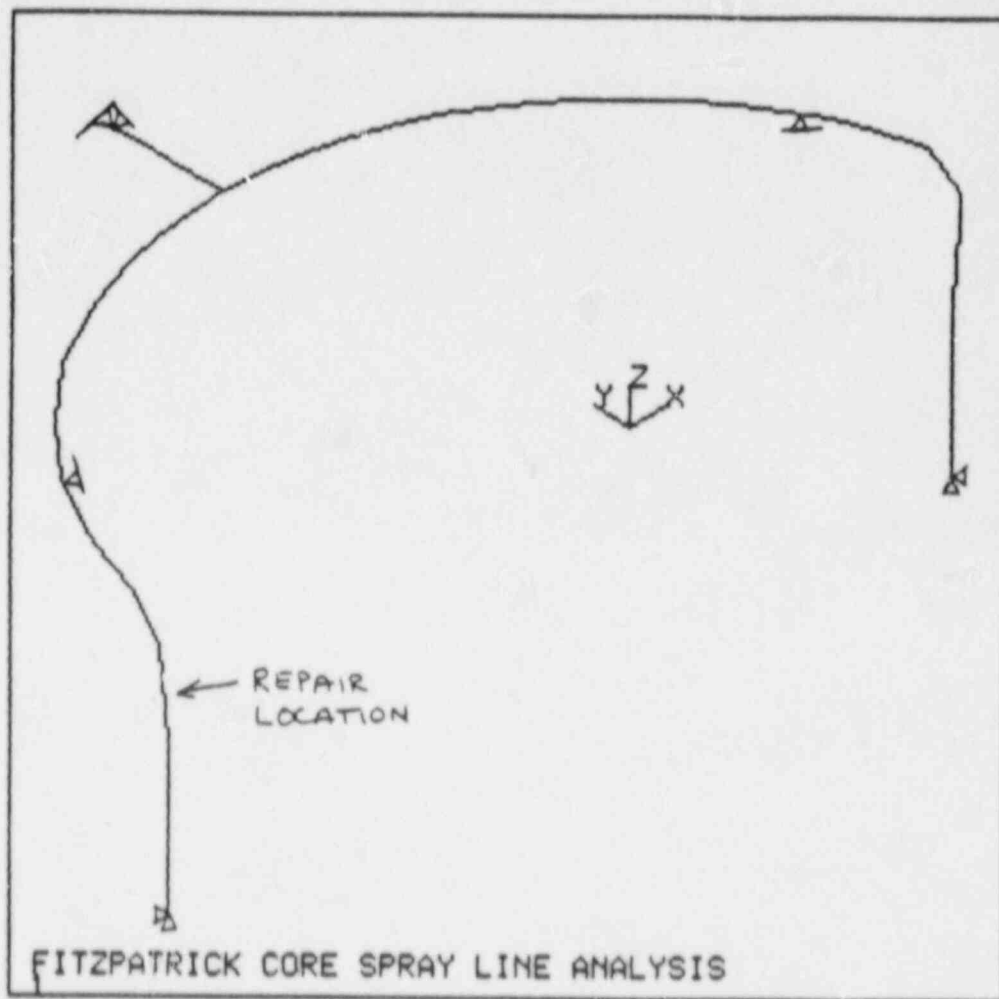
FIGURE 1 BEAM FINITE ELEMENT MODEL

The beam finite element model was used to determine the seismic, deadweight, downcomer flow impingement, and thermal and pressure expansion stresses. The ANSYS finite element program was used for the evaluation (Reference 1). The finite element model is shown in Figure 1. It should be noted that at the clam shell section no credit was taken for the original pipe. As demonstrated in the figure, appropriate boundary conditions were applied at the core spray bracket locations, core spray nozzle to safe end junction, and core spray piping/sparger/shroud connection. The clam shell was simulated by applying the appropriate cross sectional properties to the beam at the clam shell location in the finite element model.

These conditions were applied to the beam model shown in Figure 1.

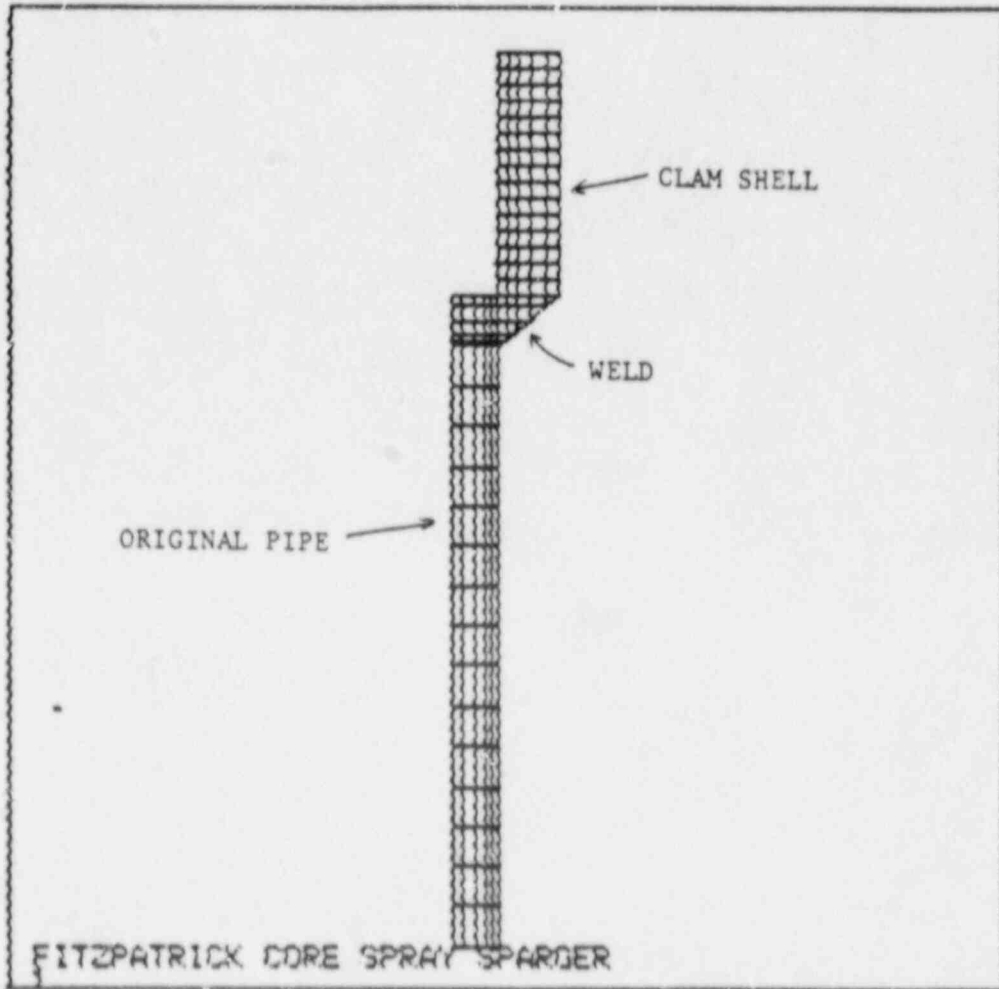
FIGURE 2 AXISYMMETRIC MODEL

The axisymmetric finite element model was used to determine the pressure and core spray flow operation induced stresses. Figure 2 shows the finite element model. Note that no credit is taken for any of the original core spray line pipe. The original pipe is removed and the entire load is assumed to be taken by the clam shell and the weld of clam shell to original pipe. Although the actual thickness of the clam shell is higher, the repair specification allowed a minimum thickness of 0.318 in. near the weld location. Furthermore, it was conservatively assumed that because of access limitations only 5/6th of the circumference would be welded. With this correction, the equivalent thickness for the clam shell was calculated as $(0.318 \times 5/6)$ or 0.265 inch.
