APPENDIX R
MULTIPLE HIGH IMPEDANCE CABLE FAULT
FLAME TEST REPORT

MAY 27, 1988

PREPARED BY
PHILADELPHIA ELECTRIC COMPANY
PHILADELPHIA, PA. 19101
NUCLEAR ENGINEERING DEPARTMENT
ENGINEERING DIVISION
N2-1, 2301 MARKET STREET

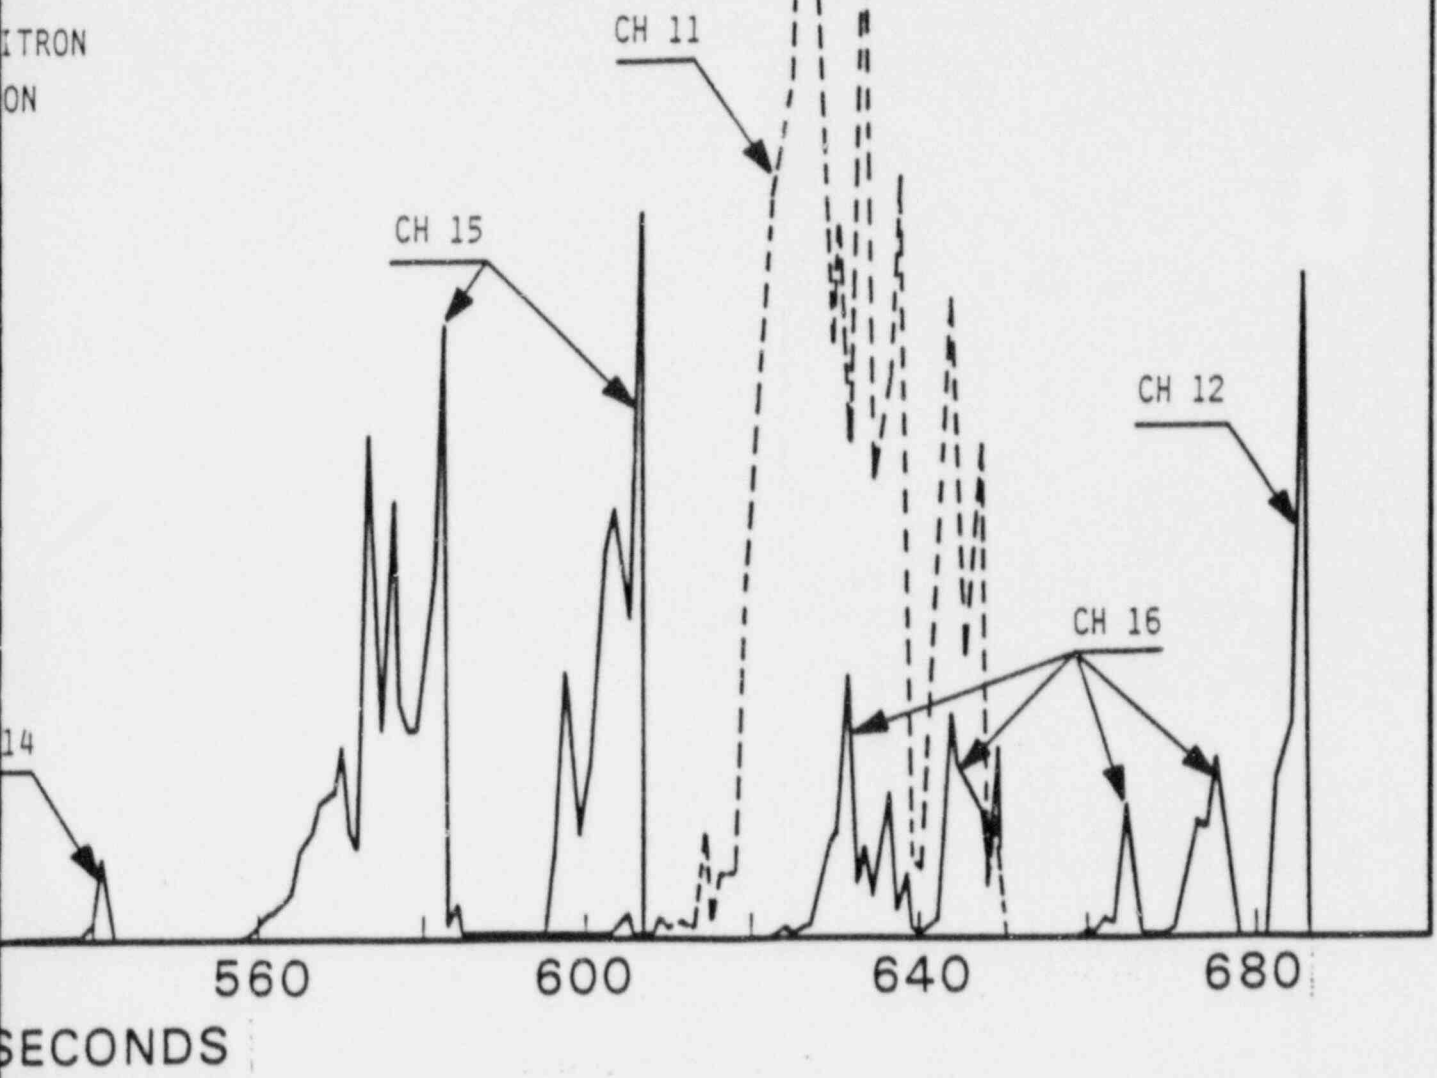
FIGURE NO 13
TEST NO 3
FUSE CURRENT VS TIME
WELDED FLAME TEST

As shown in Figure No. 13 "Load Supply Fuse Current Vs. Time During Flame Test", the short circuit characteristic of each cable fault was similar. A high impedance fault period followed by a transition to low impedance and then fuse fault clearing. The fuses used were type KTK, non-time delay fast acting which provided high speed of response above the 1000 second rating of the fuses. Under 2:1 cases the high impedance short circuit peak current recorded was below the lowest fuse rating of 10 amperes. At the transition to low impedance the fuse failed immediately. The transition to low impedance was caused by conductor to conductor contact.

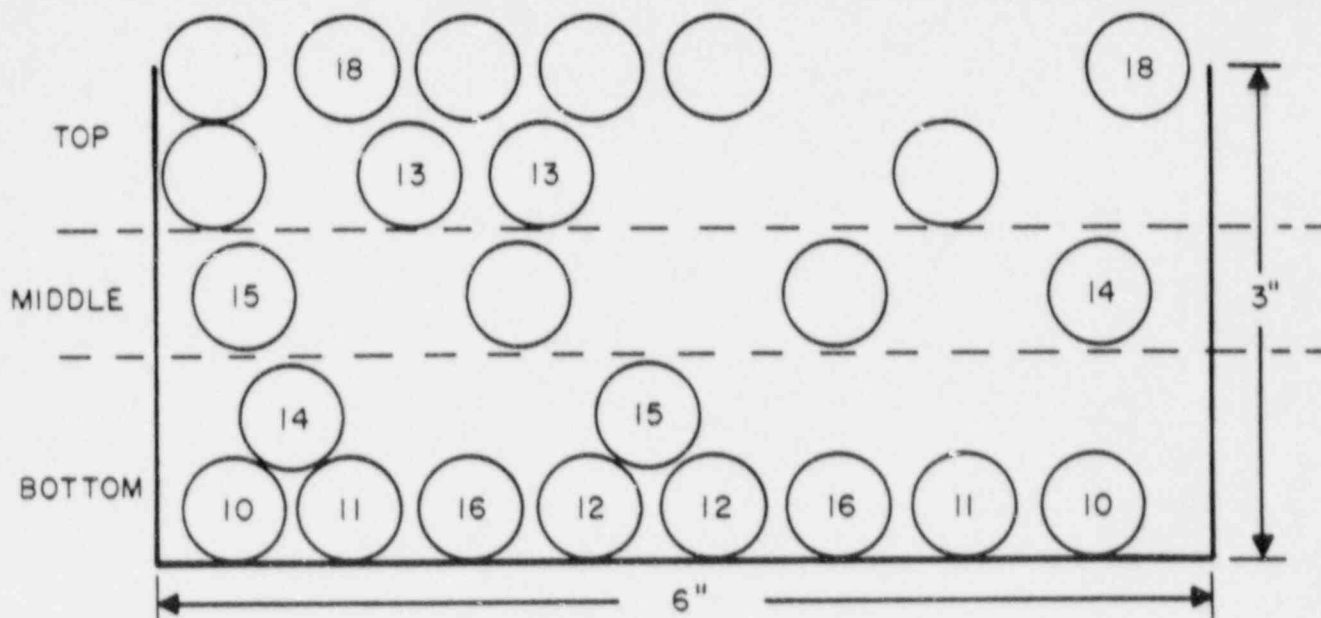
The cables were carefully removed from the tray and damage in the fire area was photographed for each separate cable. The relative position of the cable in the fire area was noted along with the channel number, cable type, fuse size and type, time until fuse failed and failure sequence. This information is shown in Figure No. 14.

- 1) The occurrence of cable faults in a common tray are not simultaneous. Cables nearest the flame source develop flame damage related short circuits before cables further away. As a result, with the exception of cables 11 and 16 no simultaneous faults occurred during the test. Faults occurred simultaneously on cables 11 and 16 which were side by side in the bottom of the cable tray closest to the flame source as can be seen in Figure No. 14 "Cable Location In Flame Area Vs. Time To Blow Fuse".

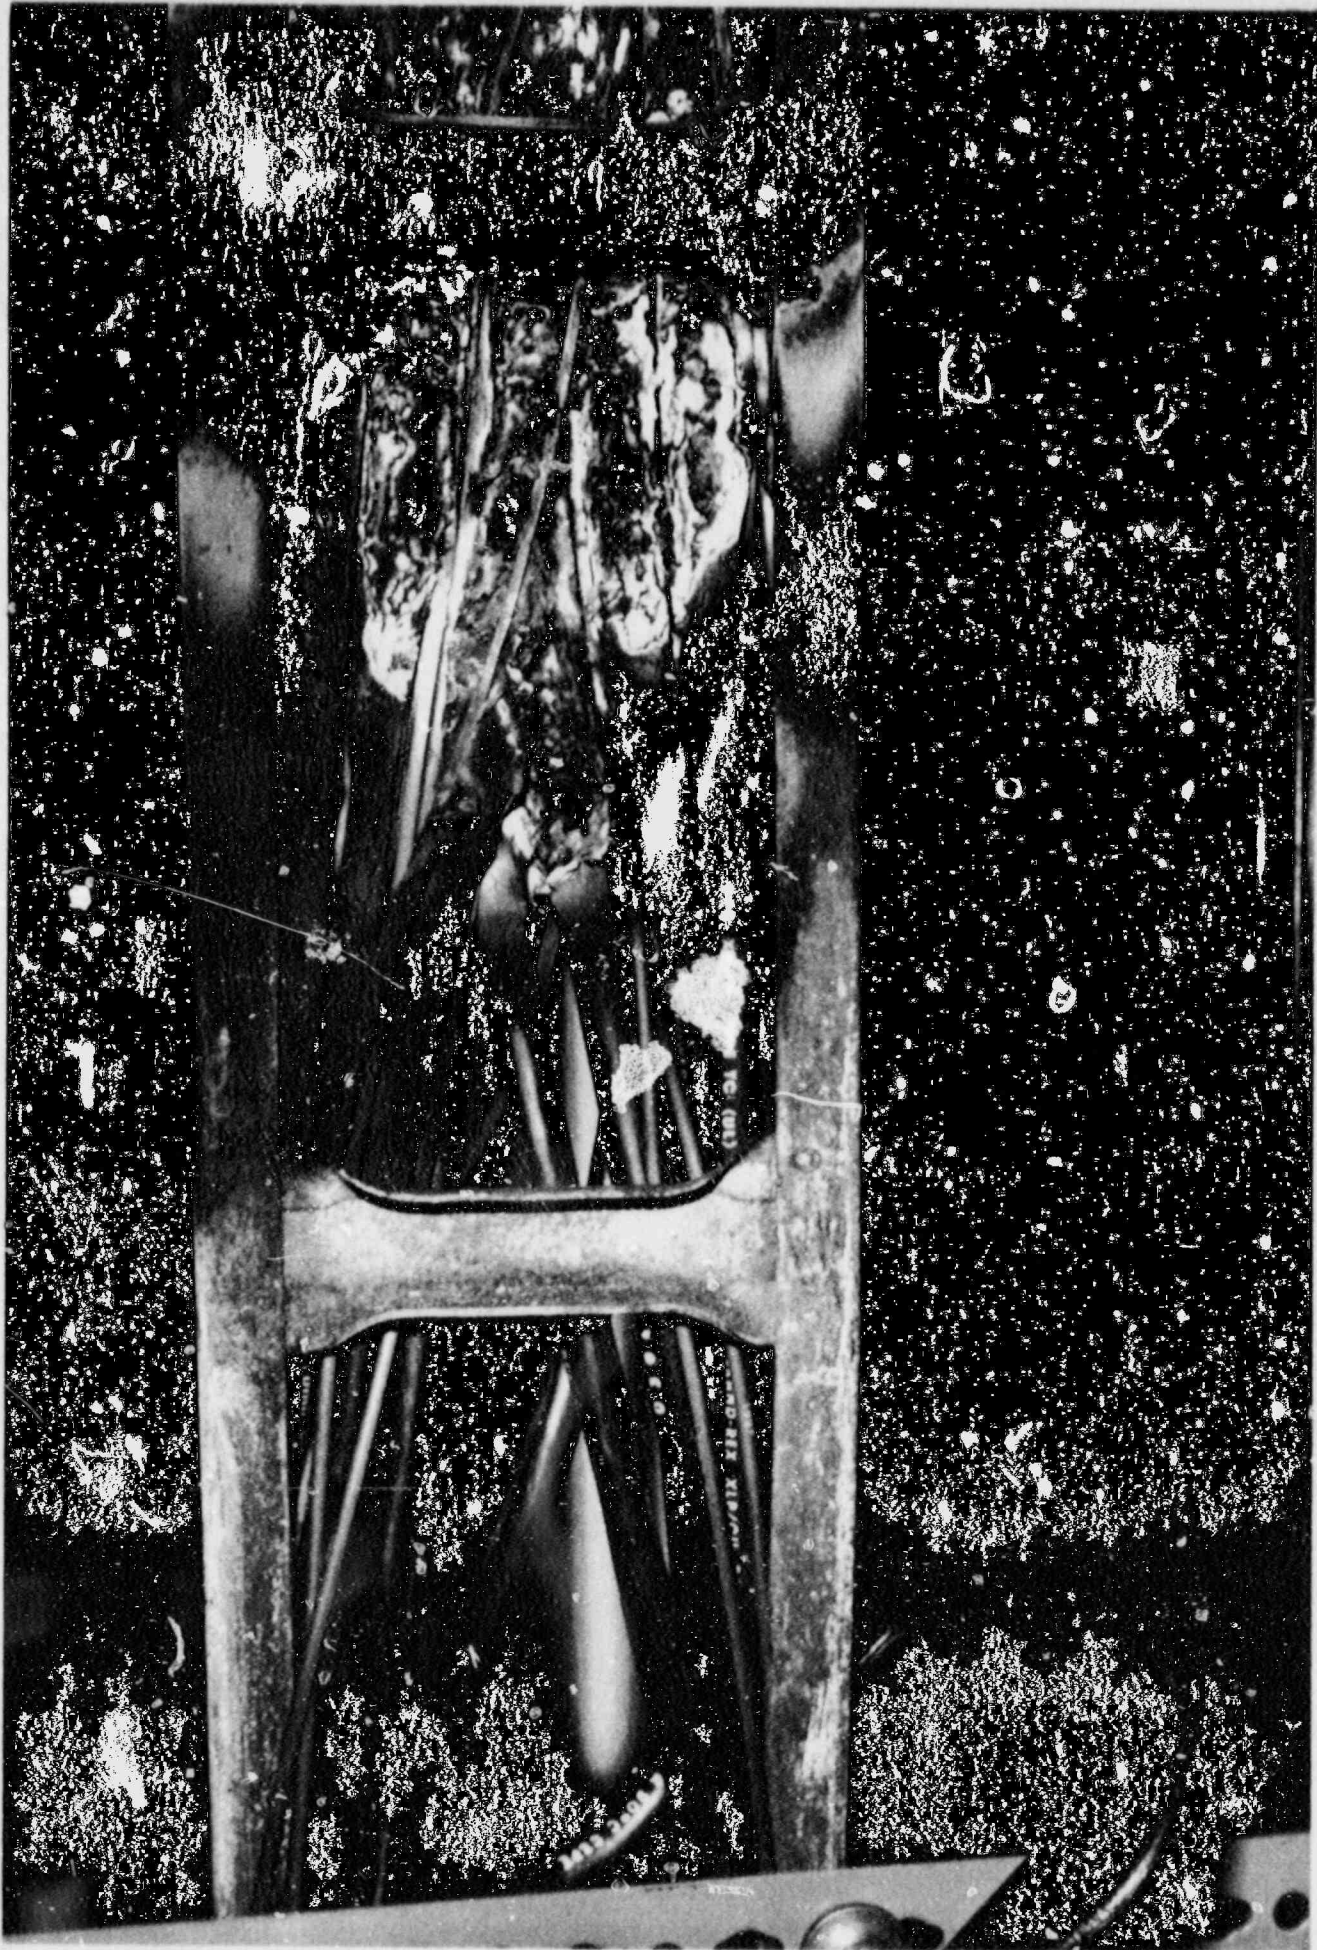
PICTURE NO. 4
Test No. 1
Cable Damage

Pictures 4 to 7 show the extensive cable insulation damage in the lower portion of the tray which is to be expected since they were closest to the flame source. In many cases the bare conductors were exposed. The top most cables experienced minor visible damage which is attributed to the non-propagating and flame retardant properties of the nuclear grade cable being tested.

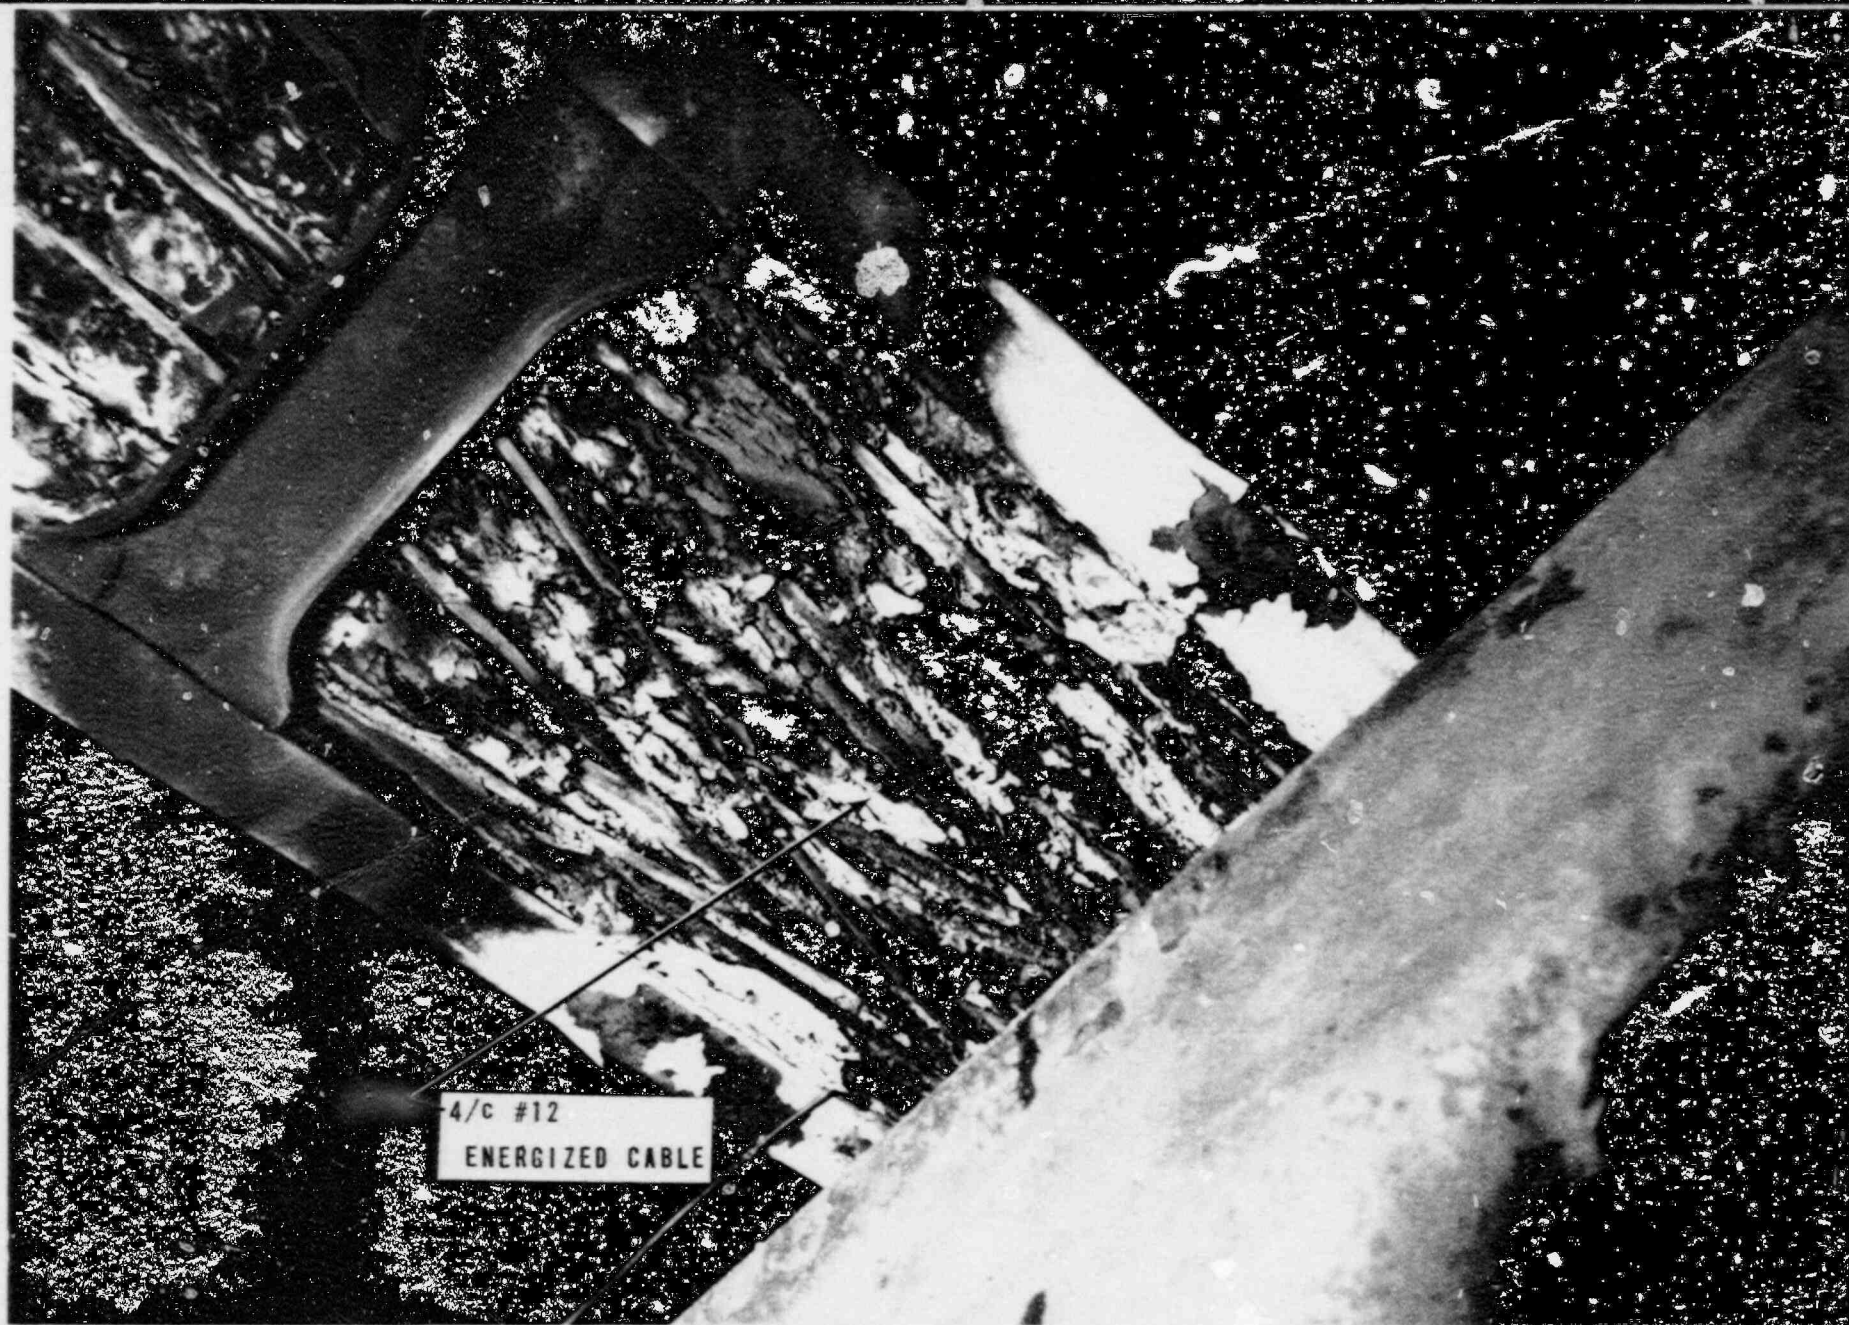
PICTURE NO. 5
Test No. 1

Picture 5 shows the location and condition of the energized 4/C #12 cable. Careful inspection of the cable in the flame area did not reveal bare conductor. It is therefore concluded that the leakage current occurred between the conductors of the same cable.

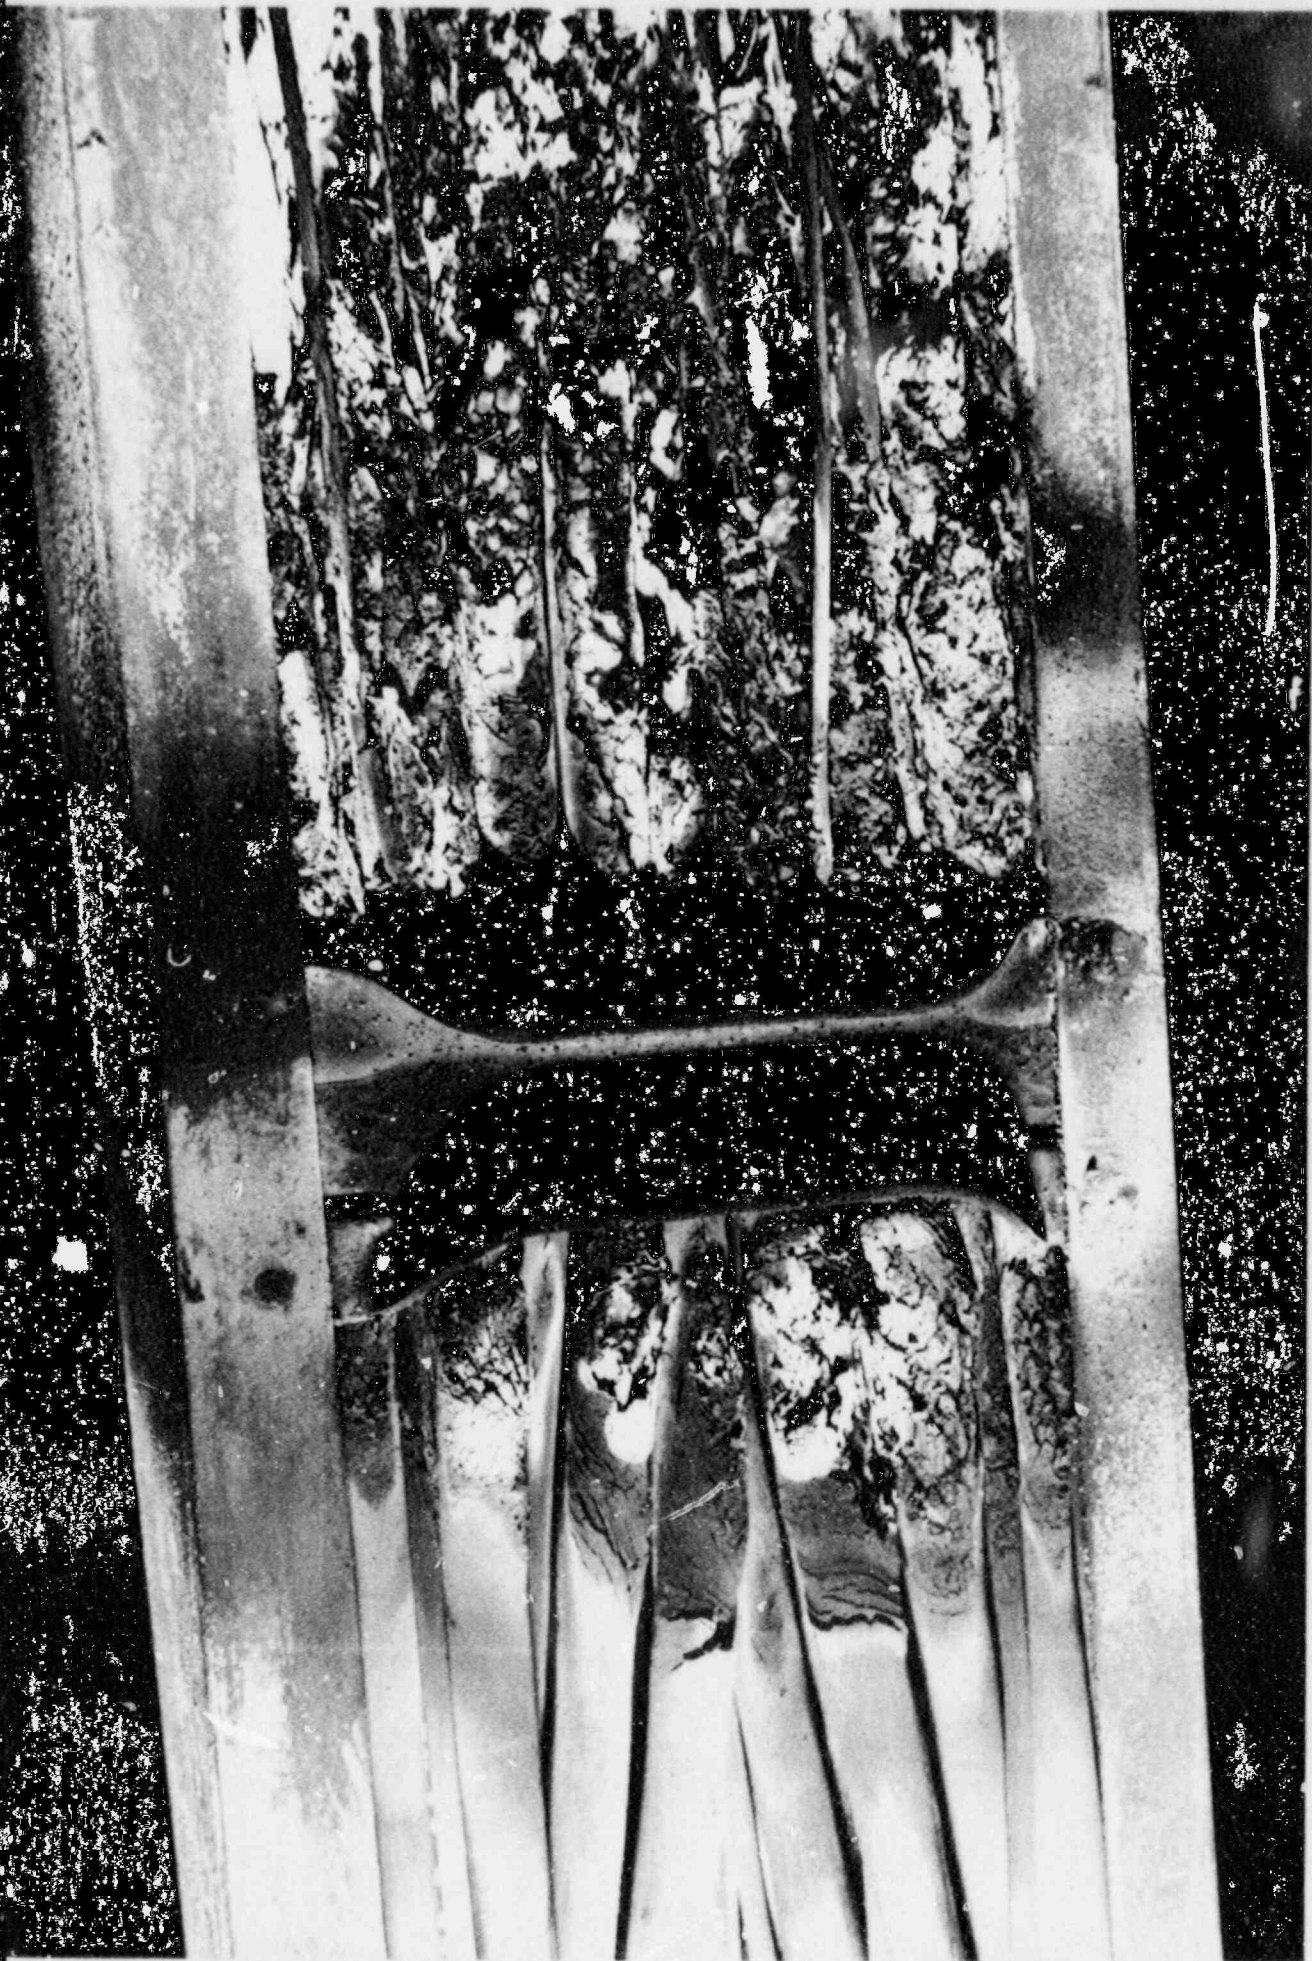
PICTURE NO. 8
Test No. 2
Cable Damage

Pictures 8 to 10 show the cable insulation damage to cables in the lower portion of the tray, closest to the flame source. The damage is very similar to that of test no. 1. As expected the top most cables experienced minor visible cable insulation damage which can be attributed to the non-propagating and flame retardant properties of the nuclear grade cables being tested. Conclusions resulting from the first test were supported by this test.

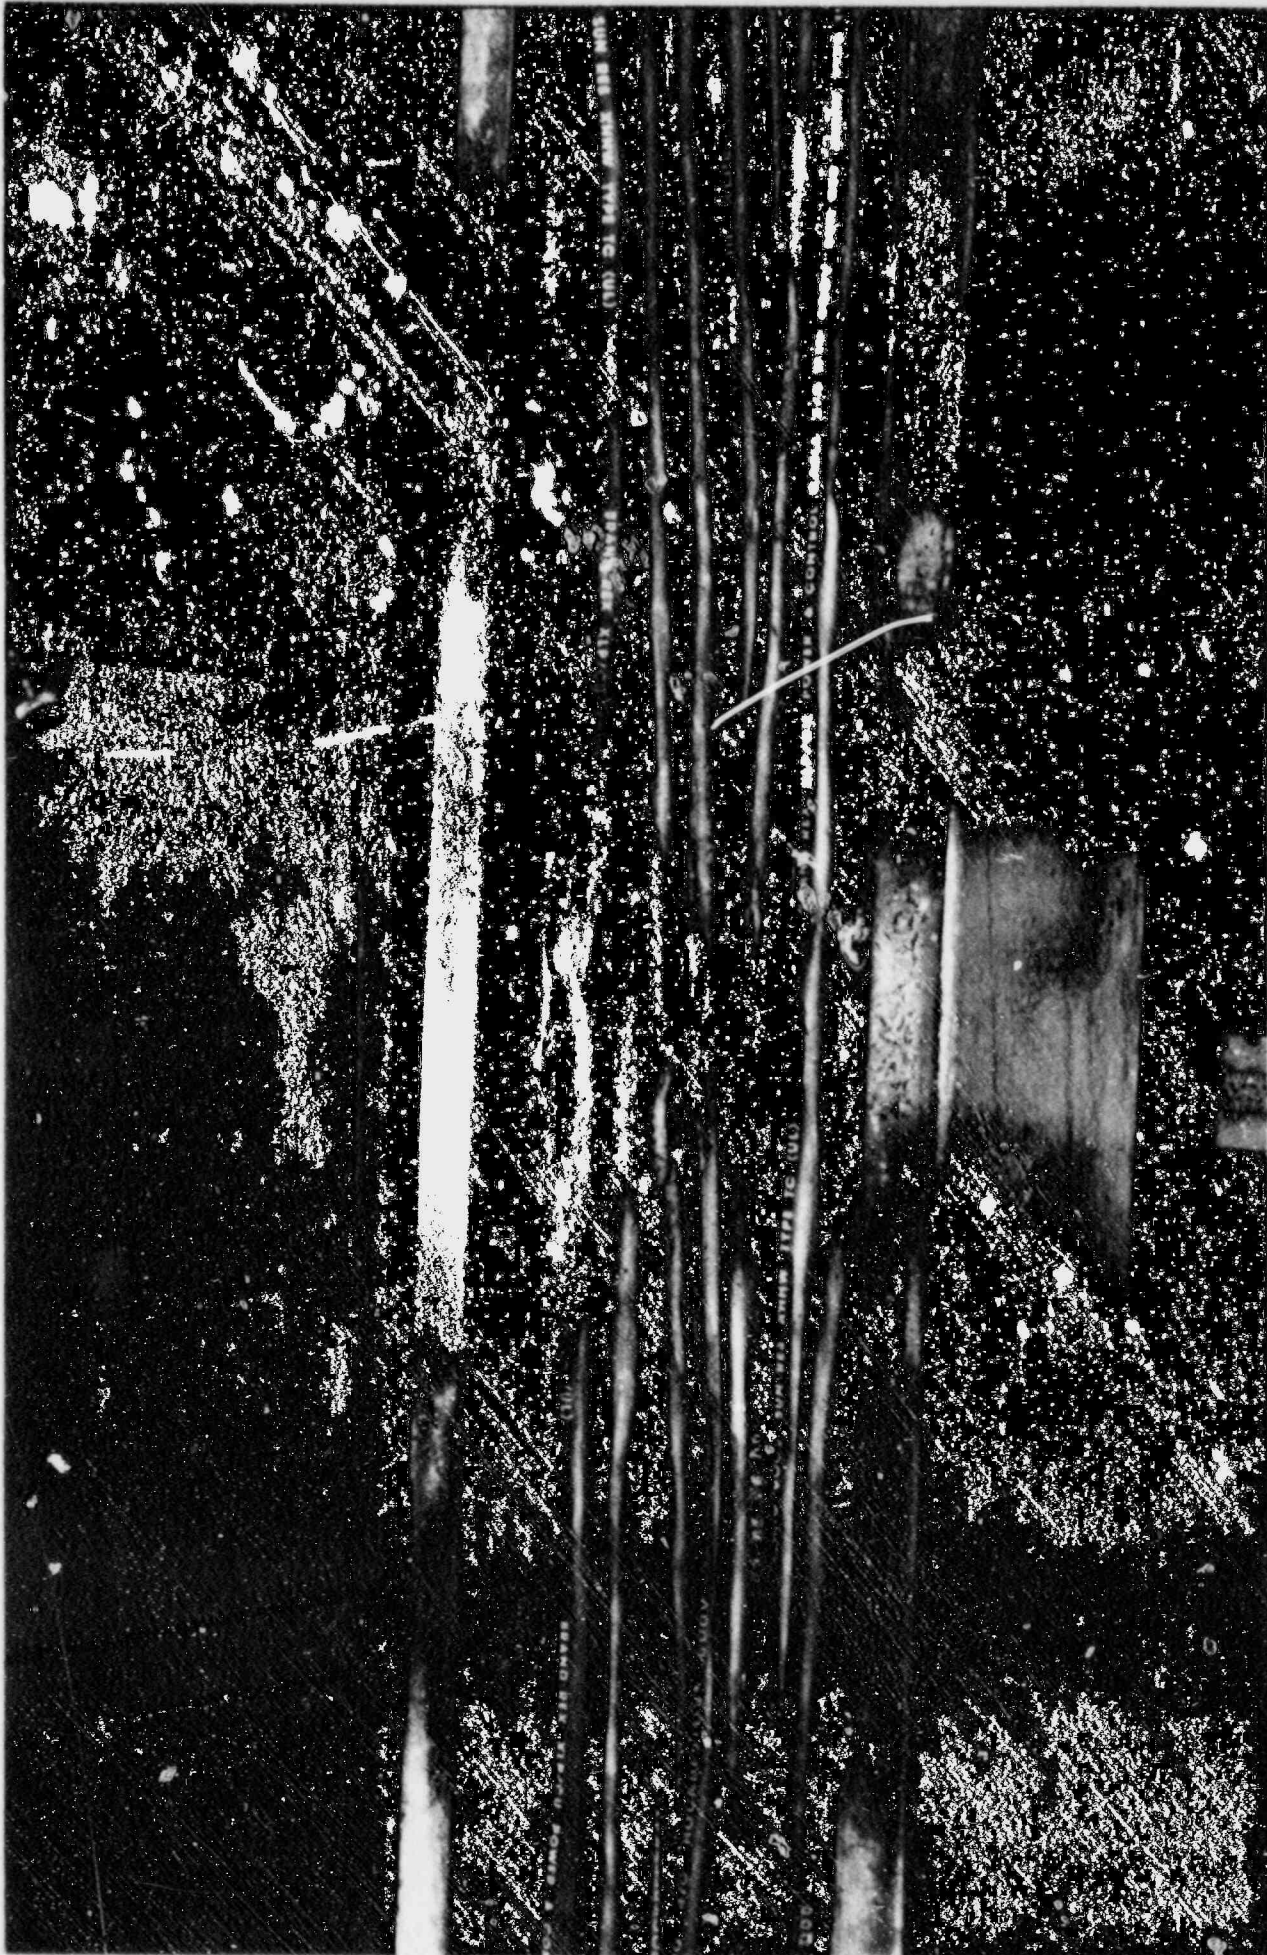
PICTURE NO. 13
Test No. 3
Cable Damage in Flame Area
Top of Tray

Pictures 13 to 18 show the cable damage in the fire area. As in the first two tests, the cables in the bottom of the tray had much more damage than the cables at the top.

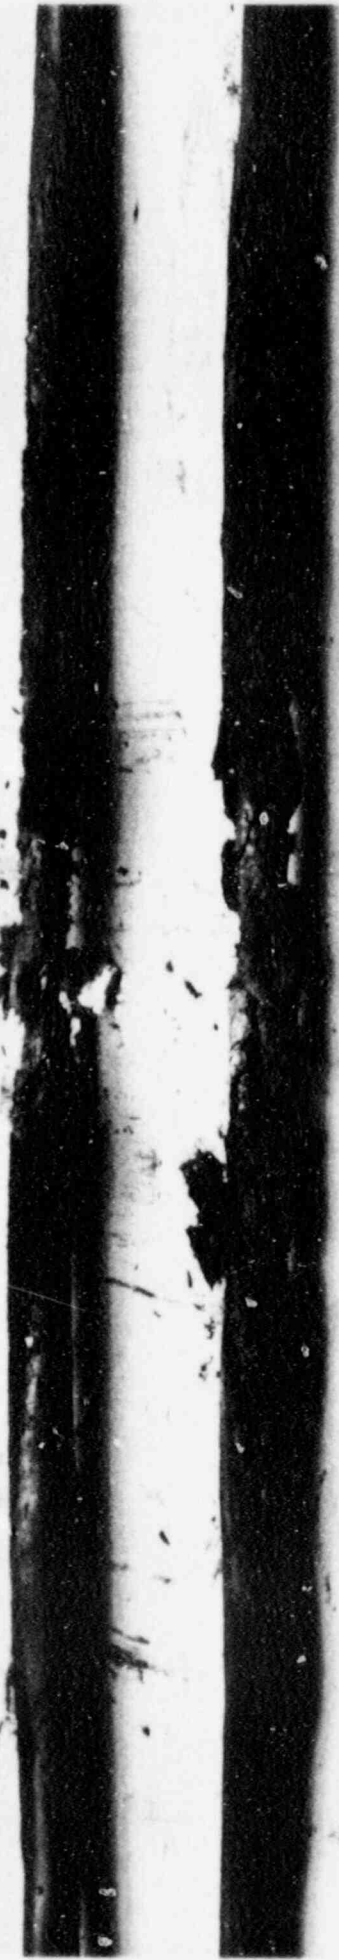
PICTURE NO. 19
Test No. 3
Channel #10

Fuses associated with cables on Channel 13 and 18 did not fail. Figure 14 shows that these cables were located in the top most part of the tray. The cable damage to these circuits is shown in Pictures No. 25 and 26. All energized cables located in the bottom and middle sections of the tray blew their fuses and sustained major cable flame damage as can be seen in Pictures 19 to 24.
