PDR-016
RESPONSE TO FREEDOM OF
INFORMATION ACT (FOIA) REQUEST

Perry MSIV Stroke Time Failure

ROOT CAUSE ANALYSIS

MSIV EG VALIDATION
TASK 3, SOLENOID VALVE
ENVIROMENTAL (THERMAL ENDURANCE) TEST PLAN
PERRY NUCLEAR POWER PLANT

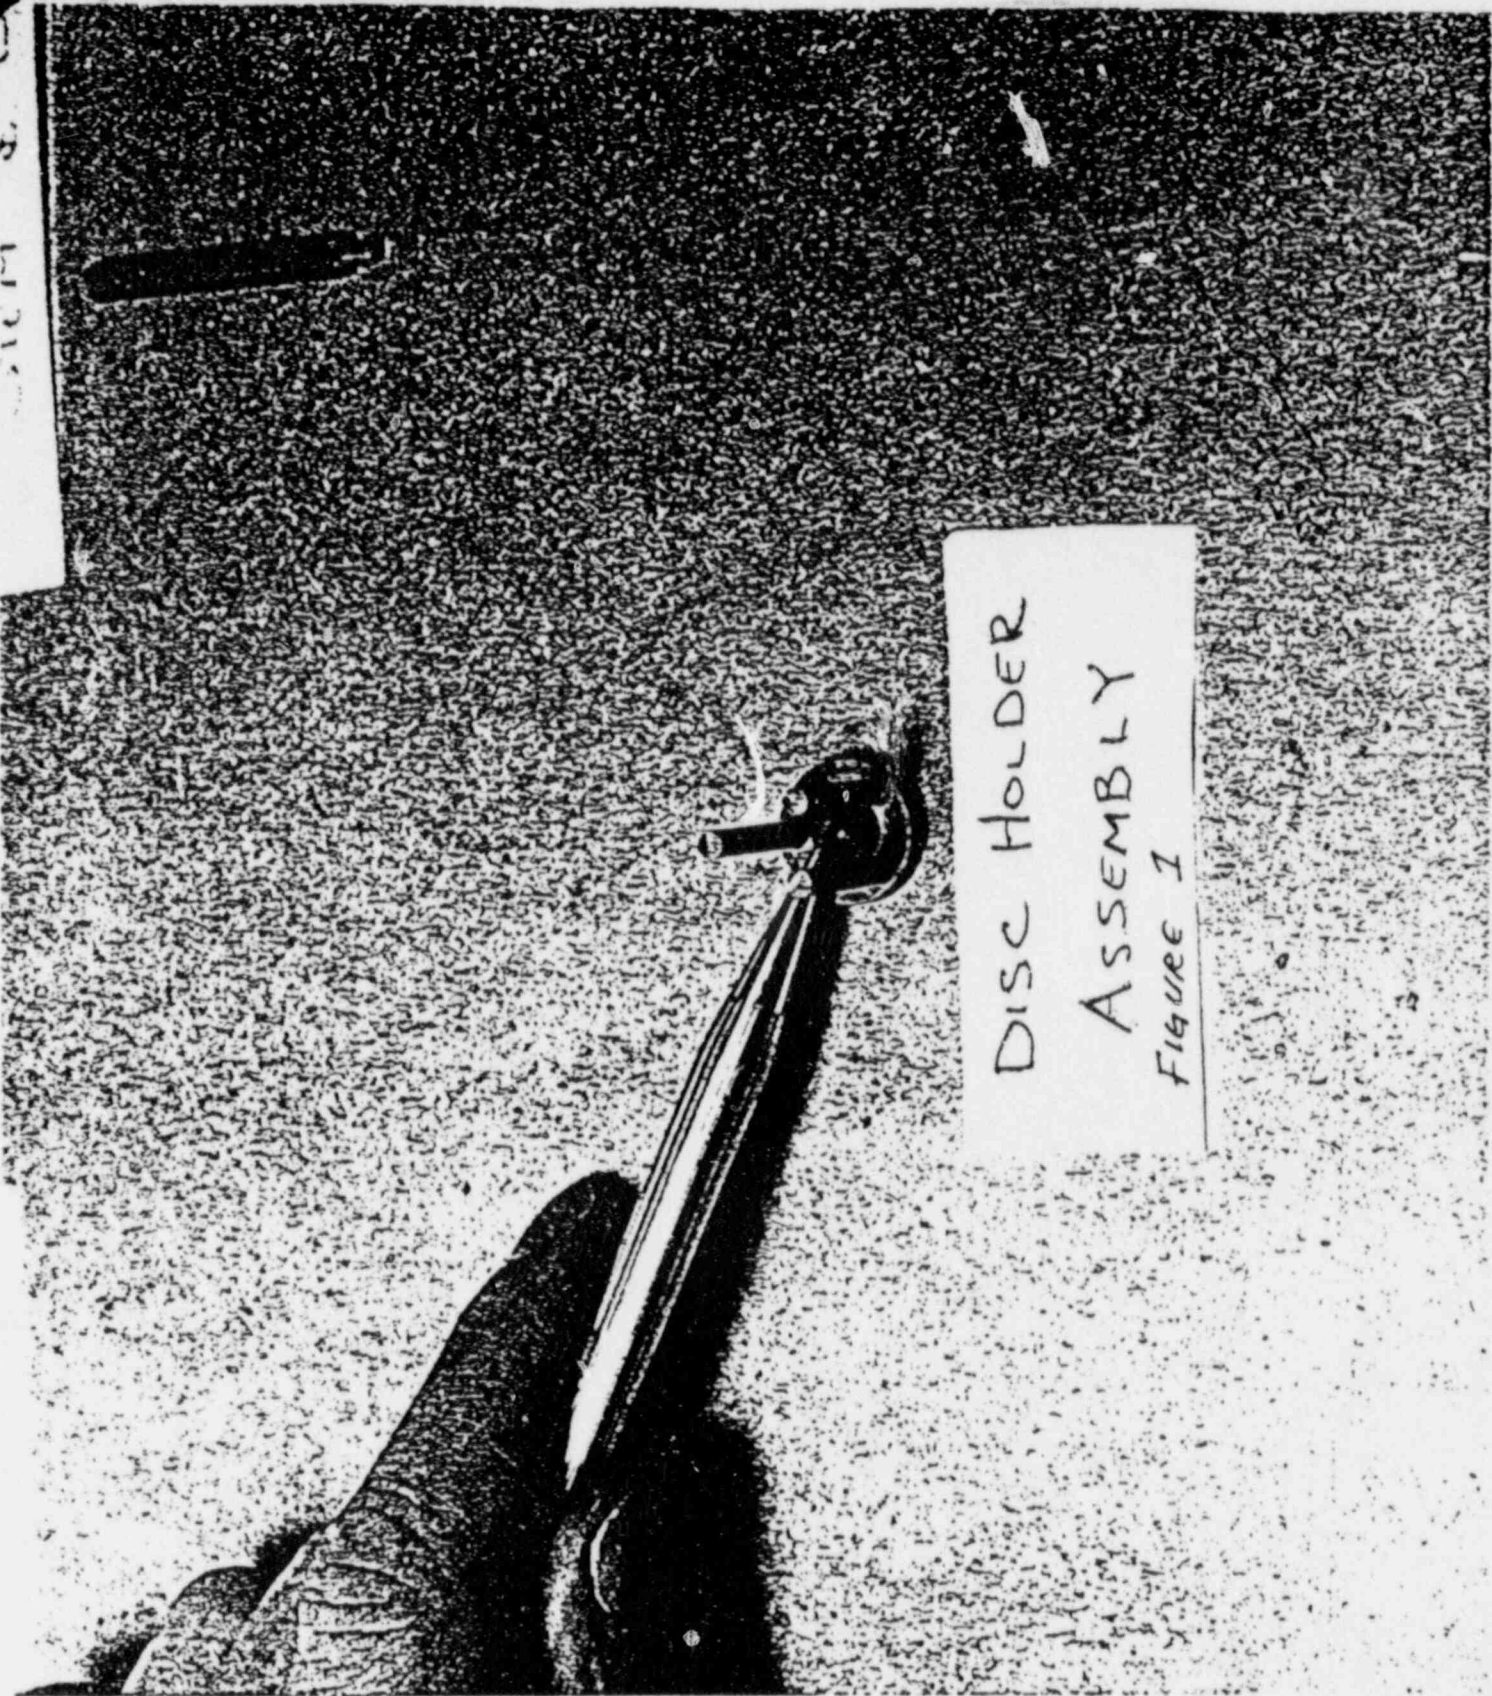
Figure 1

The most probable root cause of the observed MSIV failure to close is failure of the Automatic Signal Company (ASCO) Model 8323 3-way dual solenoid valve to shift from the energized to de-energized position. Within the component, the Ethylene Propylene Diene Monomer (EPDM) rubber disc seat material was found to be deformed. A "dimple" (see figure 1 and 2) was found in the EPDM seat material on the disc holder. This is also indicative of a general hardening and degradation of the rubber seals within the valve. If the disc holder sticks to the orifice the MSIV will not close. Delayed closure is consistent with de-energizing of the solenoid, followed by sticking of the disc holder to the orifice for some period of time, when the disc holder breaks loose and allows the air pressure to relieve through the orifice. Once the air pressure is relieved, the MSIV will close.

This failure mode is the most likely candidate for root component failure of the problem. The post-disassembly inspection has found dimpling of the EPDM rubber disc seat material. This could cause the disc holder assembly to wedge in place when the solenoid is de-energized. This would in turn not allow air pressure to relieve through the #3 air port, and preclude MSIV closure.

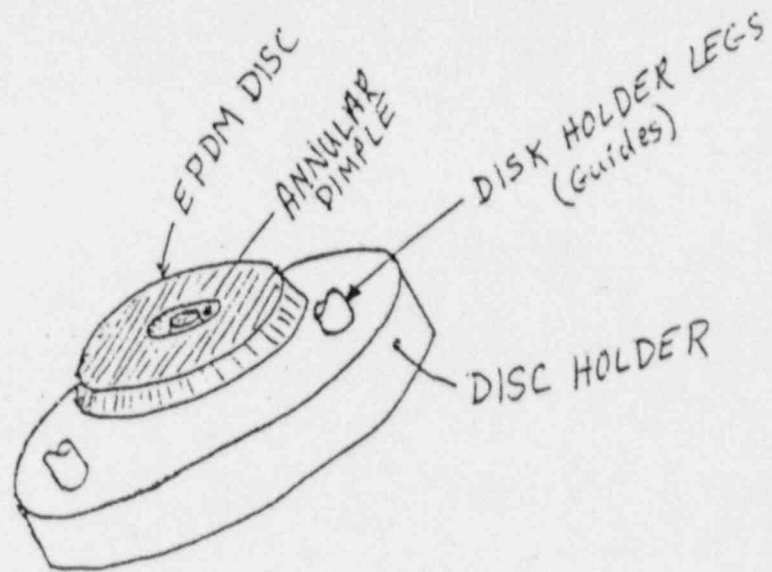
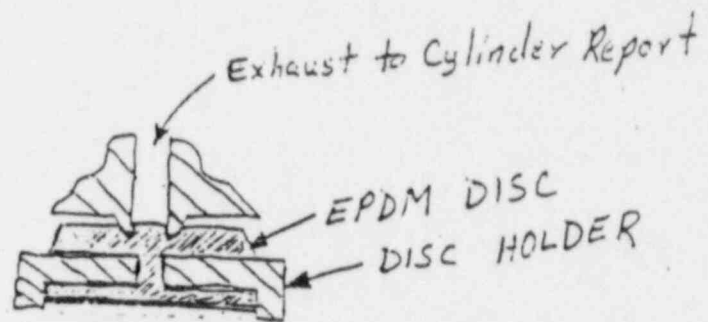
Figure 2

The EPDM degradation is most probably caused by exceeding the temperature limits of the EPDM material. EPDM was chosen for this application because of its radiation resistance from an equipment qualification standpoint. Perry has experienced bulk drywell and steam tunnel temperatures which have approached tech spec limits during much of the startup test program. Additionally, steam leaks have occurred in the vicinity of the affected MSIV solenoids. While no data exists to actually confirm that the local temperatures have exceeded the capability of the EPDM rubber, a good correlation exists between the location of steam leaks and the affected valves.

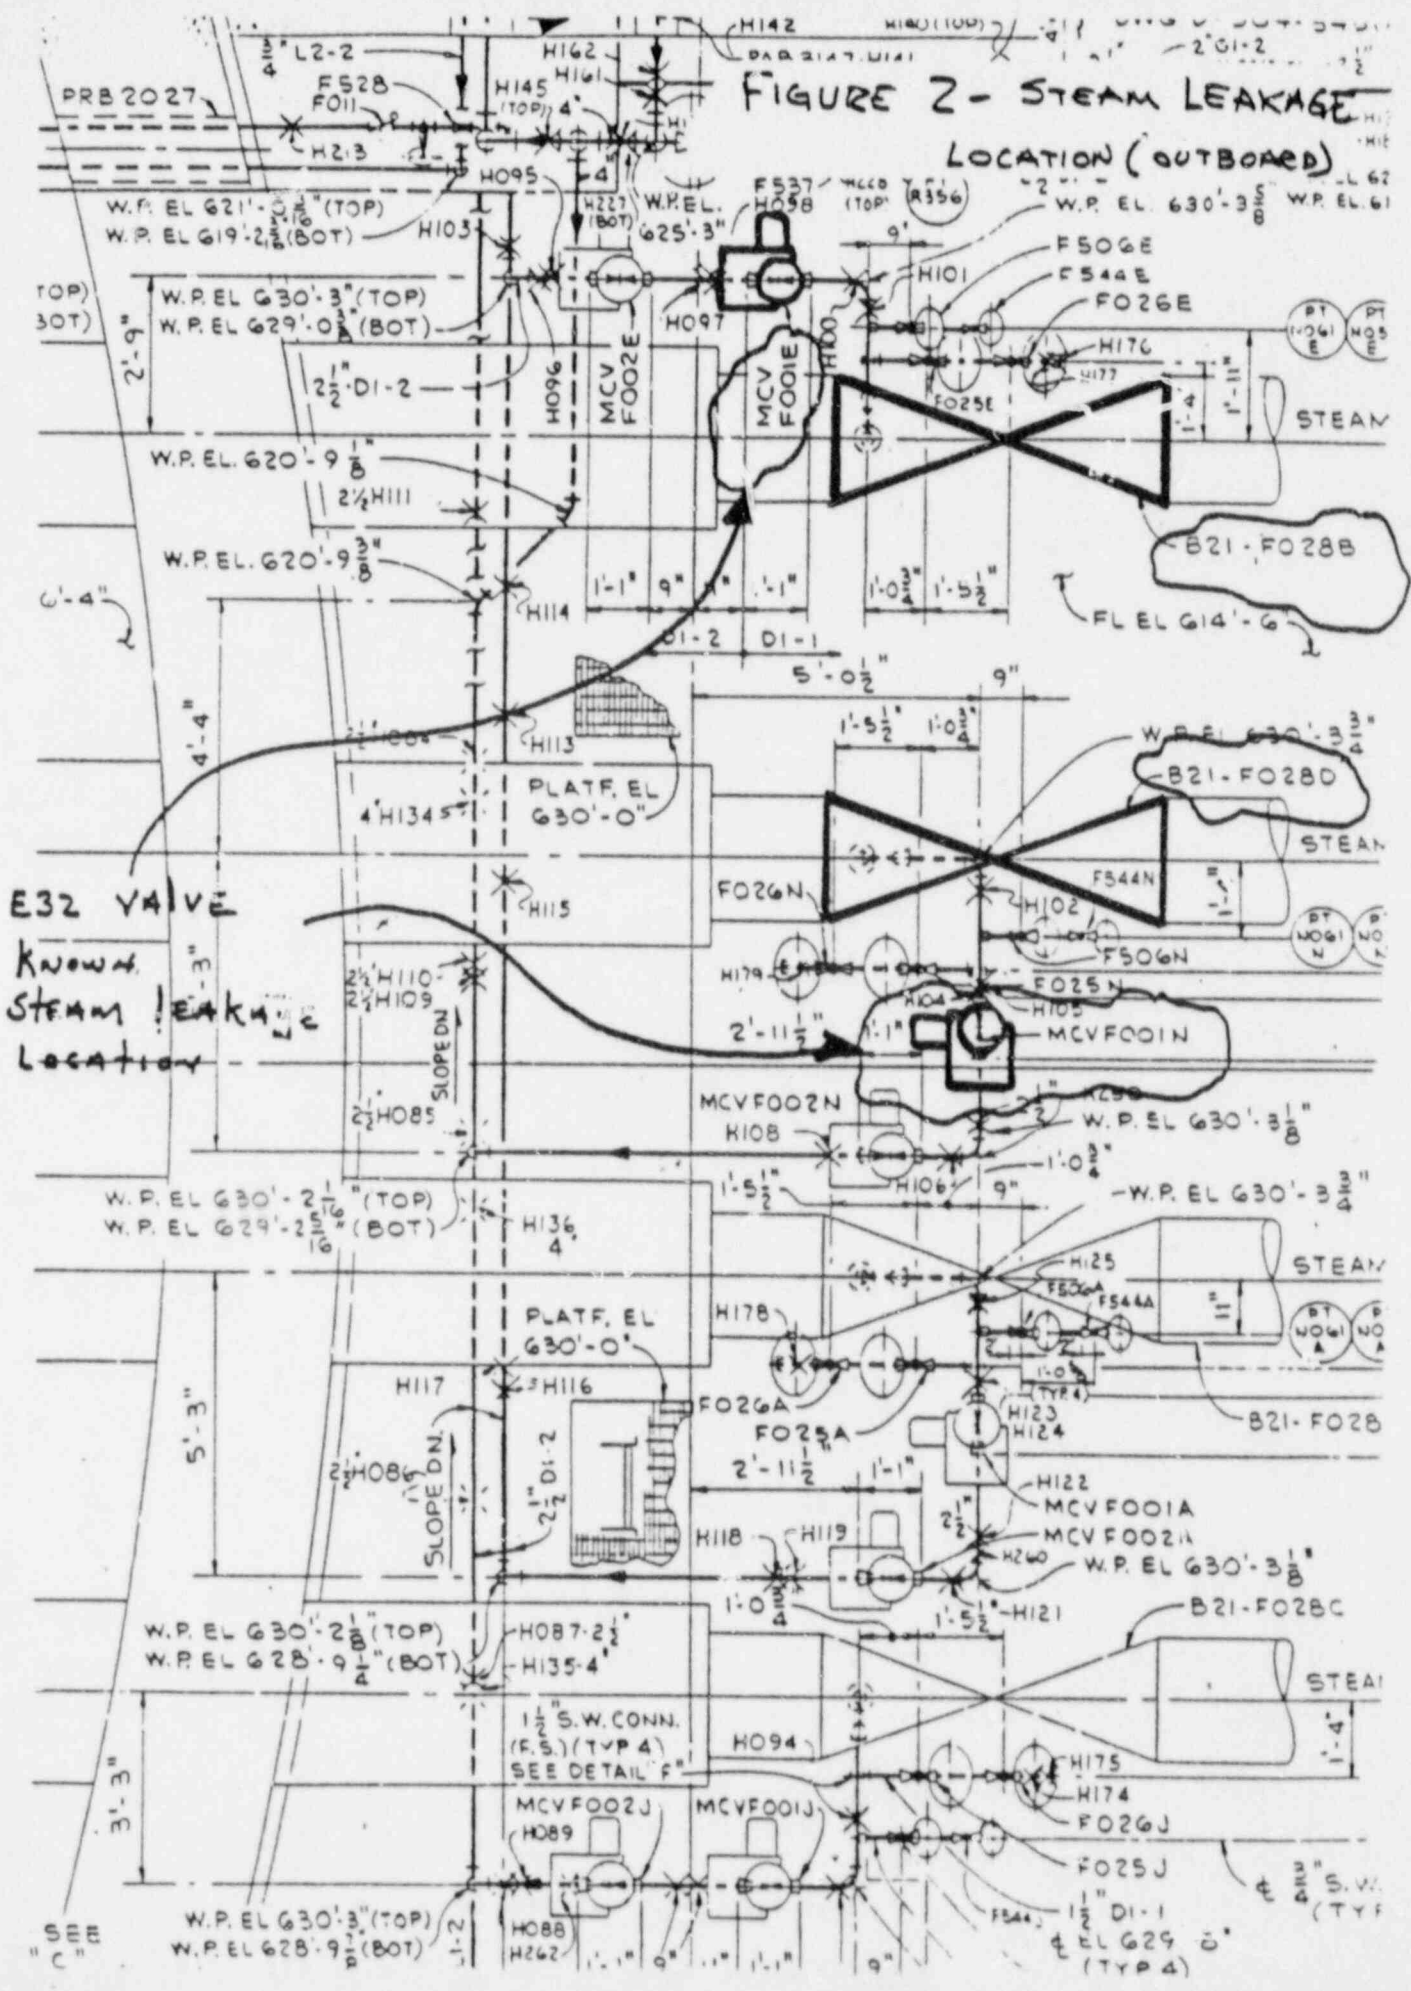
FIGURE 2 - STEAM LEAKAGE LOCATION (OUTBOARDED)

Elevated local temperature is the most probable cause for degradation of the EPDM seals in the ASCO Model 8323 pilot solenoid valve. The material is known to be temperature sensitive, the potential for elevated temperature has been shown to exist, and the best performing valves are in the lowest temperature locations.
