SUBJECT: DELUGE, PRE-ACTION AND FOAM-WATER DELUGE SPRINKLER
SYSTEMS: MODEL C DELUGE VALVES

IE INFORMATION NOTICE NO. 84-16: FAILURE OF AUTOMATIC SPRINKLER SYSTEM VALVES
TO OPERATE

**Subject: Nuclear Regulatory Commission Information Notice 84-16,
"Failure of Automatic Sprinkler System Valves to Operate"**

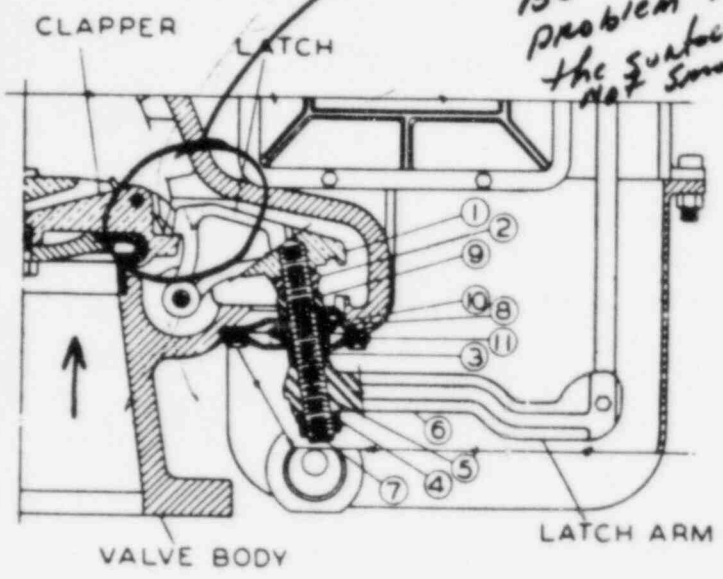
Dwg. No. SB-173-3

Press
THIS MATING SURFACE APPEARS TO BE A POTENTIAL PROBLEM IF THE SURFACE IS NOT SMOOTH

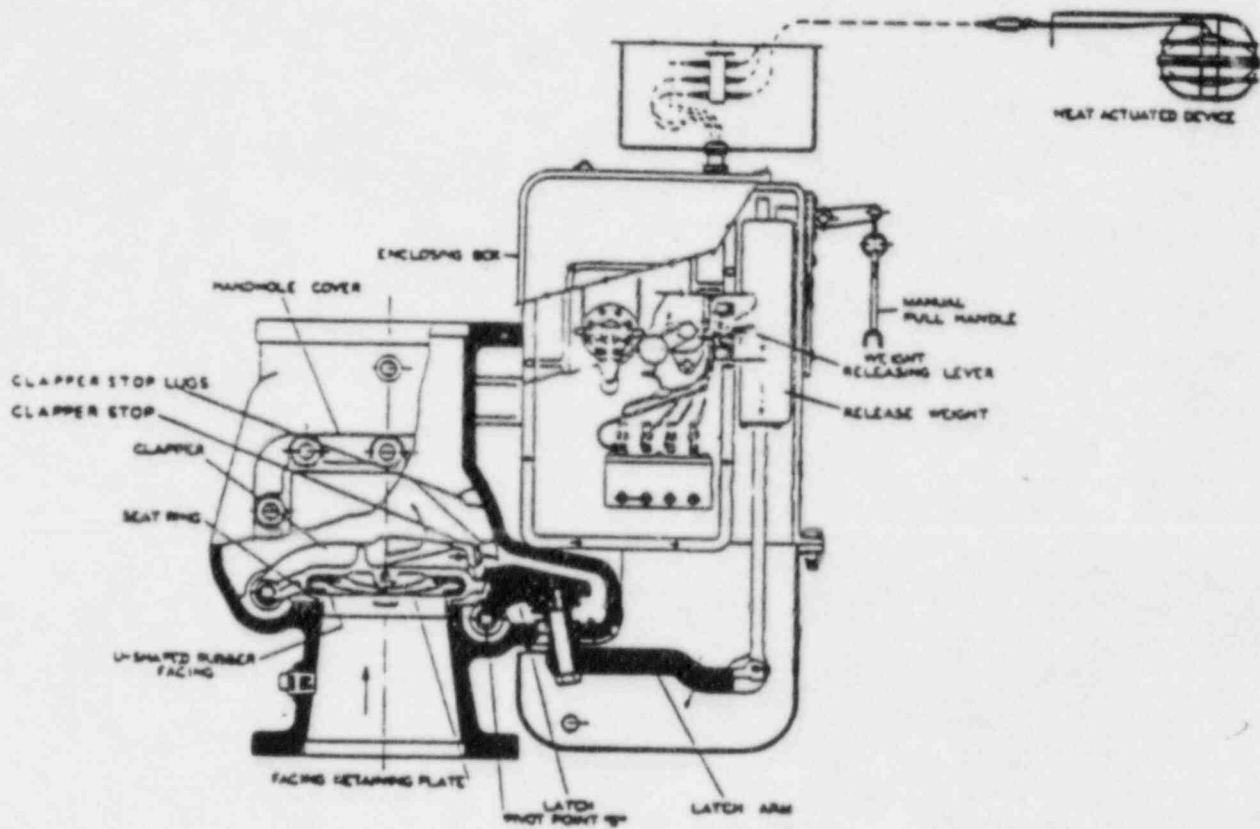
MODEL C VALVE

During subsequent testing and examination, excessive friction was noted between the weight and the weight guide rod; bowing (0.005-inch) was observed in the weight guide rod; evidence of scoring was found in two locations on the rod's surface; the weight's upper guide collar had an inside diameter (ID) of 0.637 inch rather than the manufacturer's recommended minimum of 0.647 inch; and scoring was noted on the enclosing box along the path that the weight guide bushing traces during actuation.

The licensee's preliminary investigation indicates that these failures may be related to the surface condition of the latch which holds the water clapper in the normally closed position. If the mating surfaces of the latch and clapper are not smooth, the latch may fail to disengage when the actuation weight hits the latch arm. If the normal water system pressure applied to the clapper valve exceeds 140 psig, the problem becomes more acute. The water pressure at Grand Gulf is maintained at 140 psig.

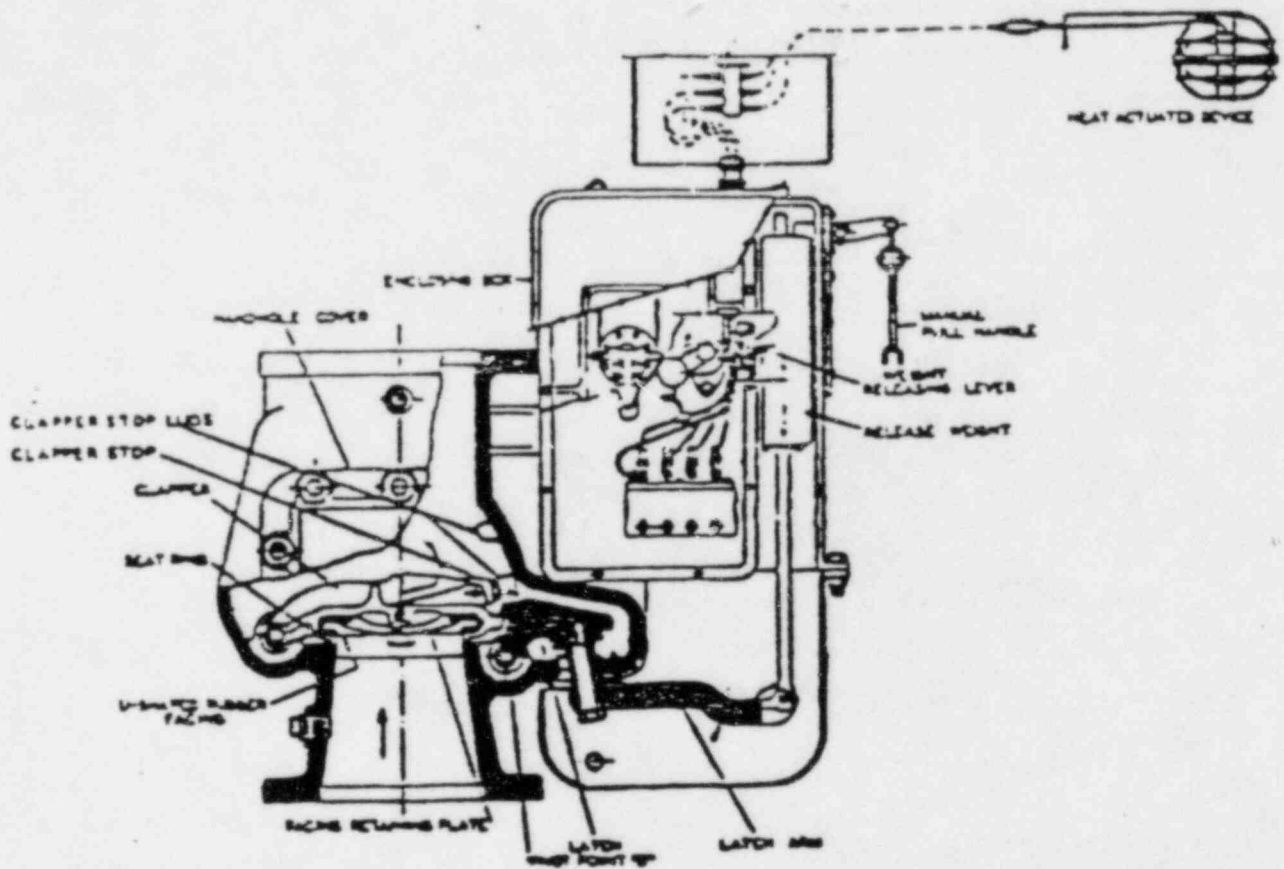
MODEL C VALVE

During subsequent testing and examination, excessive friction was noted between the weight and the weight guide rod; bowing (0.005-inch) was observed in the weight guide rod; evidence of scoring was found in two locations on the rod's surface; the weight's upper guide collar had an inside diameter (ID) of 0.637 inch rather than the manufacturer's recommended minimum of 0.647 inch; and scoring was noted on the enclosing box along the path that the weight guide bushing traces during actuation.

The licensee's preliminary investigation indicates that these failures may be related to the surface condition of the latch which holds the water clapper in the normally closed position. If the mating surfaces of the latch and clapper are not smooth, the latch may fail to disengage when the actuation weight hits the latch arm. If the normal water system pressure applied to the clapper valve exceeds 140 psig, the problem becomes more acute. The water pressure at Grand Gulf is maintained at 140 psig.

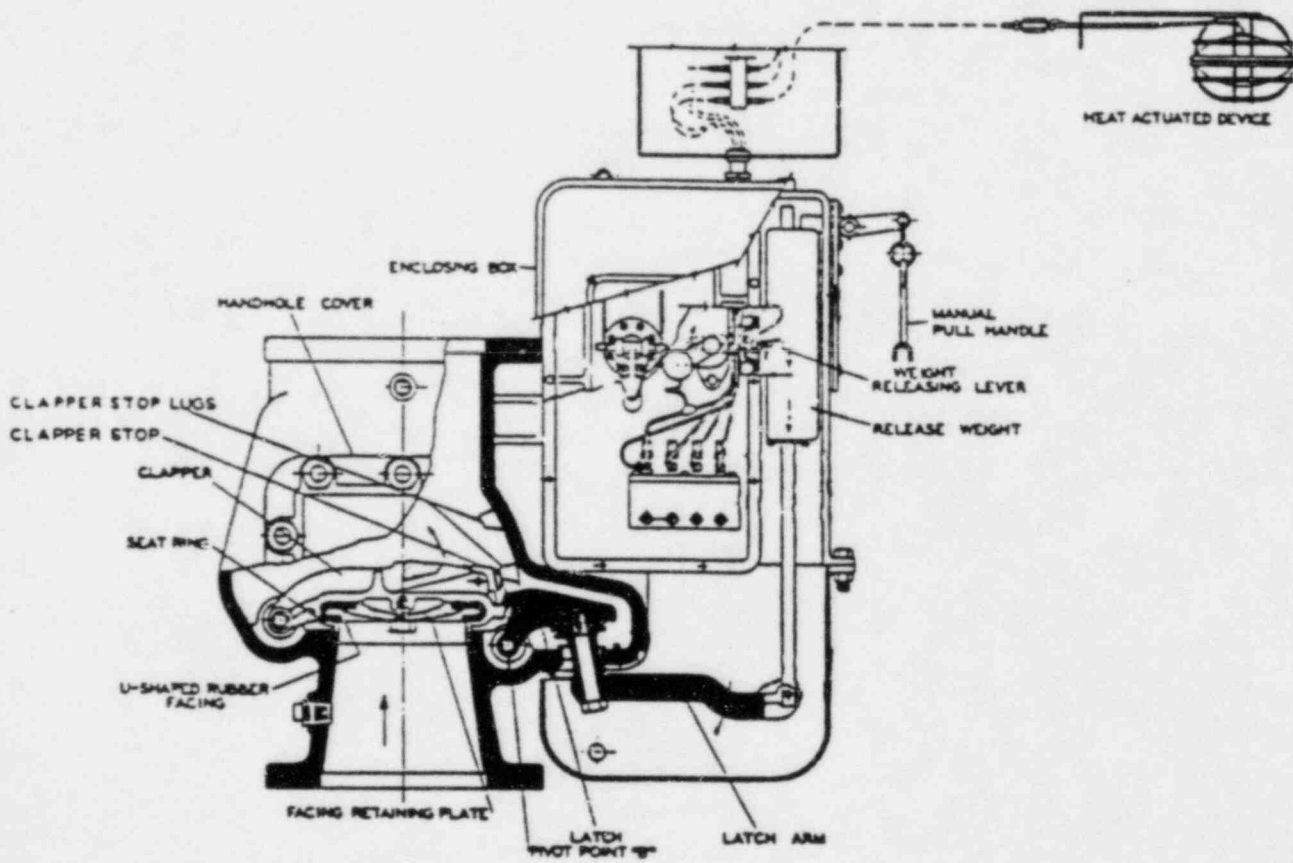
MODEL C VALVE

During subsequent testing and examination, excessive friction was noted between the weight and the weight guide rod; bowing (0.005-inch) was observed in the weight guide rod; evidence of scoring was found in two locations on the rod's surface; the weight's upper guide collar had an inside diameter (ID) of 0.637 inch rather than the manufacturer's recommended minimum of 0.640 inch; and scoring was noted on the enclosing box along the path that the weight guide bushing traces during actuation.

The licensee's preliminary investigation indicates that these failures may be related to the surface condition of the latch which holds the water clapper in the normally closed position. If the mating surfaces of the latch and clapper are not smooth, the latch may fail to disengage when the actuation weight hits the latch arm. If the normal water system pressure applied to the clapper valve exceeds 140 psig, the problem becomes more acute. The water pressure at Grand Gulf is maintained at 140 psig. *Charlie Barnett (R&D) (Zib) 526-4900 ext 307*

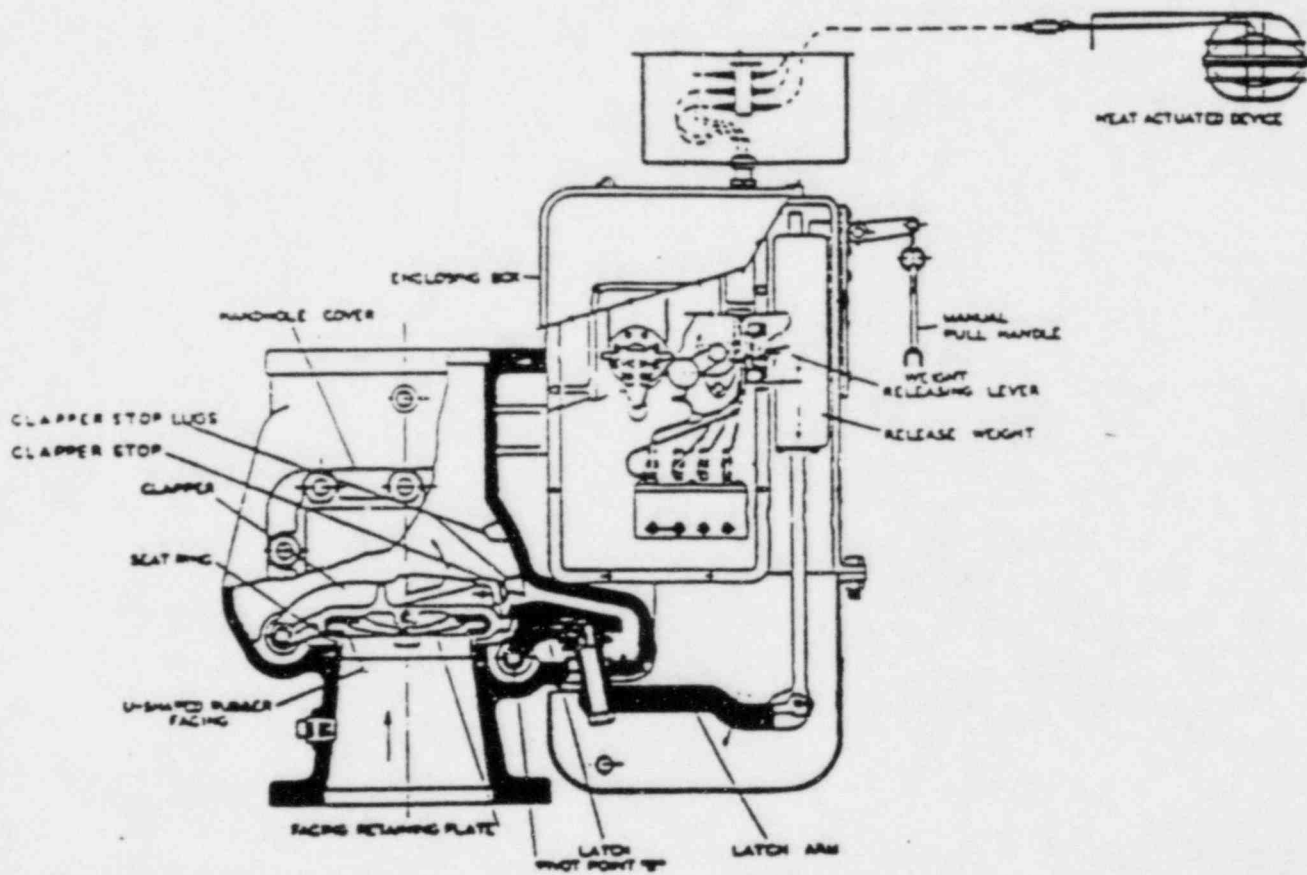
MODEL C VALVE

During subsequent testing and examination, excessive friction was noted between the weight and the weight guide rod; bowing (0.005-inch) was observed in the weight guide rod; evidence of scoring was found in two locations on the rod's surface; the weight's upper guide collar had an inside diameter (ID) of 0.637 inch rather than the manufacturer's recommended minimum of 0.647 inch; and scoring was noted on the enclosing box along the path that the weight guide bushing traces during actuation.

The licensee's preliminary investigation indicates that these failures may be related to the surface condition of the latch which holds the water clapper in the normally closed position. If the mating surfaces of the latch and clapper are not smooth, the latch may fail to disengage when the actuation weight hits the latch arm. If the normal water system pressure applied to the clapper valve exceeds 140 psig, the problem becomes more acute. The water pressure at Grand Gulf is maintained at 140 psig.

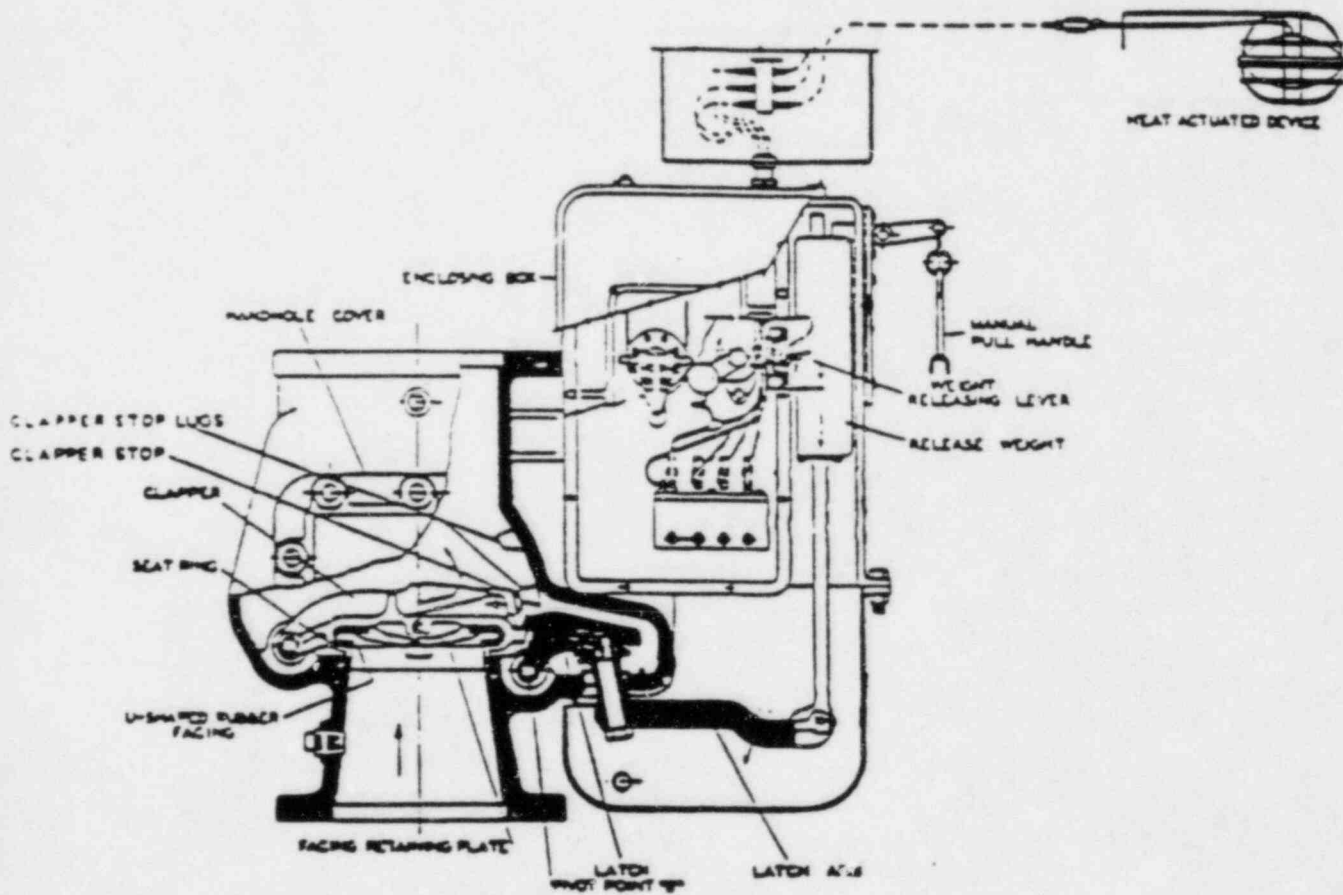
MODEL C VALVE

During subsequent testing and examination, excessive friction was noted between the weight and the weight guide rod; bowing (0.005-inch) was observed in the weight guide rod; evidence of scoring was found in two locations on the rod's surface; the weight's upper guide collar had an inside diameter (ID) of 0.637 inch rather than the manufacturer's recommended minimum of 0.647 inch; and scoring was noted on the enclosing box along the path that the weight guide bushing traces during actuation.

The licensee's preliminary investigation indicates that these failures may be related to the surface condition of the latch which holds the water clapper in the normally closed position. If the mating surfaces of the latch and clapper are not smooth, the latch may fail to disengage when the actuation weight hits the latch arm. If the normal water system pressure applied to the clapper valve exceeds 140 psig, the problem becomes more acute. The water pressure at Grand Gulf is maintained at 140 psig.
