SUBJECT: TRANSFER OF OPERATING EVENT LONG-TERM FOLLOWUP

EVENT FOLLOWUP REPORT 87-172  
50.72 EVENT #10515, OCTOBER 30, 1987  
PLANT-PERRY 1  
PROJECT MANAGER- T. COLBURN  
COGNIZANT ENGINEER- J. CARTER

BRUNSWICK 2 ISOLATION VALVES IN DRAIN LINES FAIL TO CLOSE

EVENT FOLLOWUP REPORT 88-02  
50.72 11109 JANUARY 2, 1988  
PLANT-BRUNSWICK 2  
PROJECT MANAGER-E. SYLVESTER  
COGNIZANT ENGINEER-J. CARTER

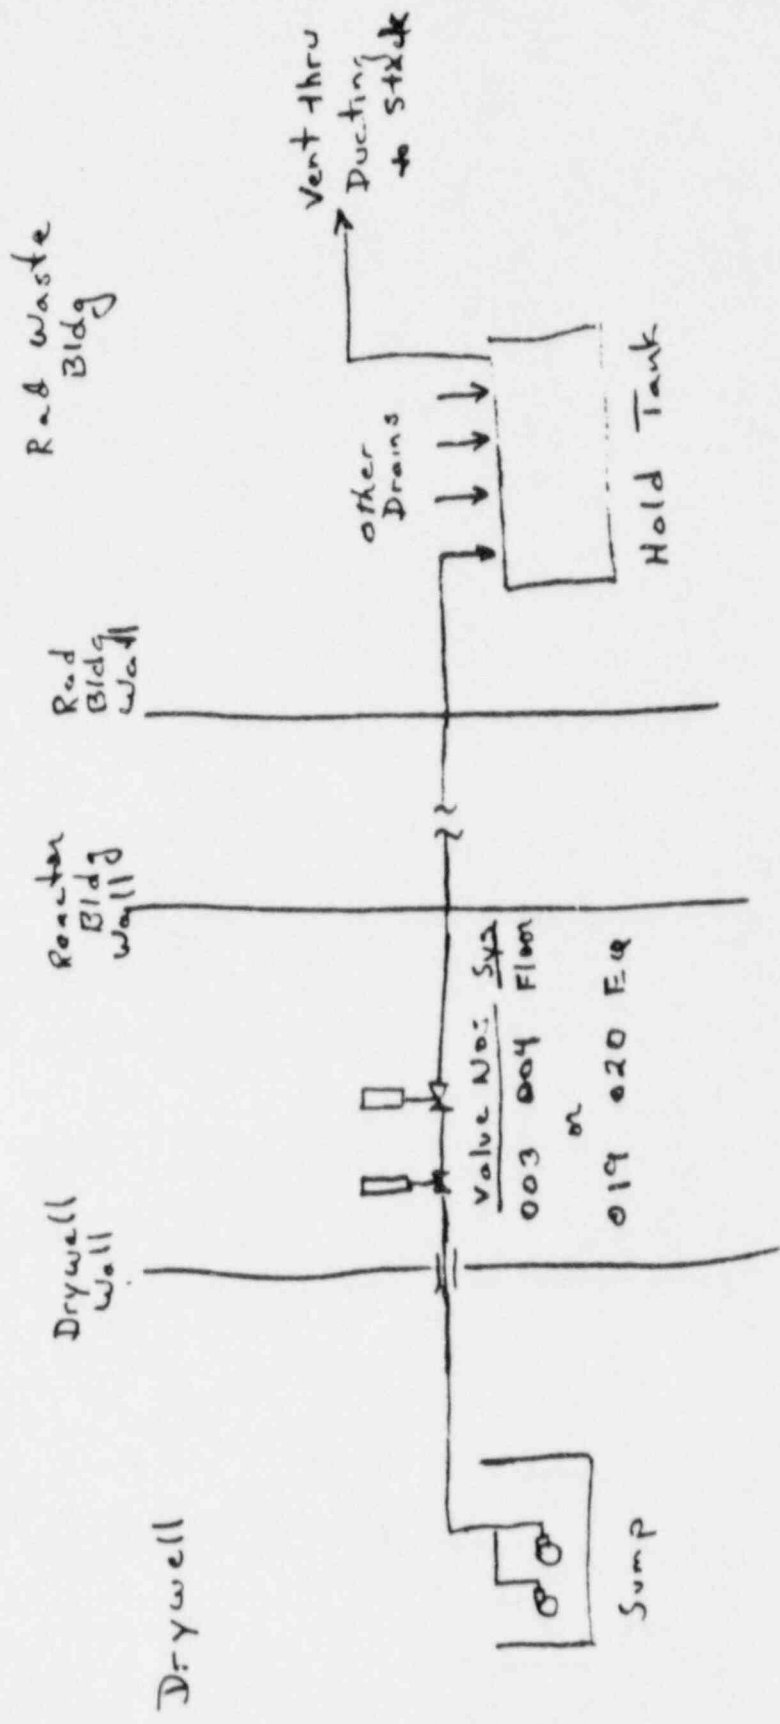
BRUNSWICK DRYWELL DRAIN  
SCHEMATIC  
FOR  
EQUIPMENT and FLOOR DRAINS

Automatically operated isolation valves in both the equipment drain line and floor drain line from the drywell did not close upon demand.

Currently unknown; however, the solenoid valves venting air from the isolation valve pistons are suspected of sticking.

Early investigation revealed that these valves use a single coil solenoid to vent and supply air to the piston which closes or opens the isolation valve. The solenoid valve design is different than the solenoid used in the control air system for MSIVs. Isolation valve failures in drain lines had been observed previously at Brunswick Unit 2; no failure of the corresponding valves at Unit 1 had been recorded. No known differences can explain why Unit 2 experienced failures. Disassembly of one solenoid valve believed to be sticking did not provide any apparent cause of failure or sticking.
