LICENSEE EVENT REPORT (LER)

FACILITY NAME (1)
Grand Gulf Nuclear Station

DOCKET NUMBER (2)
05000-416

TITLE (4)
Containment Penetration Opened Contrary to the Technical Specification Requirement

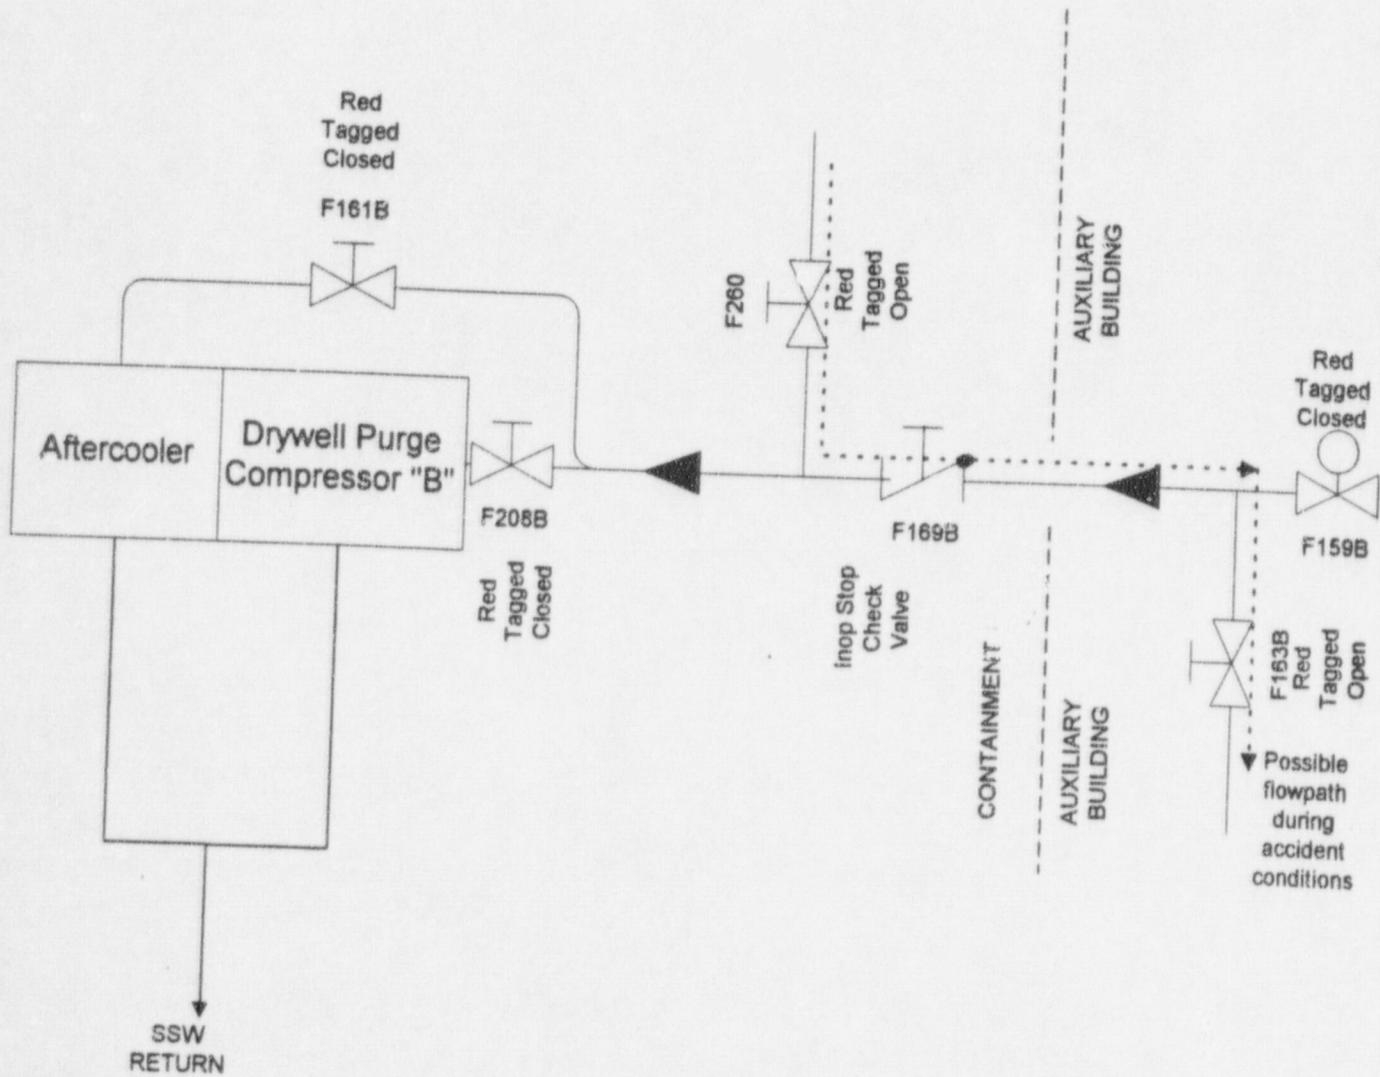
On August 4, 1998, during a routine review of the original LER to identify and assess any potential maintenance rule impact, it was identified that the Drywell Purge Compressor Inlet Vent Valve 1P41F260 [VTR], located inside of containment was not discussed in the LER. Further review of the associated work documents identified this valve as also being tagged open during the period that the test connection valve (1P41F163), i.e. the auxiliary building was open, thus resulting in a bypass of the containment.

This event was characterized by a potential leakage path through 3/4-inch valves being open on both the inboard and outboard side of containment. In this event, a primary containment isolation valve connected to a SSW [BI] pipeline that passes through the containment structure wall was inadvertently opened simultaneously with the Drywell Purge Compressor Inlet Vent Valve [VTR], resulting in bypassing Containment. Probabilistic Risk Assessment data results indicate that the probability of the occurrence of the GGNS Design Basis LOCA during the time that this condition existed to be approximately $1.2E-7$, thus well below the safety significance threshold.

Energy Industry Identification System (EIS) codes are identified in the text within brackets []. Figure 1 depicts the valves lineup configuration that led to occurrence of this event.
