ACCIDENT SEQUENCE PRECURSOR PROGRAM EVENT ANALYSIS

LER No:301/89-002Event Description:Effective LOOP due to inadvertent fire deluge system actuationDate:March 29, 1989Plant:Point Beach 2

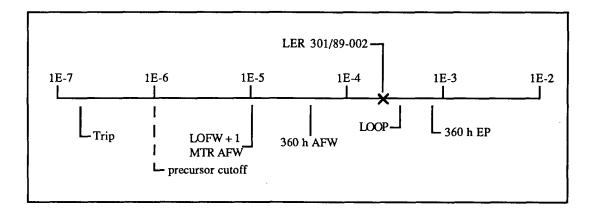
Inadvertent actuation of fire protection deluge sprays caused an electrical flashover on a main transformer. This resulted in a main transformer lockout, main generator breaker trip, and subsequent turbine and reactor trips from 100% power. A switchyard bus sectionalizing breaker operated unnecessarily, resulting in a voltage degradation in the offsite power supply. The emergency diesels started and energized vital loads. The core damage probability estimated for the event is 2.5×10^{-4} . The relative significance of the event compared with other postulated events at Point Beach is shown below.

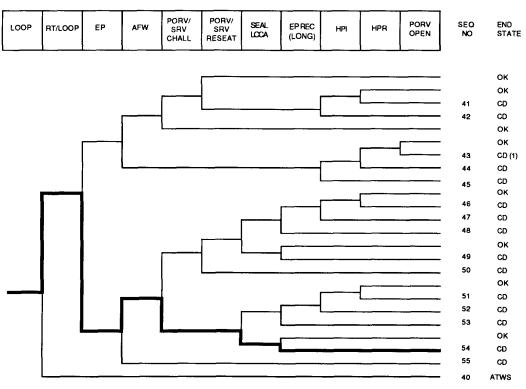
The conditional probability of severe core damage estimated for this event is 2.5×10^{-4} . The dominant sequence to core damage involves station blackout: failure to recover from the LOOP in the short term (p = 0.3), emergency power failure (p = 2.3×10^{-3}), and failure to recover AC power in the long term but prior to battery depletion (p = 0.35). The dominant sequence for this event is highlighted on the following event tree.

Dominant core damage sequence for LER 301/89-002
