PRECURSOR DESCRIPTION AND DATA

NSIC Accession Number: 158228

Title: Loss of Offsite Power at Prairie Island 2

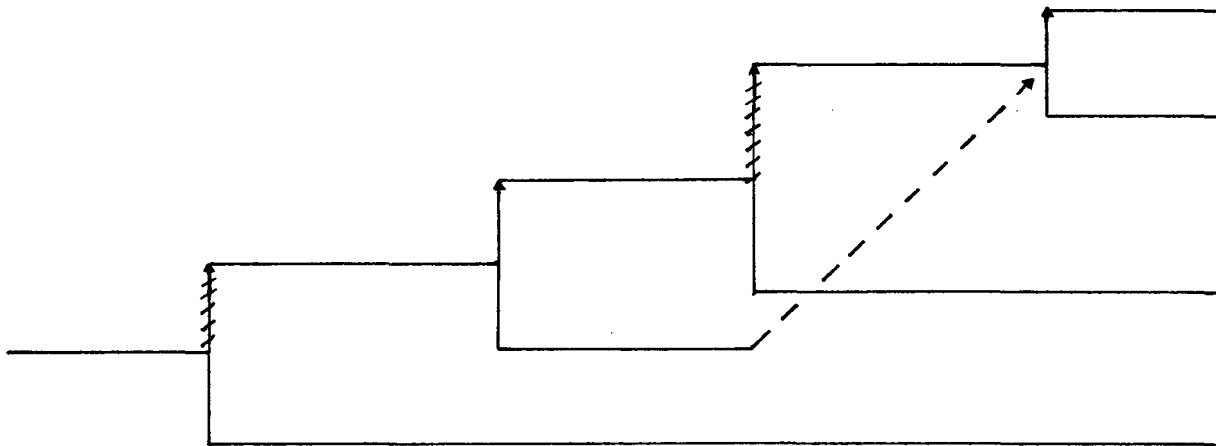
NSIC 158228 - Actual Occurrence for Loss of Offsite Power at Prairie Island 2

1. With Unit 2 at 100% power a severe electrical storm caused operation of several breakers in the substation.
2. The unit generator separated from the grid and the reactor and reactor coolant pumps tripped.
3. About 8 minutes later, the 345/161/13.8 kV No. 10 transformer locked out.
4. The diesel generators started and provided power to safety-related loads.

Reactor at 100% power	Severe electrical storm causes operation of several switch-yard breakers	Unit generator separates from grid, reactor and reactor coolant pump trip	#10 transformer lockout results in effective loop and loss of power to safety-related loads	Diesel generators start and provide power to safety-related loads
-----------------------	--	---	---	---

Offsite power sources were restored.

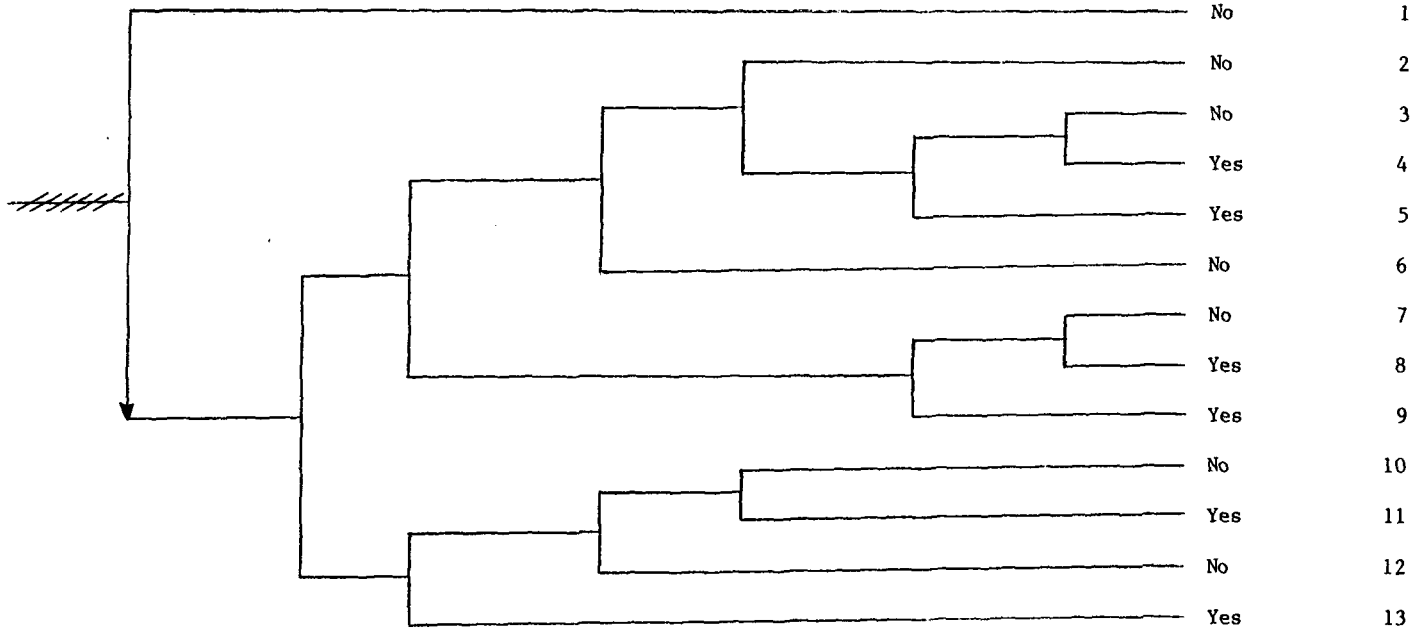
NSIC 158228 - Sequence of Interest for Loss of Offsite Power at Prairie Island 2

Loss of Offsite Power	Turbine Generator Runs Back and Assumes House Loads	Emergency Power	Auxiliary Feedwater and Secondary Heat Removal	PORV Demanded	PORV or PORV Isolation Valve Closure	High Pressure Injection	Long Term Core Cooling	Potential Severe Core Damage	Sequence No.
-----------------------	---	-----------------	--	---------------	--------------------------------------	-------------------------	------------------------	------------------------------	--------------
