PRECURSOR DESCRIPTION AND DATA

NSIC Accession Number: 161906

Title: RCIC and HPCI Inoperable at Quad-Cities 2

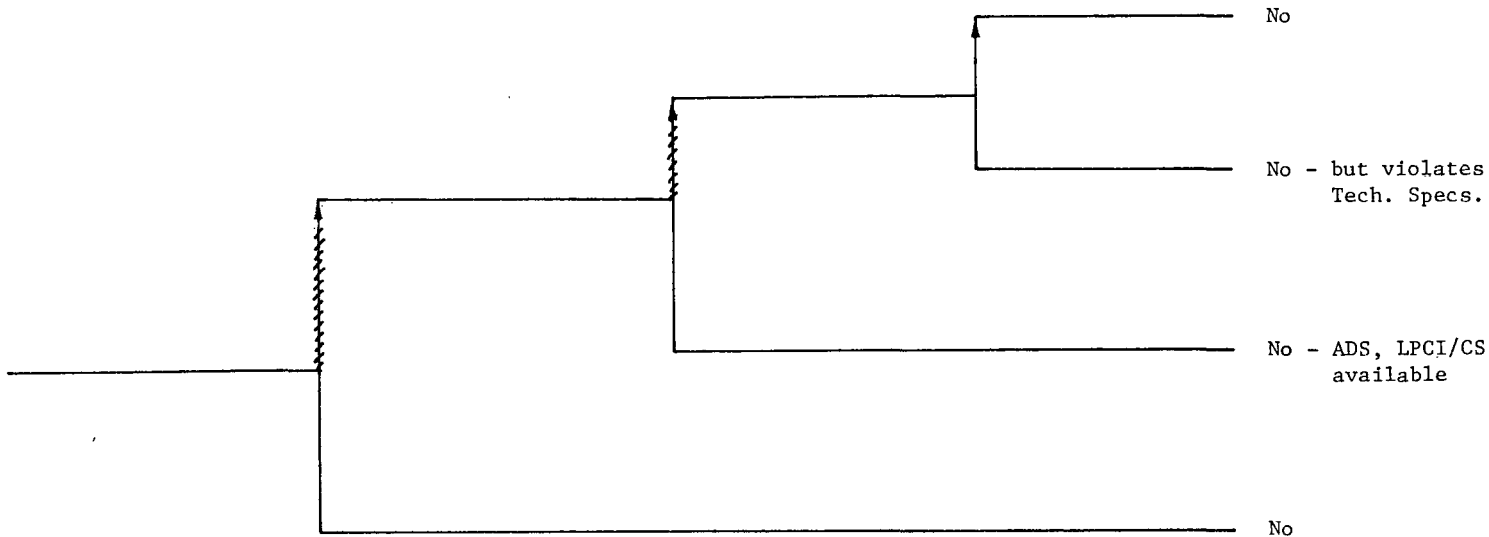
NSIC 161906 - Actual Occurrence of RCIC and HPCI Inoperable at Quad Cities 2

1. During performance test of the monthly operability at 99% power, the RCIC discharge isolation valve would not open from the control room. This caused RCIC to be inoperable. A torque switch on the valve was faulty.
2. HPCI was subsequently declared inoperable due to an oil leak in the HPCI turbine stop valve actuator cover.
3. An orderly shut down was commenced.

RCIC performance tests were under way while at full reactor power	The RCIC discharge isolation valve fails to open, leaving RCIC inoperable	HPCI fails to run during required surveillance testing	An orderly shutdown was commenced
---	---	--	-----------------------------------

Potential Severe Core Damage

1. The RCIC torque switch was replaced before shutdown was reached and the shutdown was terminated.
2. The HPCI valve actuator cover was replaced with a cover from Unit 1.
3. About 10 h was required to correct the simultaneous loss of RCIC and HPCI.

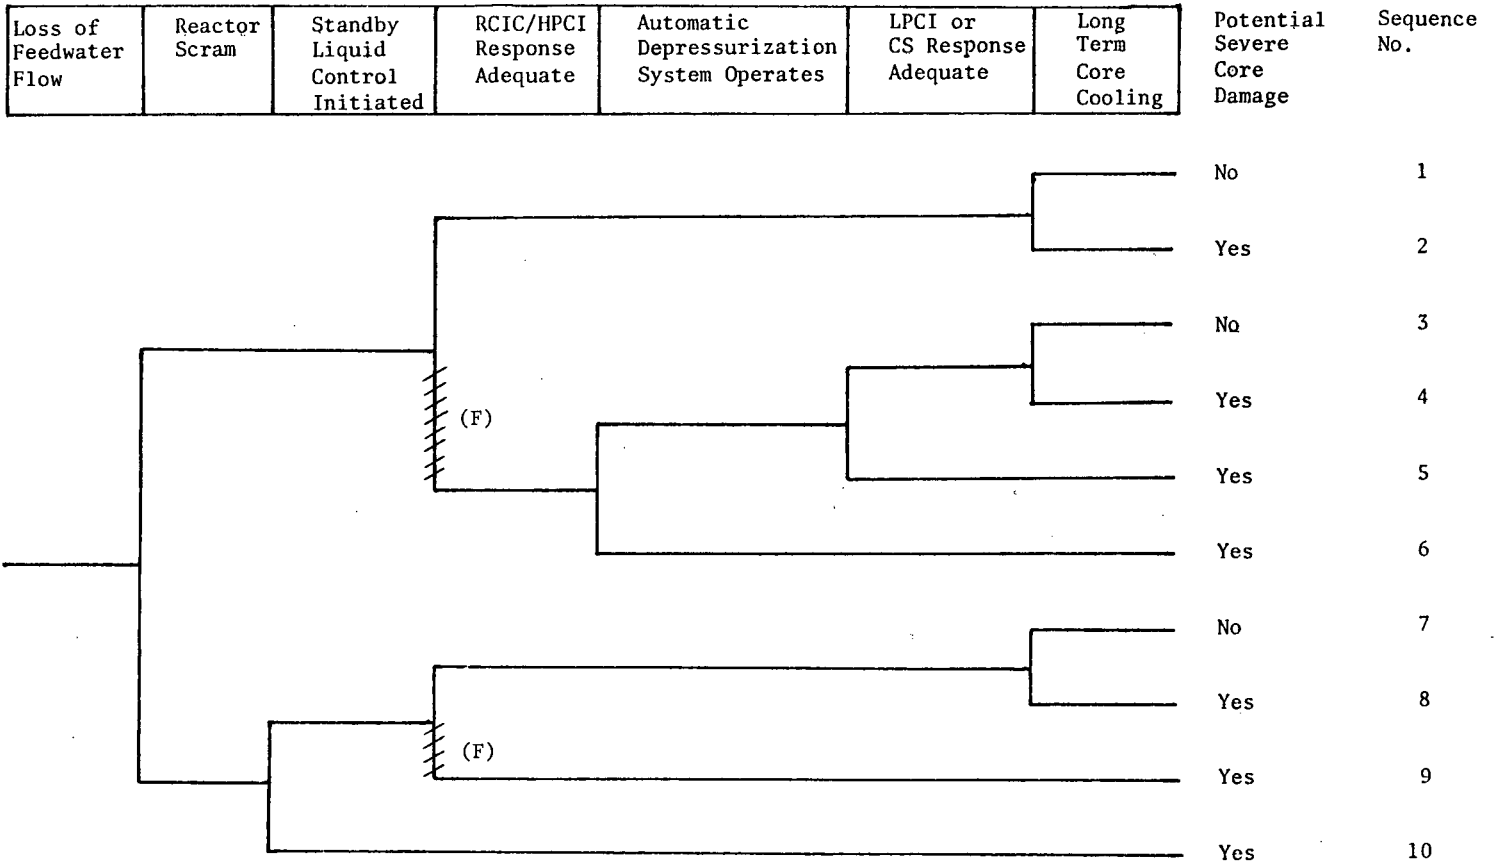
NSIC 161906 - Sequence of Interest for RCIC and HPCI Inoperable at Quad Cities 2

SEQUENCE OF INTEREST: Loss of feedwater
