## PRECURSOR DESCRIPTION AND DATA

NSIC Accession Number: 167117

Title: Switchyard Voltage Drops Below Low Limit at Rancho Seco

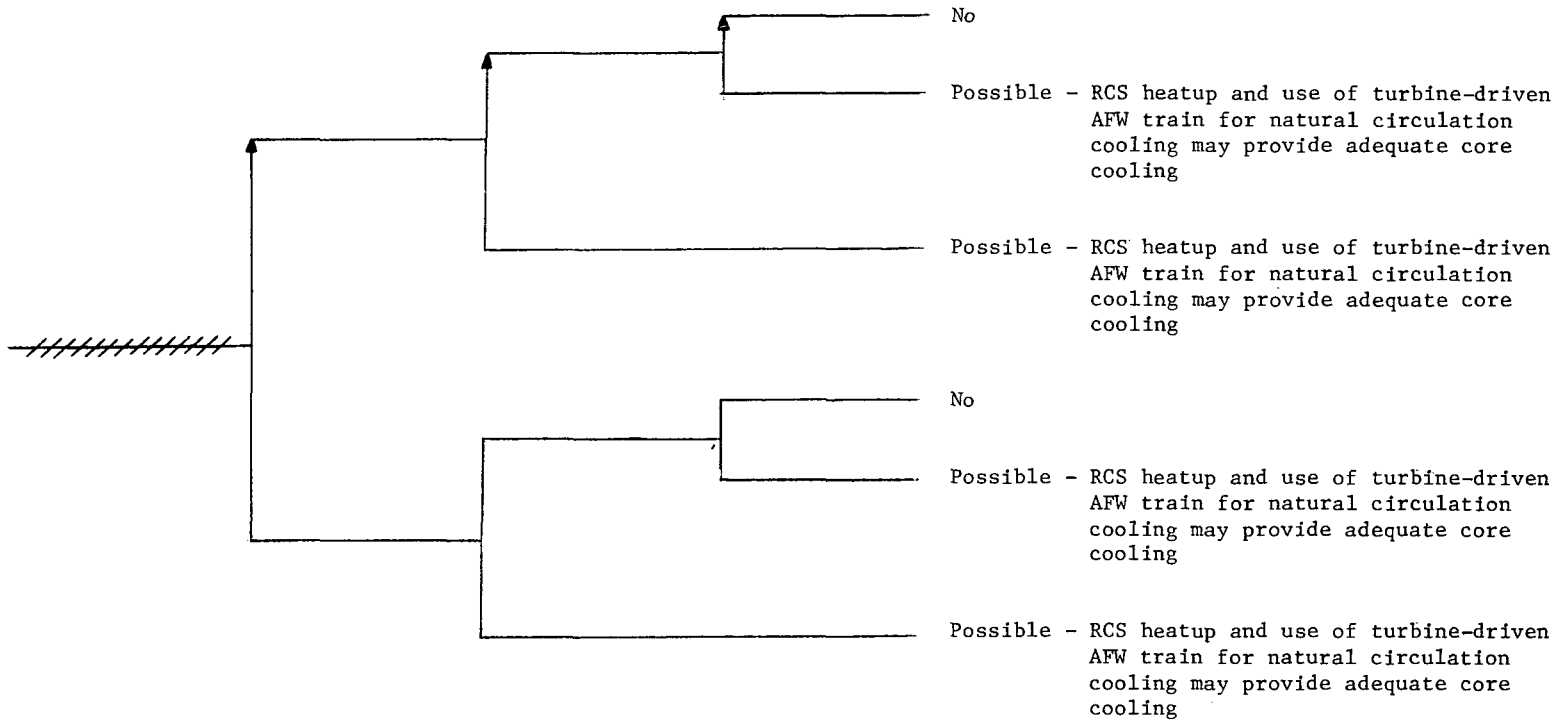
Reactor shutdown and excessive grid demand results in low switchyard voltage	Reactor coolant pumps tripped	Diesel generators supply safety-related loads	Reactor heat removal via decay heat removal system	Potential Severe Core Damage
--	-------------------------------	---	--	------------------------------

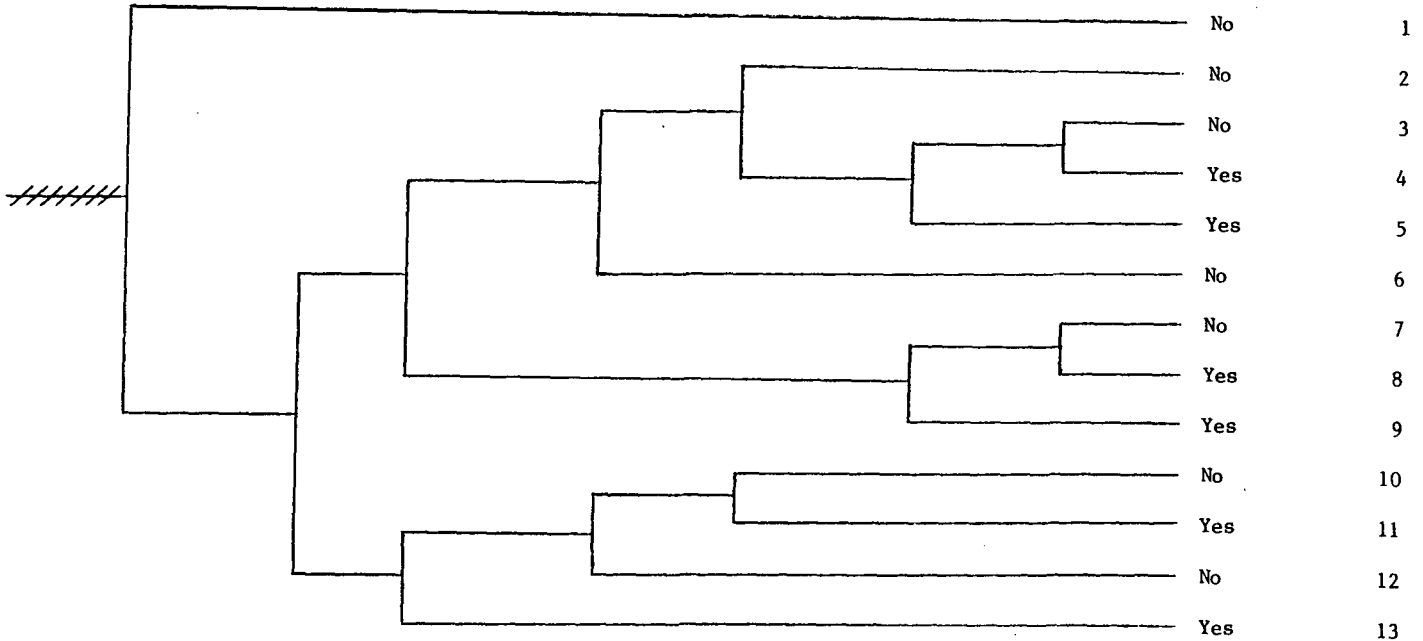
NSIC 167117 - Sequence of Interest for Effective LOOP at Rancho Seco

Loss of Offsite Power	Turbine Generator Runs Back and Assumes House Loads	Emergency Power	Auxiliary Feedwater and Secondary Heat Removal	PORV Demanded	PORV or PORV Isolation Valve Closure	High Pressure Injection	Long Term Core Cooling	Potential Severe Core Damage	Sequence No.
-----------------------	---	-----------------	--	---------------	--------------------------------------	-------------------------	------------------------	------------------------------	--------------
