PRECURSOR DESCRIPTION AND DATA

NSIC Accession Number: 168548

Title: Switchyard Voltage Drops Below Low Limit at Rancho Seco

LER NO.: 81-039

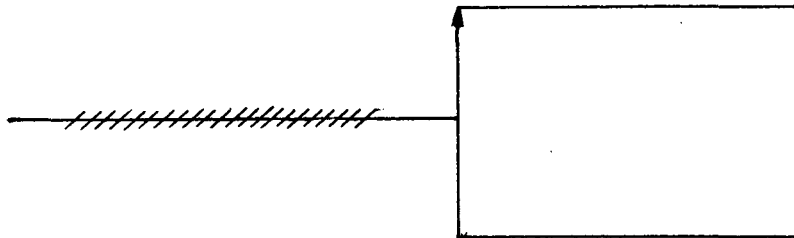
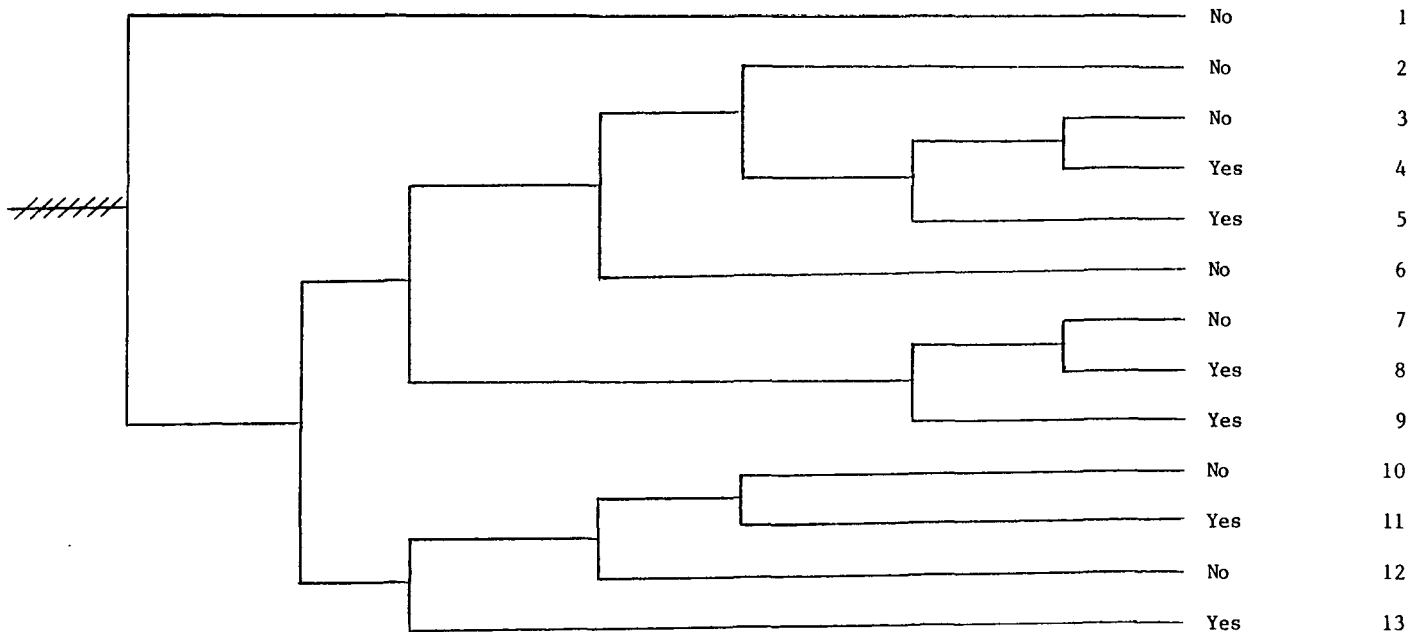
NSIC 168548 - Sequence of Interest for Effective LOOP at Rancho Seco

1. With the reactor in hot shutdown, excessive electrical demand resulted in a reduction in switchyard voltage to 206 kV. This is below the minimum voltage (214 kV) assumed for analysis.
2. The diesel generators were started and provided power to the safety-related buses.

Reactor in hot shutdown and excessive load demand results in reduction of switchyard voltage to below 214-kV minimum voltage	Diesel generators supply safety-related loads
---------------------------------------------------------------------------------------------------------------------------------------------	-----------------------------------------------------

Possible - (Use of turbine-driven AFW
 train for natural circulation
 cooling may provide adequate
 core cooling)

Direct switchyard voltage indications and alarms were to be installed to facilitate control room monitoring of switchyard voltages.
