PRECURSOR DESCRIPTION AND DATA

NSIC Accession Number: 164149

Title: Isolable Small Break LOCA at Robinson 2

LER NO.: 81-005

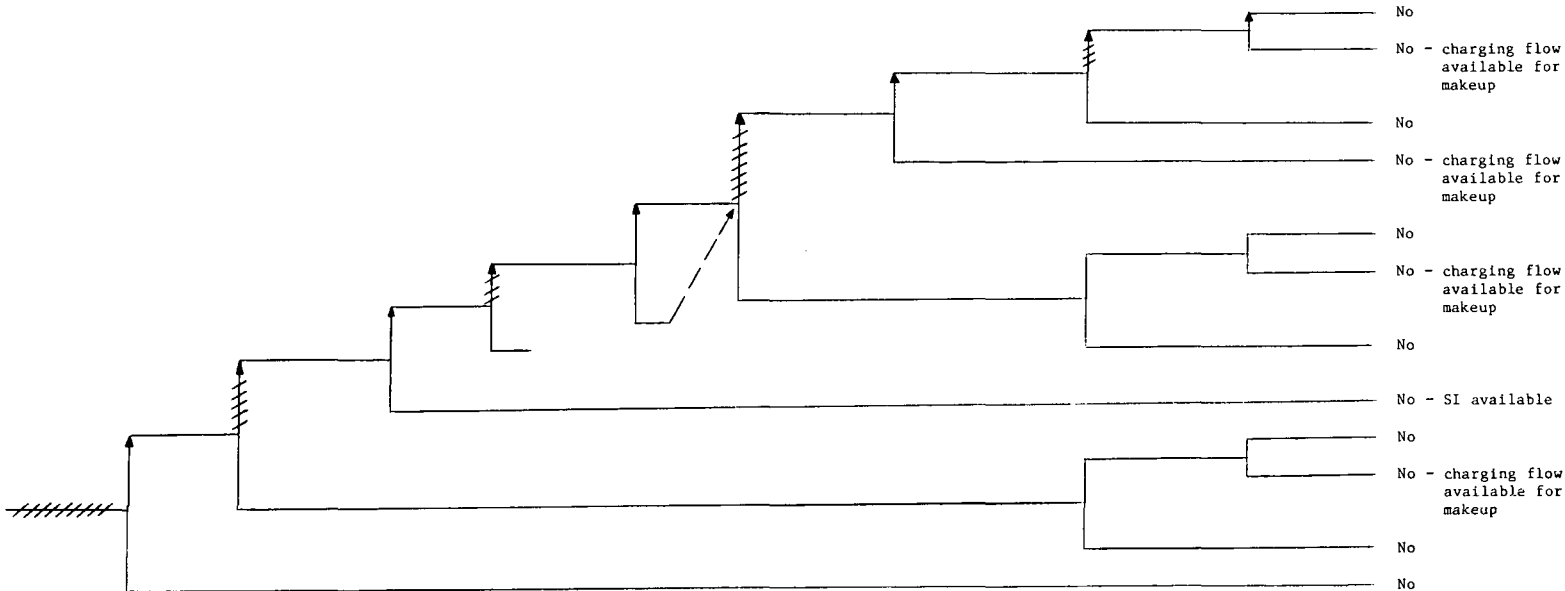
NSIC 164149 - Actual Occurrence for Isolable Small Break LOCA at Robinson 2

Reactor at 100% power and secondary side problems result in train B SI signal and reactor trip	Train A safety injection initiated and MSIVs closed	CVCS pressure surges and slow valve closures result in CVCS relief valve bellows failure and drain valve pipe cap failure	SI reset and letdown restored	RCS pressure decrease due to unisolated CVCS leakage paths (~3000 gal in 15 min)	Letdown isolated	Pressurizer pressure continues to decrease due to leakage flow through closed CVCS valves, second safety injection	Second containment entry made and failed relief valve and open drain line identified; drain line closed; additional letdown isolation valve closed	Continued reduction in RCS pressure due in part to leaking pressurizer spray valve	Leaking pressurizer spray valve identified by stopping RC pumps B and C
--	---	---	-------------------------------	--	------------------	--	--	--	---

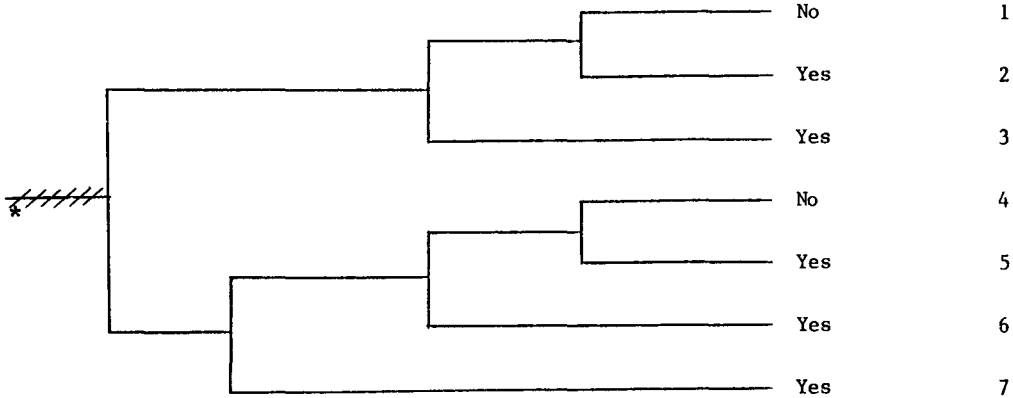
NSIC 164149 - Sequence of Interest for Isolable Small Break LOCA at Robinson 2

*auto isolation on safety injection closure of upstream valves
