### B.21 LER No. 311/83-001 and 311/82-072

Event Description: Transient with One Automatic Trip Breaker Failing to Open

Date of Event: January 6, 1983

Plant: Salem 2

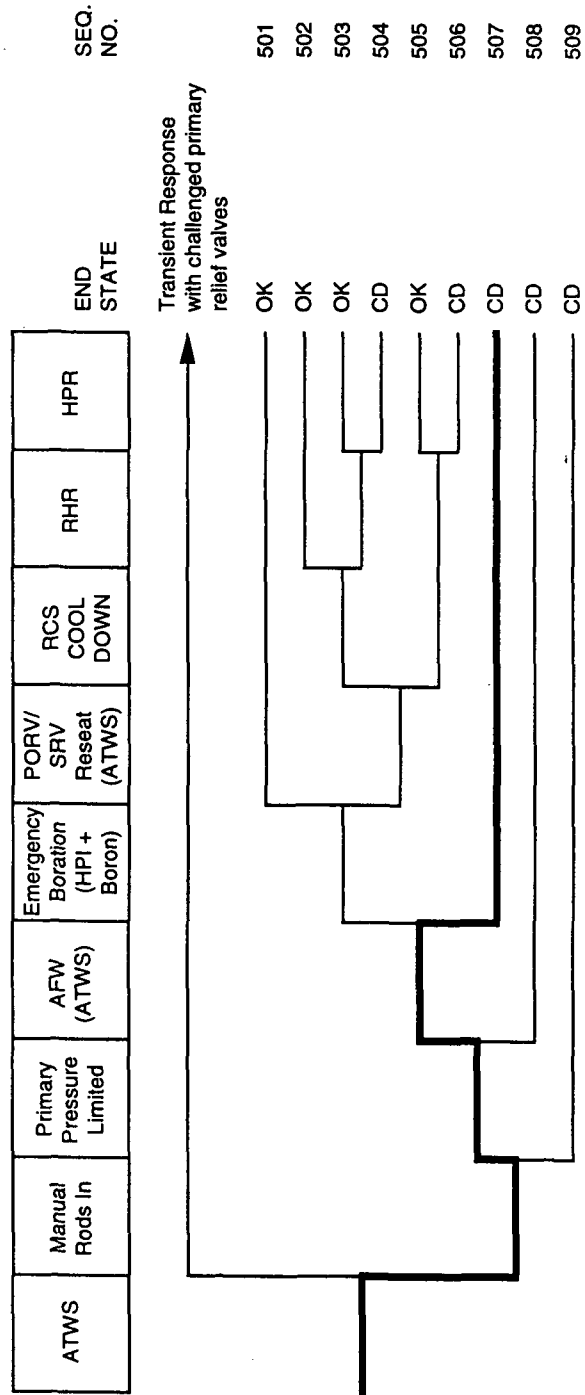
The conditional core damage probability for this event is  $4.4 \times 10^{-4}$ . The dominant sequence is a postulated ATWS sequence involving a failure to trip, success of auxiliary feedwater (AFW) given ATWS, and failure of emergency boration, and is highlighted on the event tree shown in Figure B.21.1.

Figure B.21.1 Dominant core damage sequence for LER 311/83-001 and 311/82-072
