PRECURSOR DESCRIPTION AND DATA

NSIC Accession Number: 155475

Title: Total Loss of Saltwater Cooling System at San Onofre 1

LER NO.: 80-006

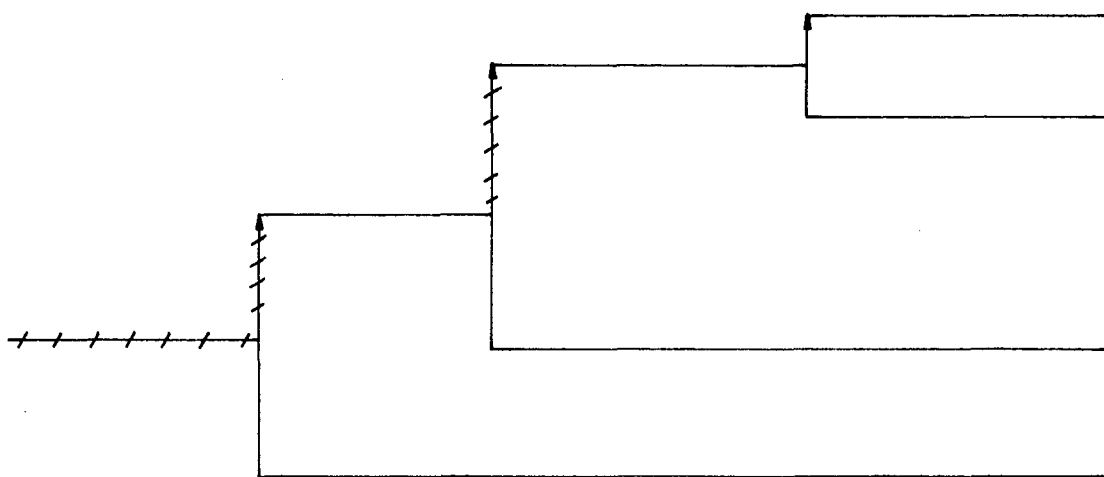
Reactor at full power and loss of SWC pump G-13B due to shaft failure	SWC pump G-13A starts but discharge valve fails to open	Auxiliary SWC pump G-13C manually started but fails to provide flow due to inadequate prime	Screen wash pumps manually started (locally) and re-aligned to provide flow to component cooling water heat exchangers
---	---	---	--

Potential
Severe
Core
Damage

No

No - but reactor shutdown and natural circulation cooling required without component cooling water; turbine cycle cooling still available

No - turbine-driven AFW pump apparently self cooled

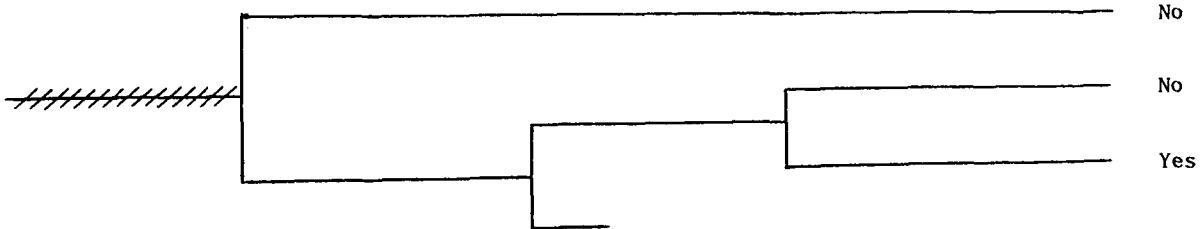
NSIC 155475 - Sequence of Interest for Loss of Saltwater Cooling System at San Onofre 1

Reactor at Power and Loss of Salt-water Cooling System	Screen Wash Pumps Provide Adequate CCW Cooling	Manual Reactor Shutdown, RCPS Tripped	Auxiliary Feedwater and Secondary Heat Removal	Potential Severe Core Damage	Sequence No.
--	--	---------------------------------------	--	------------------------------	--------------
