PRECURSOR DESCRIPTION AND DATA

NSIC Accession Number: 164453

Title: Brief Loss of Offsite Power and Degraded Load Shed Capability at San Onofre 1

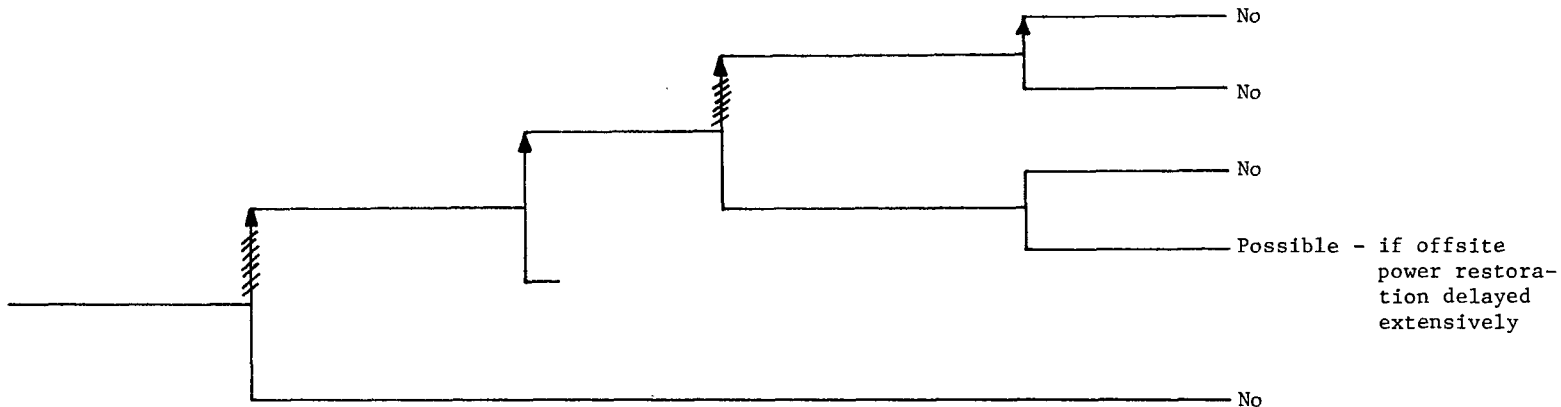
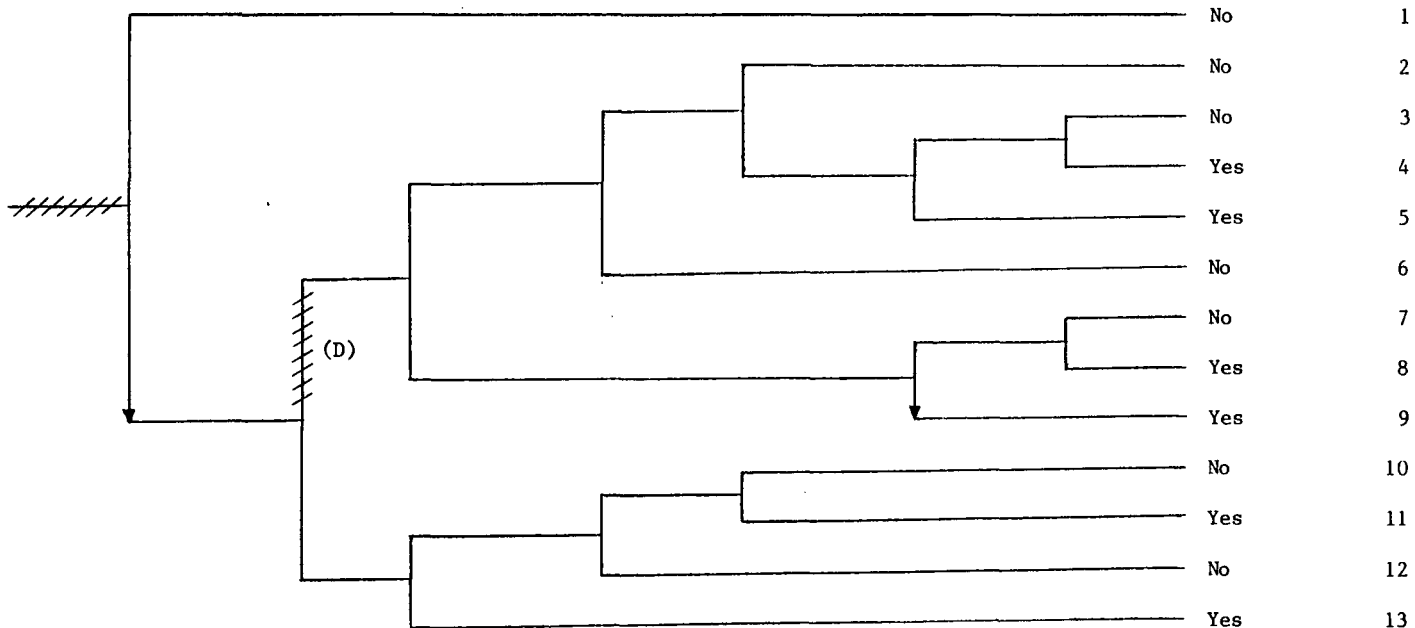
NSIC 164453 - Sequence of Interest for Brief Loss of Offsite Power and Degraded Load Shed at San Onofre 1

Reactor in shutdown and operator intends to transfer 1-C and 2-C buses from auxiliary transformer C to auxiliary transformers A and B	Operator error results in opening of bus tie breaker in lieu of transformer C bus supply breakers	Loss of power to buses 1-C and 2-C	Diesel generators start and are available for loading. Bus 1C source breaker fails to open due to unavailable undervoltage scheme	Offsite power restored
---	---	------------------------------------	---	------------------------

Loss of Offsite Power	Turbine Generator Runs Back and Assumes House Loads	Emergency Power	Auxiliary Feedwater and Secondary Heat Removal	PORV Demanded	PORV or PORV Isolation Valve Closure	High Pressure Injection	Long Term Core Cooling	Potential Severe Core Damage	Sequence No.
-----------------------	---	-----------------	--	---------------	--------------------------------------	-------------------------	------------------------	------------------------------	--------------
