PRECURSOR DESCRIPTION AND DATA

NSIC Accession Number: 168829

Title: Both Safety Injection Trains Inoperable Due to Valve Problems at San Onofre 1

LER NO.: 81-020

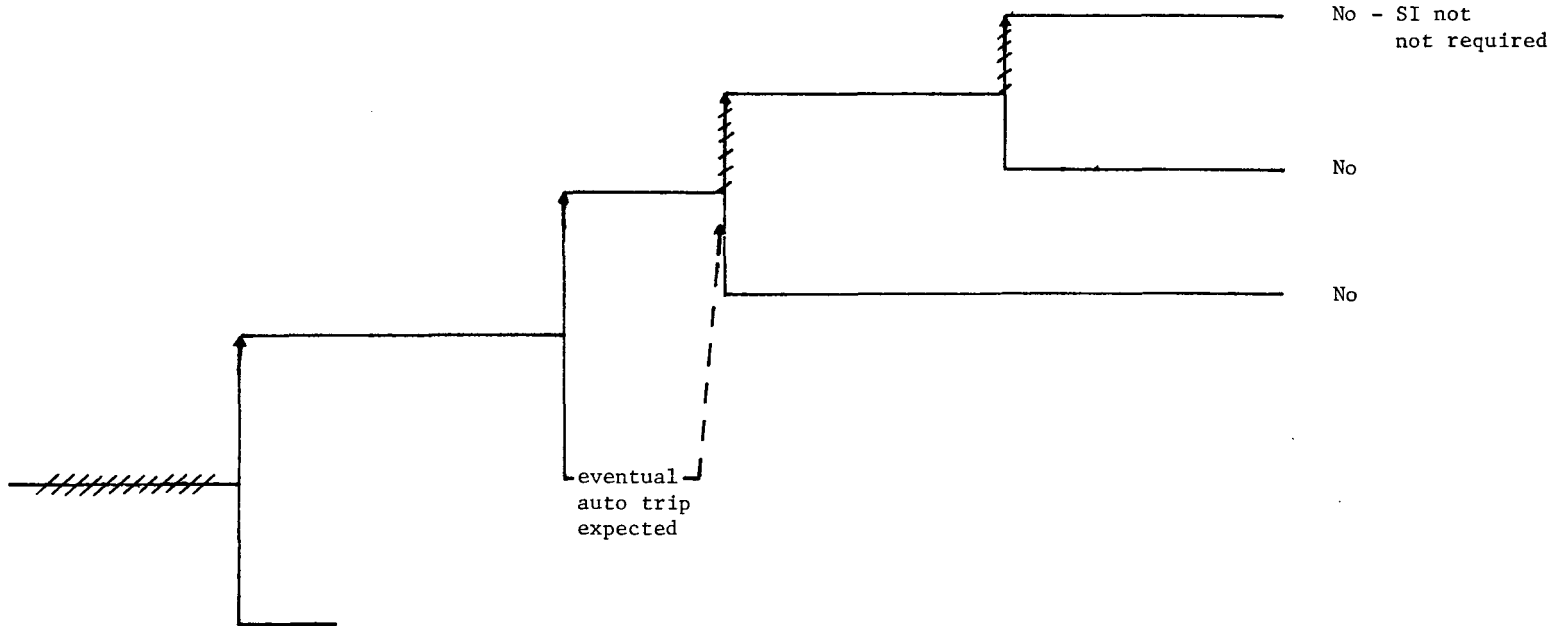
Large LOCA	Safety injection	Low pressure recirculation	Potential Severe Core Damage	Sequence No.
			No	
			Yes	
			Yes

NSIC 168829 - Sequence of Interest for Both Safety Injection Trains Inoperable Due to Valve Problems at San Onofre 1
