Accident Sequence Precursor Program Event Analysis

LER No: 328/88-027 R1
 Event Description: Reactor trip following loss of main feedwater with turbine-driven AFW pump unavailable
 Date of Event: June 6, 1988
 Plant: Sequoyah Unit 2

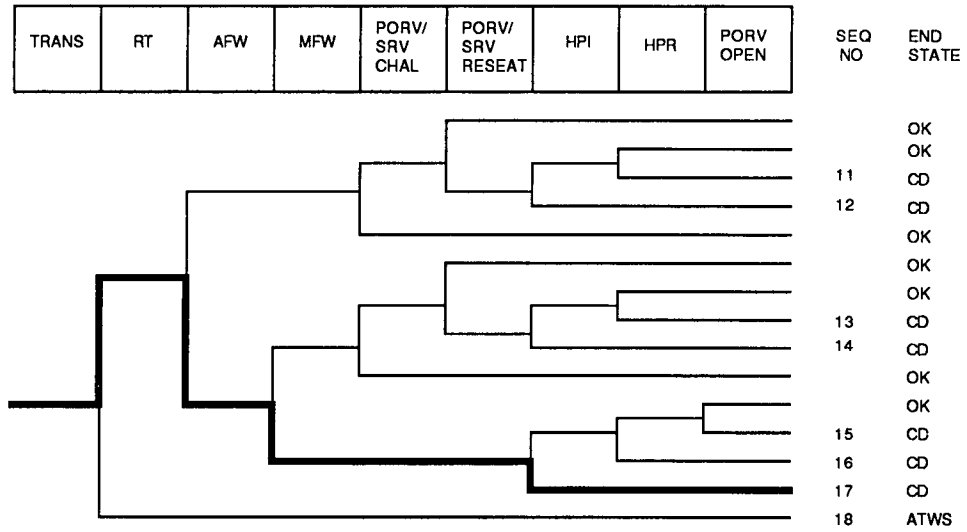
Dominant Core Damage Sequence for LER 328/88-027 R1

Dominant sequences leading to core damage for this event involve the initiating transient and successful scram, failure of AFW ($p = 6.0 \times 10^{-4}$), failure to recover main feedwater ($p = 0.34$), and failure of feed and bleed ($p = 0.02$, including failure to initiate). The dominant sequence associated with the event is highlighted on the following event tree.
