## PRECURSOR DESCRIPTION AND DATA

NSIC Accession Number: 158233

Title: Loss of Reactor Coolant Pumps and Top Head Bubble Incident at St. Lucie 1

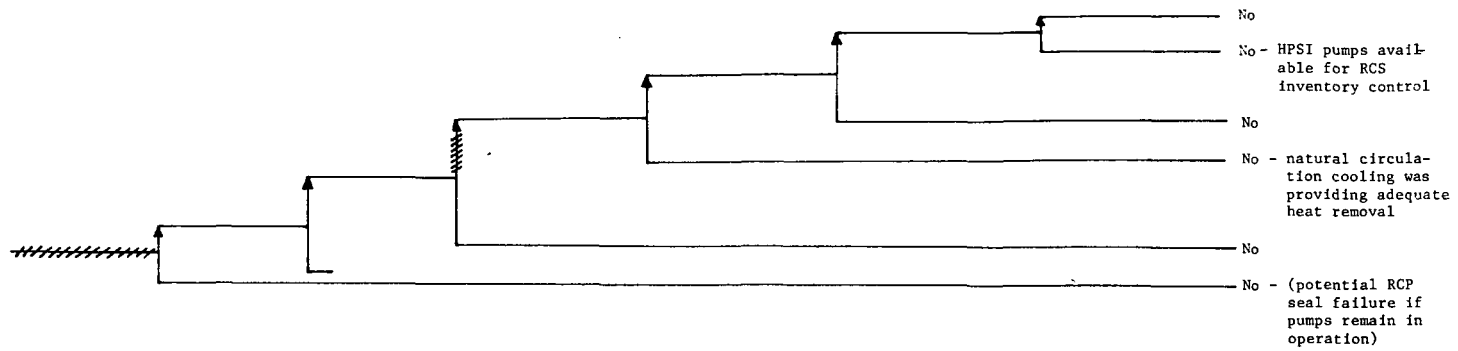
NSIC 158233 - Actual Occurrence for Loss of Reactor Coolant Pumps and Top Head Bubble Incident at St. Lucie 1

Reactor at power and RCP CCW return valve fails shut due to shorted solenoid	Manual Reactor/RCP trip	Natural circulation cooldown initiated	Due to slower top head cooling than RCS, steam bubble forms in top head when auxiliary spray was used to reduce pressurizer level (Anomalous pressurizer response noted)	RCS cooldown depressurization to SCS entry point effected and SCS initiated	Leakage from shutdown cooling loops to RWST occurs due to partially open recirculation valve	Second LPSI pump used to re-establish RCS inventory
--	-------------------------	--	--	---	--	---

Potential Severe Core Damage

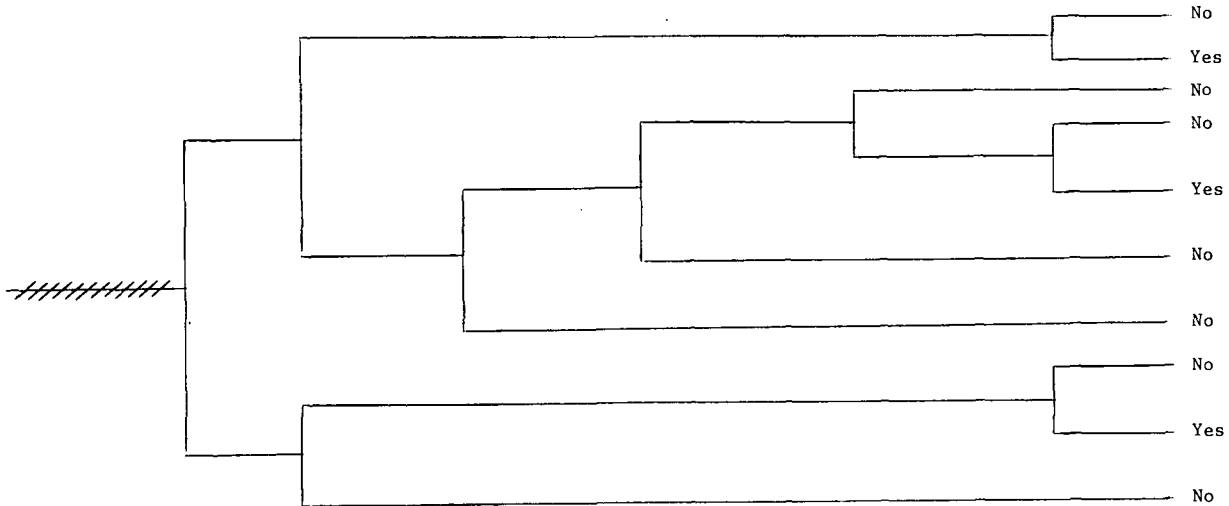
NSIC 158233 - Sequence of Interest for Loss of Reactor Coolant Pumps and Top Head Bubble Incident at St. Lucie 1

Reactor at power and RCP CCW return valve fails shut due to shorted solenoid	Manual reactor/RCP trip	RCP seal failure due to loss of CCW	Due to slower top head cool-down than RCS, steam bubble forms in top head	Steam bubble prevents natural circulation	Lack of natural circulation detected by operator and RCP started for core cooling	High pressure injection	Potential Severe Core Damage	Sequence No.
--	-------------------------	-------------------------------------	---	---	---	-------------------------	------------------------------	--------------
