## PRECURSOR DESCRIPTION AND DATA

NSIC Accession Number: 172198

Title: Inadvertent MSIV Closure and Inadvertent Safety Valve Lifts at St. Lucie 1

NSIC 172198 - Actual Occurrence Tree for Inadvertent MSIV Closure and Inadvertent Safety Valve Lifts at St. Lucie 1

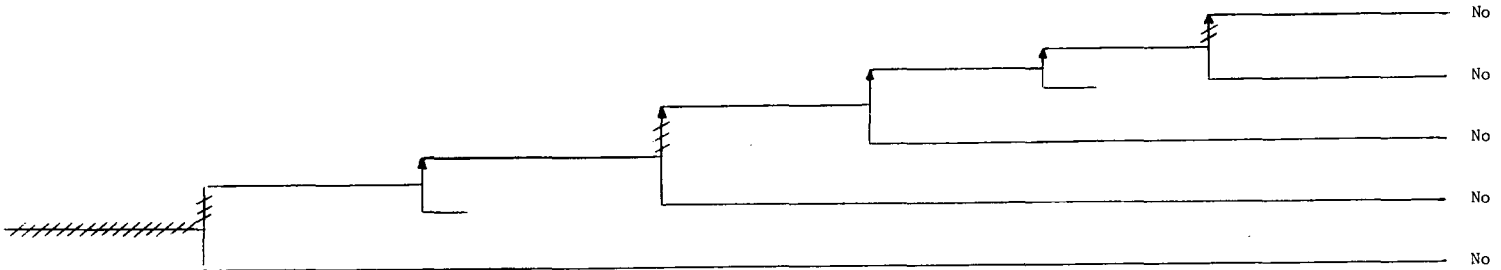
<p>Reactor at power and MSIV (both valves) closure due to low instrument air pressure and slightly high steam flow</p>	<p>Reactor trip on high pressurizer pressure. Quench tank rupture Disk ruptured because of relief valve discharge. Pressurizer code safety VI200 apparently lifts (lift is undetected), disk/seat damage results from improper set screw installation</p>	<p>Reactor restarted and held below power range for rupture disk repairs and MSIV troubleshooting</p>	<p>Pressurizer code safety VI200 lifts spriously; high blowdown due to maladjusted nozzle ring</p>	<p>RCS pressure decrease, trip on thermal margin/Low pressure</p>	<p>Cooldown to replace VI200</p>	<p>Turbine/reactor trip during next startup; reactor restarted, power operation commencing when steam generator B saftey valve started lifting due to closed MSIV B (valve was indicating open)</p>	<p>Potential Severe Core Damage</p>
--	---	---	--	---	----------------------------------	---	-------------------------------------
