NSIC Accession Number: 102146

Date: April 9, 1975

Title: Loss of Offsite Power at Brunswick 2

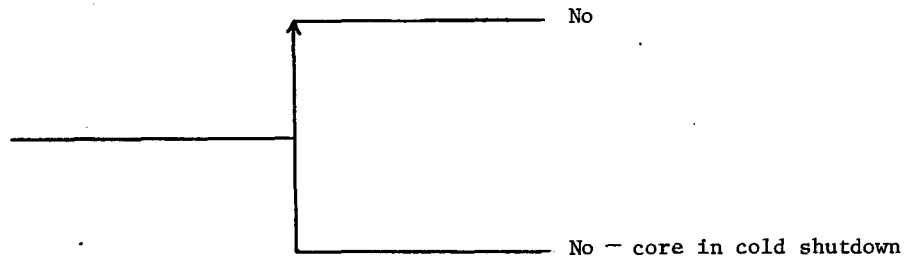
NSIC 102146 - Actual Occurrence of Loss of Offsite Power at Brunswick 2

1. The plants 1A and 2A 230kv buses had been incorrectly tied together.
2. With the reactor in cold shutdown, a single phase to ground fault caused the lockout relays for busses 1A and 2A to trip.
3. The diesels started and loaded as expected.
4. The relays were reset and offsite power restored (~4 min).

Reactor in cold shutdown, when phase to ground fault trips breakers	Diesels start and load as expected	Potential Severe Core Damage
---	------------------------------------	------------------------------

CAUSE: improper tying together of the 1A and 2A 230kv buses, human error

This problem was corrected.

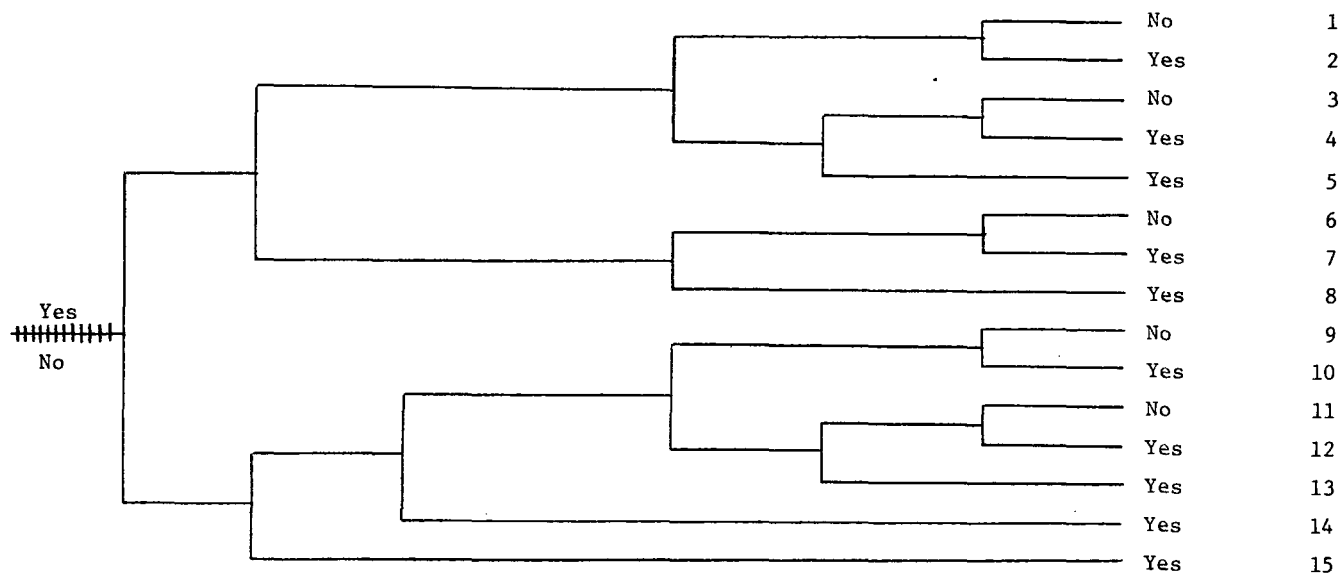
NSIC 102146 - Sequence of Interest for Loss of Offsite Power at Brunswick 2

Loss of Offsite Power	Reactor Scram	Diesel Start and Load	Reactor Made Subcritical by the SBLCS Or Rods Are Manually Driven In	RCIC/HPCI Initiates	ADS/LPCI CS Initiates	Long Term Core Cooling	Potential Severe Core Damage	Sequence No.
-----------------------	---------------	-----------------------	--	---------------------	-----------------------	------------------------	------------------------------	--------------
