PRECURSOR DESCRIPTION AND DATA

NSIC Accession Number: 150271

Title: Both RHR Service Water Pumps Inoperable at Brunswick 2

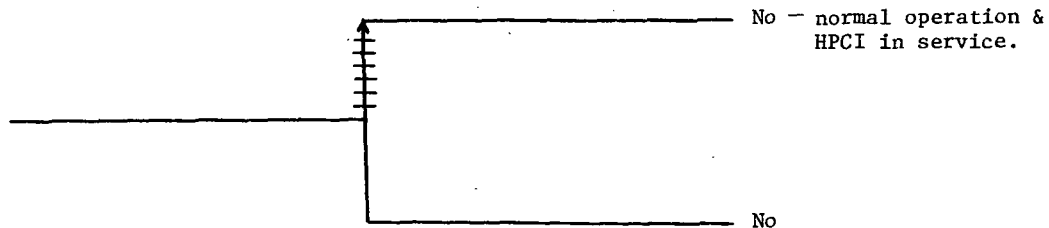
NSIC 150271 - Actual Occurrence of Both RHR Service Water Pumps Inoperable at Brunswick 2

With the reactor at 88% power, the operator gives clearance to uncouple RHR pump 2B for alignment check	Mechanic uncouples pump 2A by mistake, leaving both pumps out of service for 7 days	Potential Severe Core Damage
---	---	---------------------------------------

Seven hours later the error was discovered and pump 2A was recoupled and tested to ensure operability.

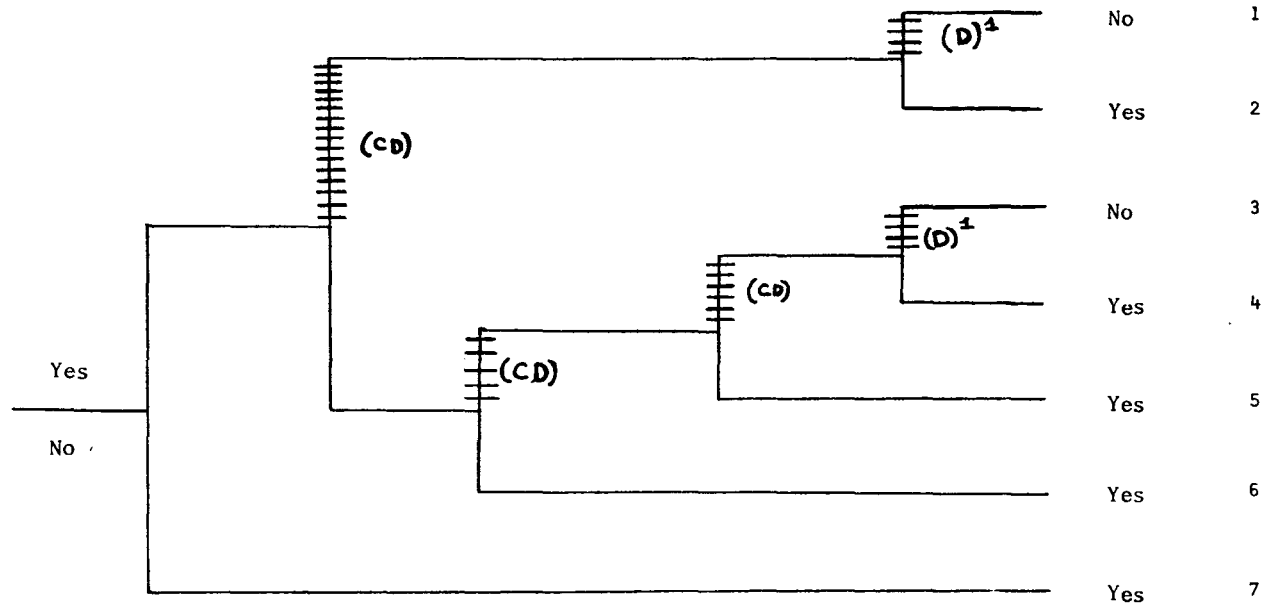
NSIC 150271 - Sequence of Interest of Both RHR Service Water Pumps Inoperable at Brunswick 2

Loss of Feedwater Flow	Reactor Subcritical	RCIC/HPCI Response Adequate	Automatic Depressurization System Operates	LPCI or CS Response Adequate	Long Term Core Cooling	Potential Severe Core Damage	Sequence No.
------------------------	---------------------	-----------------------------	--	------------------------------	------------------------	------------------------------	--------------

¹For success the operator must rack the pumps backin within 2-24 hours.
