PRECURSOR DESCRIPTION AND DATA

NSIC Accession Number: 128906

Title: No Break Power Panel De-energized at Cooper

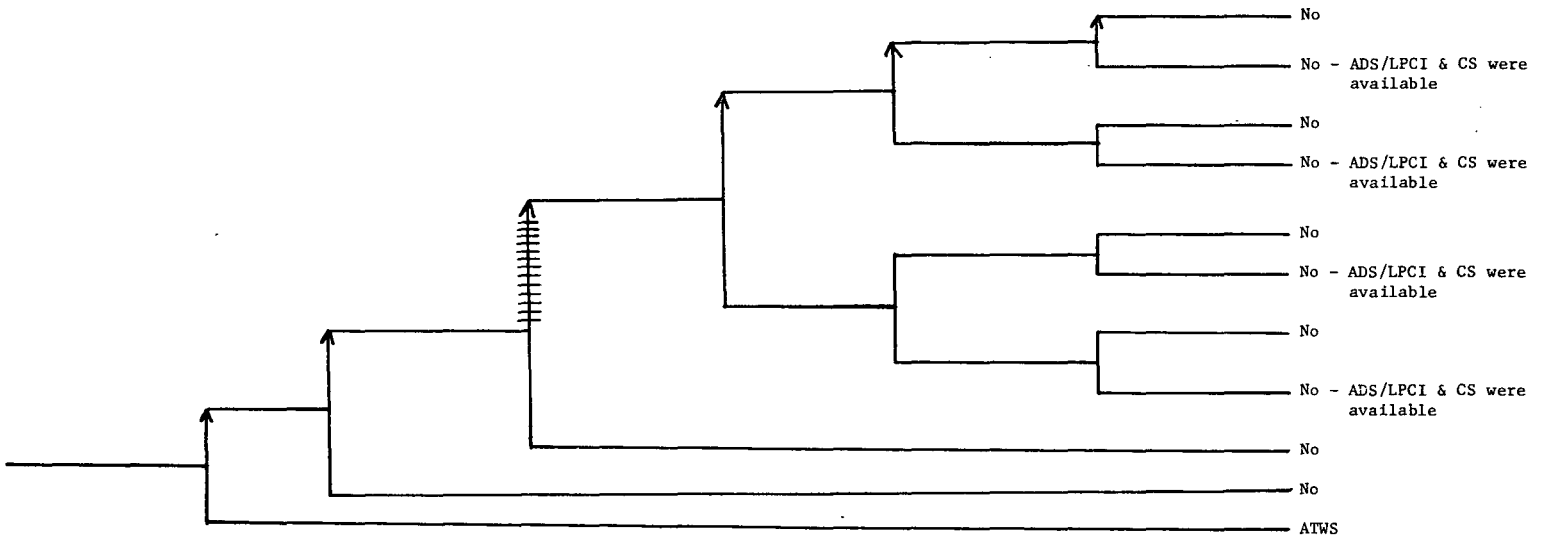
NSIC 128906 - Actual Occurrence for No Break Power Panel De-energized at Cooper

Blown fuse fails the no break power panel resulting in minimum feedwater flow	Reactor trips on low water level	Low-low water level reached, causes MSIV to close and sends initiation signal to HPCI/RCIC	RCIC/HPCI system response is insufficient to control water level	Pressure relief valve opens at 1080 psig	Water level reaches -110 inches, operator actuate relief valve to increase HPCI flow	Power restored to panel, HPCI/RCIC respond satisfactorily	Potential Severe Core Damage
---	----------------------------------	--	--	--	--	---	------------------------------

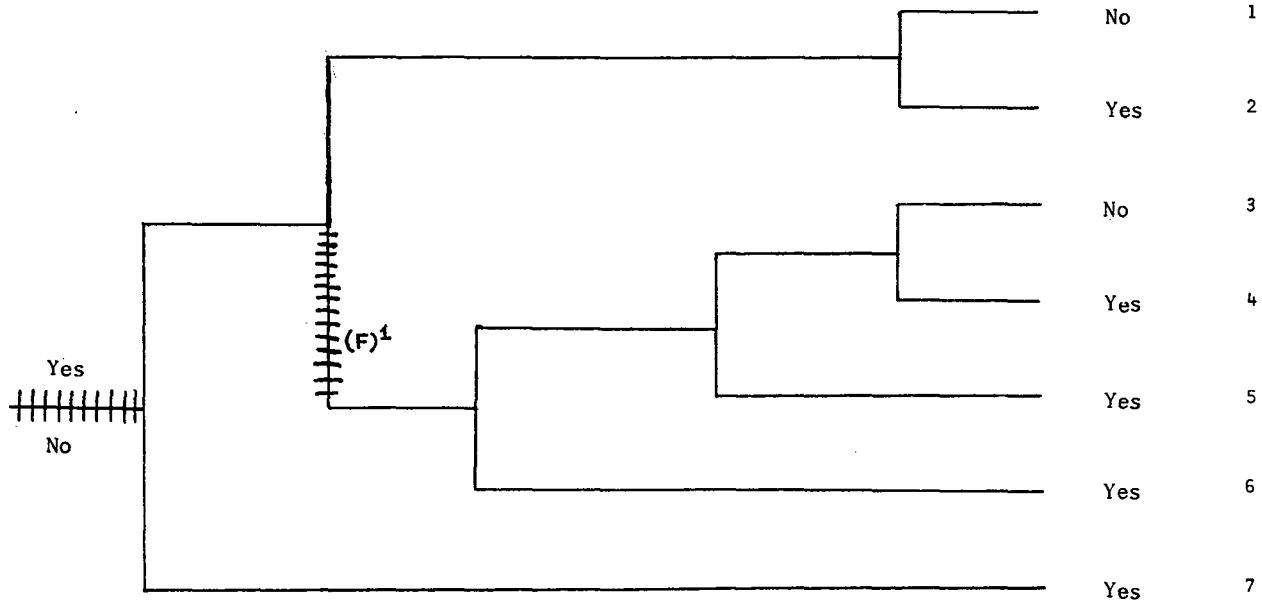
NSIC 128906— Sequence of Interest for No Break Power Panel De-energized at Cooper

Loss of Feedwater Flow	Reactor Subcritical	RCIC/HPCI Response Adequate	Automatic Depressurization System Operates	LPCI or CS Response Adequate	Long Term Core Cooling
------------------------	---------------------	-----------------------------	--	------------------------------	------------------------

¹Success requires restoration of power to the NBPP.
