PRECURSOR DESCRIPTION AND DATA

NSIC Accession Number: 130788

Title: Half-trip of SFRCS Causes RCS Pressure Rise at Davis-Besse 1

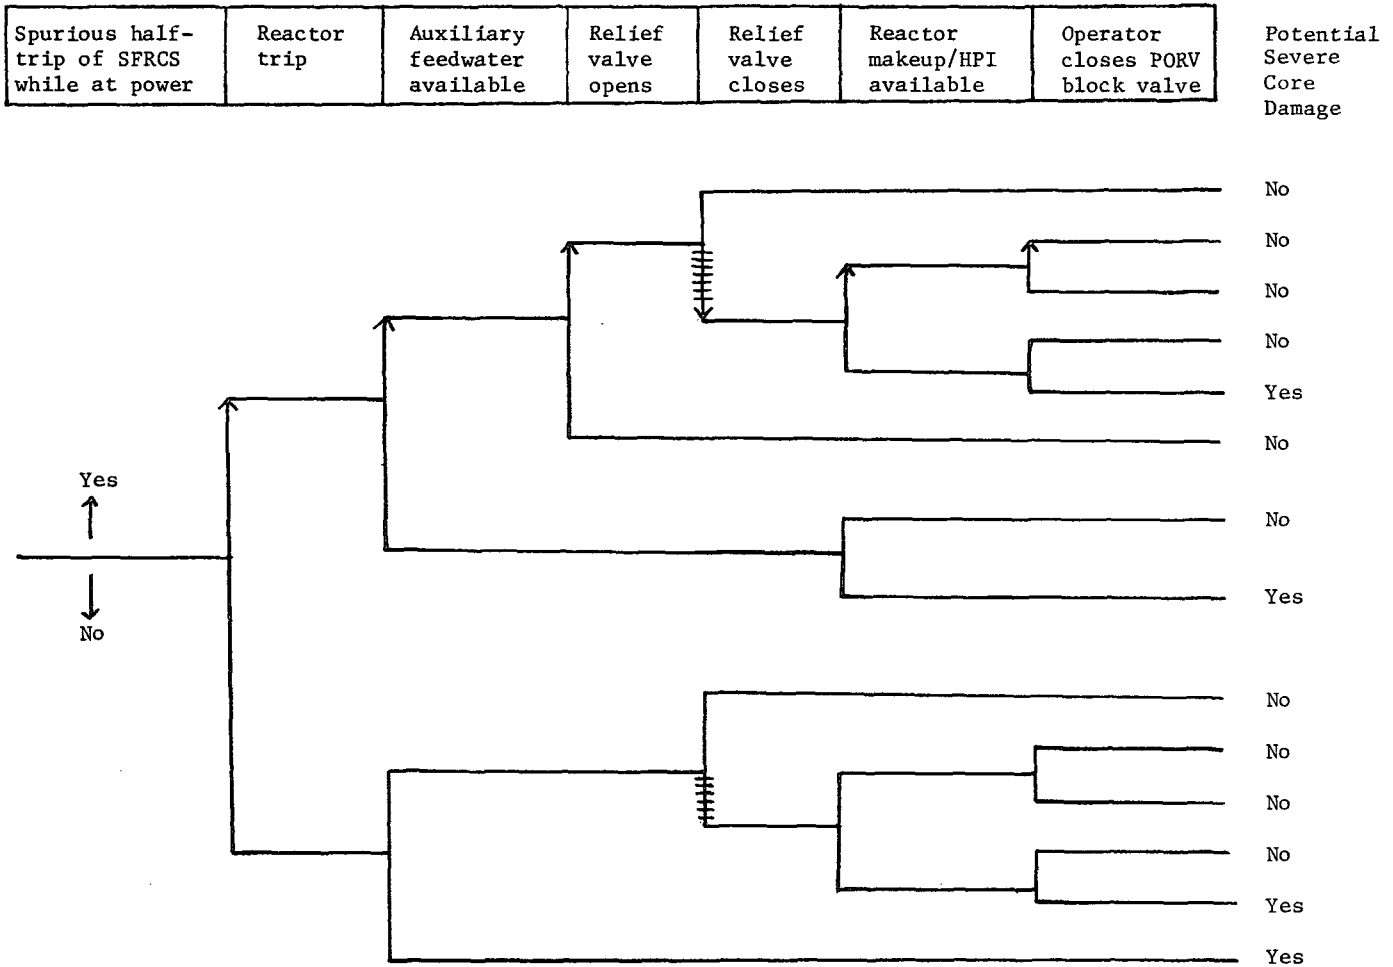
NSIC 130788 - Actual Occurrence for Spurious Half-Trip fo SFRCS Causes RCS Pressure Rise at Davis-Besse 1

CAUSE: Close relay missing from relief valve control circuit (PORV failure).

SEQUENCE OF INTEREST: Stuck open PORV — small LOCA.

COMMENT: No cause found for the 1/2 trip valve stuck open because pilot valve stem failed.

1. The SFRCS was monitored to detect spurious signals.
2. Plans were also being developed to add additional SFRCS alarm windows and seal in alarm conditions.
3. A missing PORV control circuit relay was installed.
