PRECURSOR DESCRIPTION AND DATA

NSIC Accession Number: 39380

Title: Safety Valve Operation After Feedwater Transient at Dresden 3

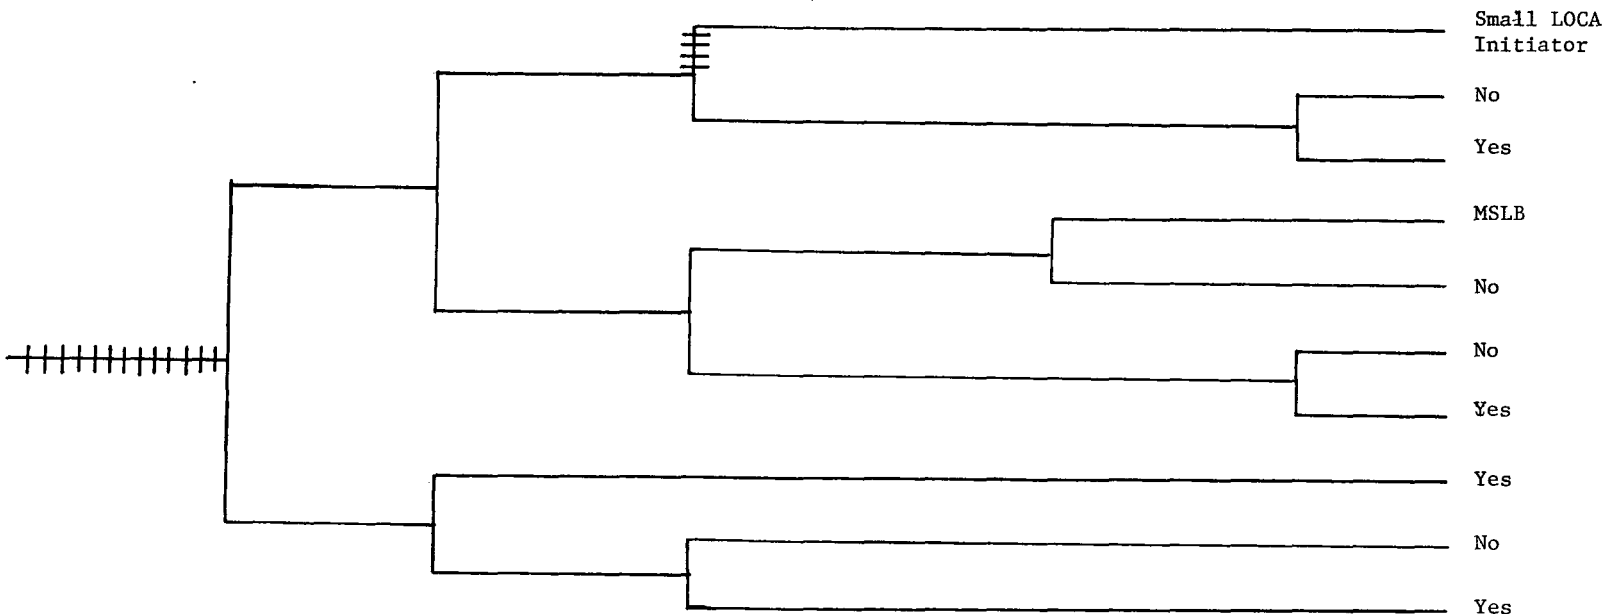
| Excessive Coolant Inventory | Reactor Scram | Reactor Vessel Or Turbine Isolate | Reactor Coolant Overflows Into Steam Lines, Is Discharged Through Relief Valves, Which Stick Open | Steam Line Break Due To Turbine Missiles, etc. | Long Term Core Cooling Success |

Potential Severe Core Damage
