PRECURSOR DESCRIPTION AND DATA

NSIC Accession Number: 88451

Title: Total Loss of Station Service Power and Failure of Service Water Pumps for One Diesel-Generator to Start at Connecticut Yankee

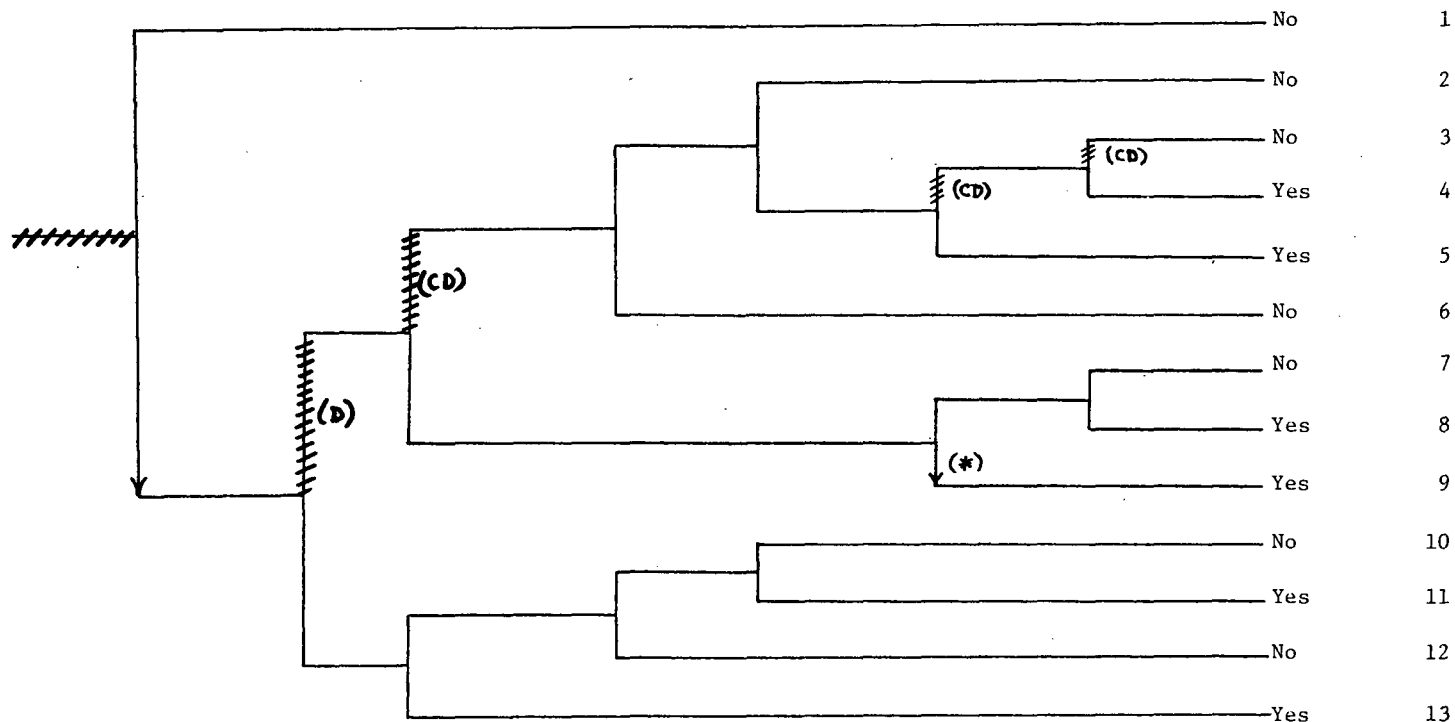
NSIC 88451 - Sequence of Interest for Total Loss of Station Service Power and Failure of Service Water Pump for One Diesel-Generator at Connecticut Yankee

*Use of HPI following loss of AFW was not included in mitigation procedures.
