PRECURSOR DESCRIPTION AND DATA

NSIC Accession Number: 149961

Title: HPCI Fails to Start When Turbine Stop Valve Fails to Open at Hatch 2

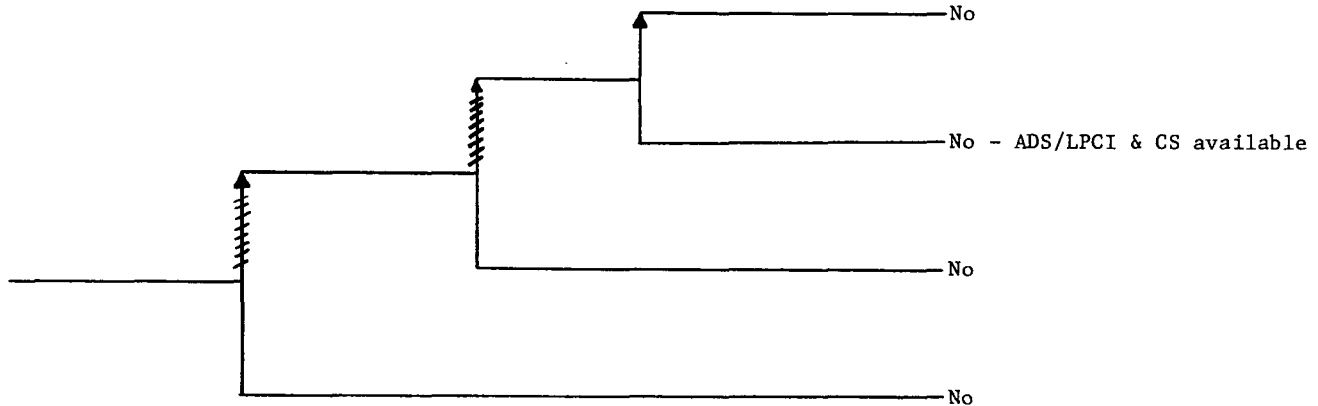
Reactor trip during power accession due to condensate system trip	HPCI failed to initiate on low-low reactor water inventory due to failed turbine stop valve	RCIC system was out of service	Reactor water level controlled by condensate system which had been immediately repaired
---	---	--------------------------------	---

NSIC 149961 - Actual Occurrence for HPCI Fails to Start When Its Turbine Stop Valve Fails to Open at Hatch 2

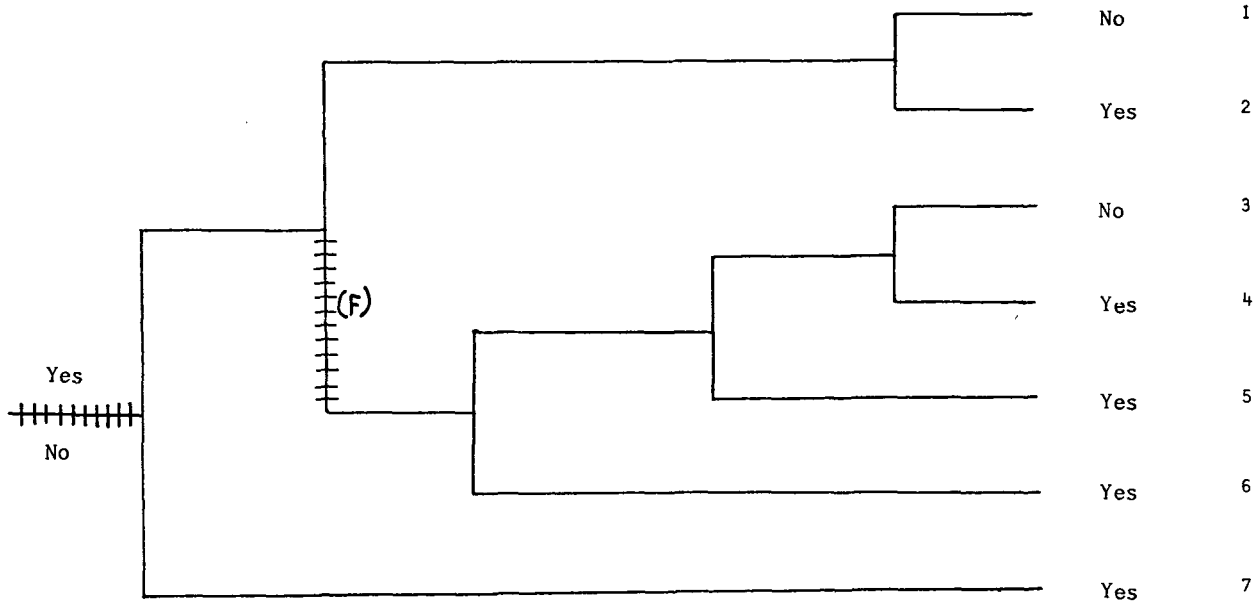
NSIC 149961 - Sequence of Interest for HPCI Fails to Start When the Turbine Stop Valve Fails to Open at Hatch 2

¹ RCIC was out of service.
