PRECURSOR DESCRIPTION AND DATA

NSIC Accession Number: 61434

Title: Loss of Offsite Power and Failure of an Emergency Condenser Valve to Open at Humboldt Bay (Semi-Annual Report July-December 1970)

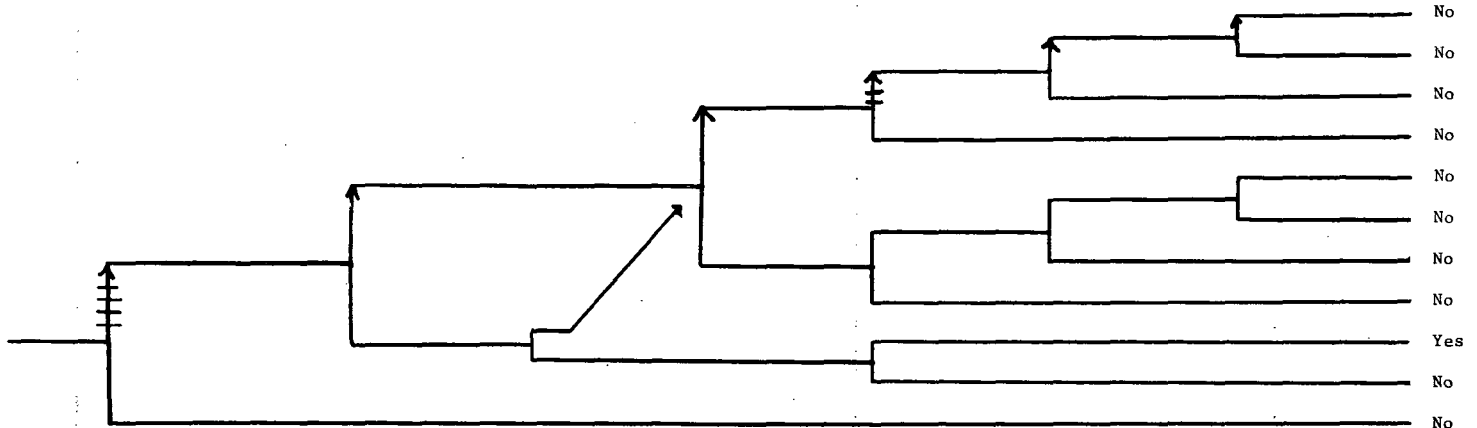
1. With the reactor at power, a switching error at the Humboldt Substation caused protective relaying which resulted in a generator and turbine trip, loss of the 60 KV bus, and consequent loss of offsite power.
2. Loss of normal power resulted in reactor scram, loss of feedwater flow, loss of drywell cooling, and loss of control room indication of reactor vessel pressure and level.
3. The emergency propane generator started and assumed safety-related loads. (A back-up feed was available from the adjacent fossil unit.) A CRD hydraulic pump was started to provide reactor makeup.
4. The emergency condenser return valve failed closed due to an incorrectly adjusted torque switch.

5. Reactor vessel level shrink to the low water level setpoint due to the opening of a safety valve (a result of the failed emergency condenser) combined with the loss of feedwater and an increase in drywell pressure (due to loss of drywell cooling plus a failed relief valve expansion joint) resulted in the actuation of the reactor vent system. This system was manually secured four minutes later.
6. The low pressure core flood and core spray systems subsequently automatically initiated and were used for core cooling until normal power was restored.

NSIC 61434 - Actual Occurrence for Loss of Offsite Power and Failure of an Emergency Condenser Valve to Open at Humboldt Bay

1. Normal power was restored to the plant 2.4 KV bus from an adjacent fossil unit.
2. The emergency condenser isolation valve was repaired and returned to service.

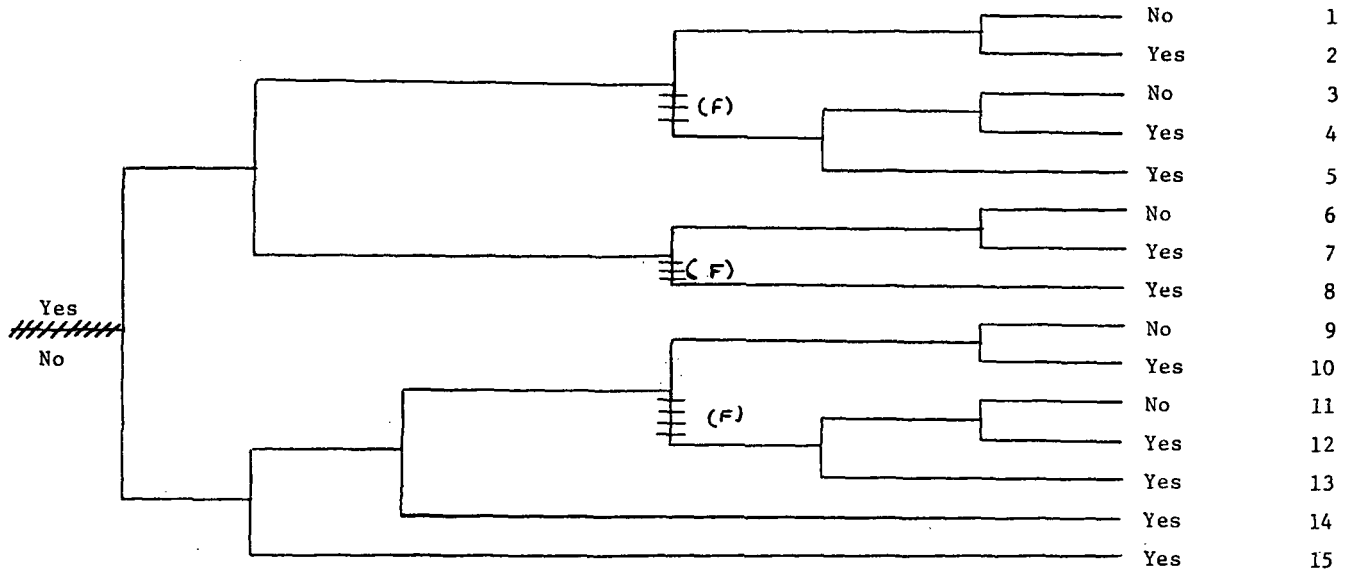
NSIC 61434 - Sequence of Interest for Loss of Offsite Power and Failure of an Emergency Condenser Valve to Open at Humboldt Bay

¹Humboldt Bay utilized an emergency condenser and CRD hydraulic pumps/safety valves for decay heat removal
