PRECURSOR DESCRIPTION AND DATA

NSIC Accession Number: 108078

Title: Auxiliary Feedwater Pump Flows Restricted at Kewaunee

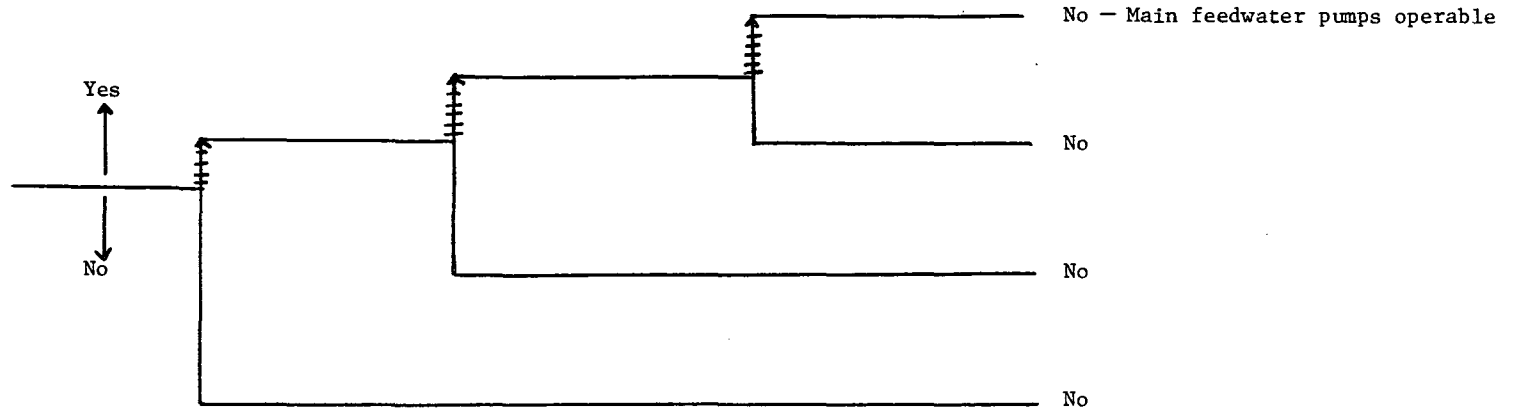
NSIC 108078 - Actual Occurrence for Auxiliary Feedwater Pump Flows Restricted at Kewaunee

1. Resin beads were leaking from a mixed-bed demineralizer in the makeup water system and travelling to the condensate storage tank..
2. During a unit startup, AFW pumps 1A and 1B suction strainers became clogged with resin beads, resulting in low pump flow.
3. The turbine-driven AFW pump (1C) suction strainer was also clogged, which resulted in low flow from that pump also.

| Unit in startup operations | Mixed-bed demineralizer leaking resin beads to condensate storage tank | Reduced auxiliary feedwater flow from 1A and 1B motor-driven AFW pumps due to suction strainers clogged with resin | Reduced auxiliary feedwater flow from 1C turbine-driven AFW pump due to suction strainer clogged with resin |

1. The condensate storage tank and the pump suction strainers were cleaned and returned to service.
2. At a later date the fine mesh strainers were to have been removed.

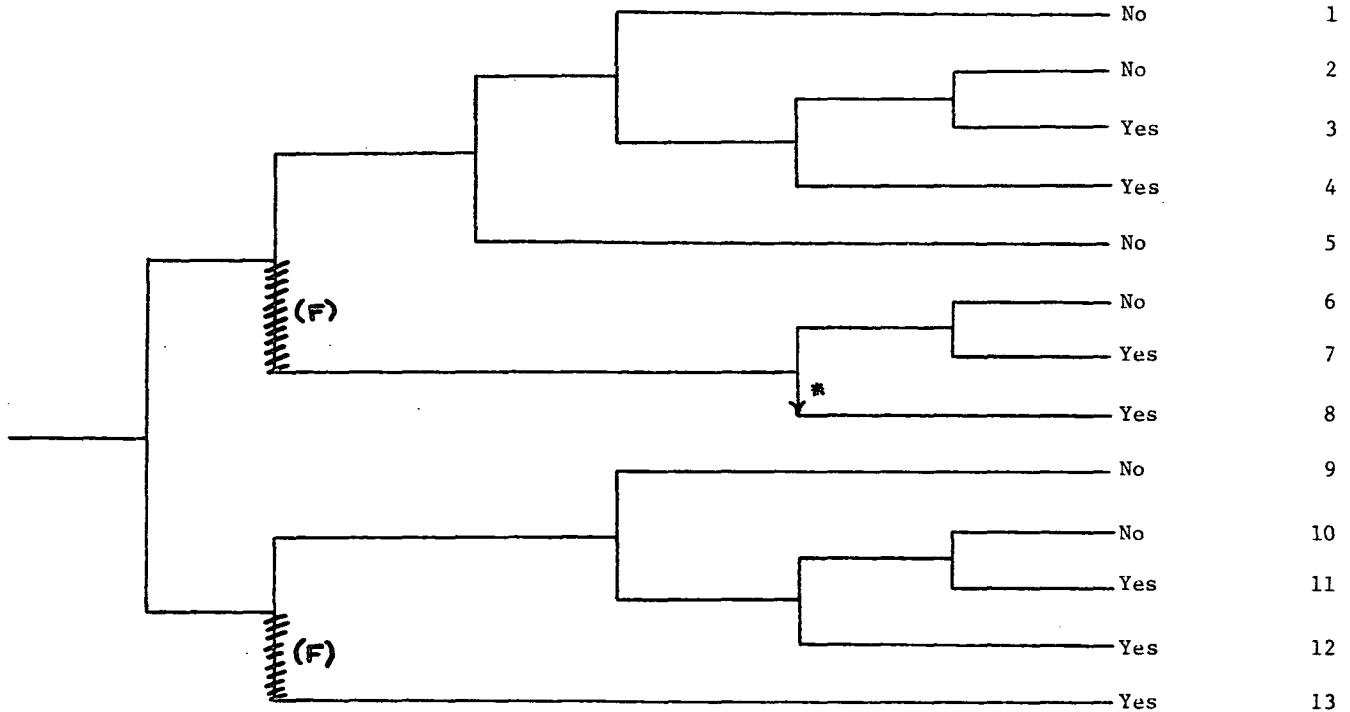
NSIC 108078 - Sequence of Interest for Auxiliary Feedwater Pump Flows Restricted at Kewaunee

| Loss of Main Feedwater | Reactor Trip | Auxiliary Feedwater and Secondary Heat Removal | PORV Demanded | PORV or PORV Isolation Valve Closure | High Pressure Injection | Long Term Core Cooling | Potential Severe Core Damage | Sequence No. |
