PRECURSOR DESCRIPTION AND DATA

NSIC Accession Number: 112309

Title: Gas Turbine Becomes Inoperable at Millstone

REACTOR NAME: Millstone 1

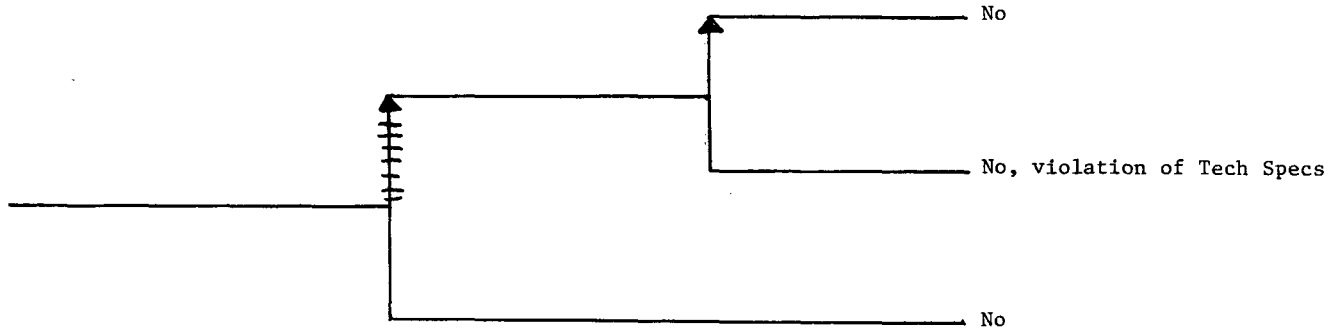
NSIC 112309 - Actual Occurrence of Gas Turbine Becomes Inoperable at Millstone 1

With The I.C. Inoperable It Was Decided To Initiate The Gas Turbine For Precaution As Hurricane Bell Passed	The Gas Turbine Failed To Run	Reactor Placed In Cold Shutdown	Potential Severe Core Damage
---	-------------------------------	---------------------------------	------------------------------

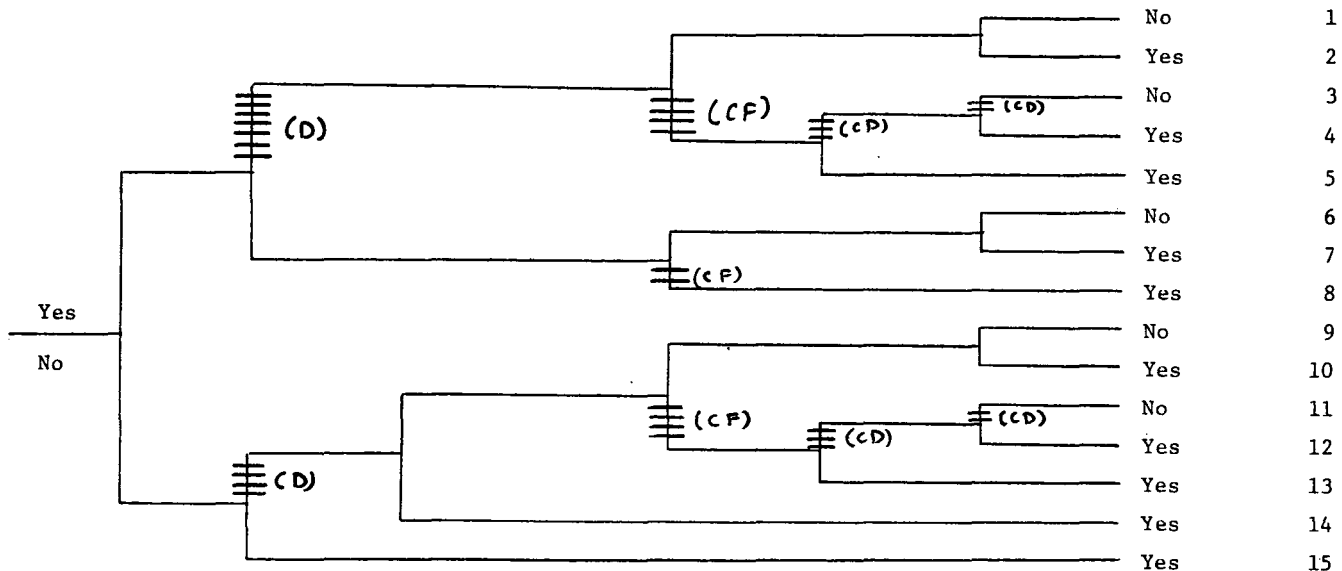
Loss of Offsite Power	Reactor Scram	Diesel Start and Load	Reactor Made Sub-critical by the SBLCS Or Rods Are Manually Driven In	RCIC/HPCI Initiates	ADS/LPCI CS Initiates	Long Term Core Cooling	Potential Severe Core Damage	Sequence No.
-----------------------	---------------	-----------------------	---	---------------------	-----------------------	------------------------	------------------------------	--------------
