PRECURSOR DESCRIPTION AND DATA

NSIC Accession Number: 153003

Title: LPR Service Water Valves Left Closed Following Testing at Oconee 2

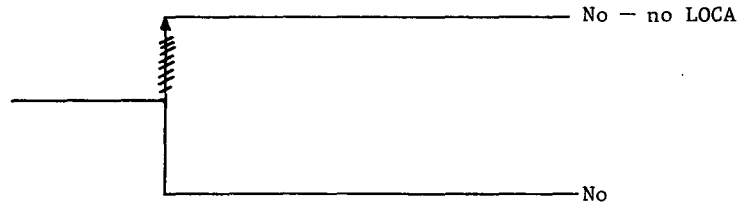
1. Following a revision of the LPR system valve alignment procedure to provide a table of valve positions (to permit double verification of valve position), a LPR system valve alignment was performed.
2. Two days later, with the reactor at 49% power, the LPR cooler service water valves were found to be improperly positioned, due to failure to include the LPR service water valves in the revised check list and failure of the personnel performing the valve check to note that the service water valves were still included in the body of the procedure.

Reactor at 99% Power	Low Pressure Recirculation System Cooler Service Water Outlet Valves Found Improperly Positioned As a Result of an Improperly Revised Procedure
-------------------------	--

NSIC 153003 - Actual Occurrence for LPI Service Water Valves
Left Closed Following a Test at Oconee 2

1. The valves were returned to their correct positions.
2. The LPR procedure was rewritten to include the service water valves in the check list.

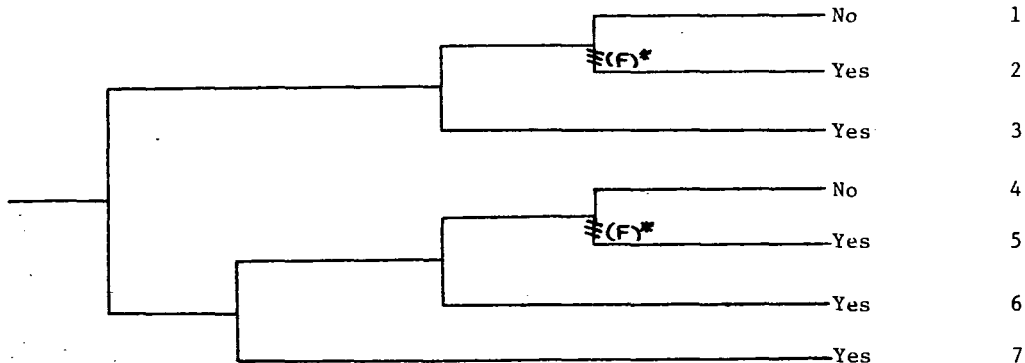
NSIC 153003 — Sequence of Interest for LPR Service Water Valves Left Closed Following Testing at Oconee 2

* Success requires operator detection and opening of closed valves prior to need for LPR.
