PRECURSOR DESCRIPTION AND DATA

NSIC Accession Number: 83833

Date: September 8, 1973

Title: Total Loss of AC Power at Oyster Creek

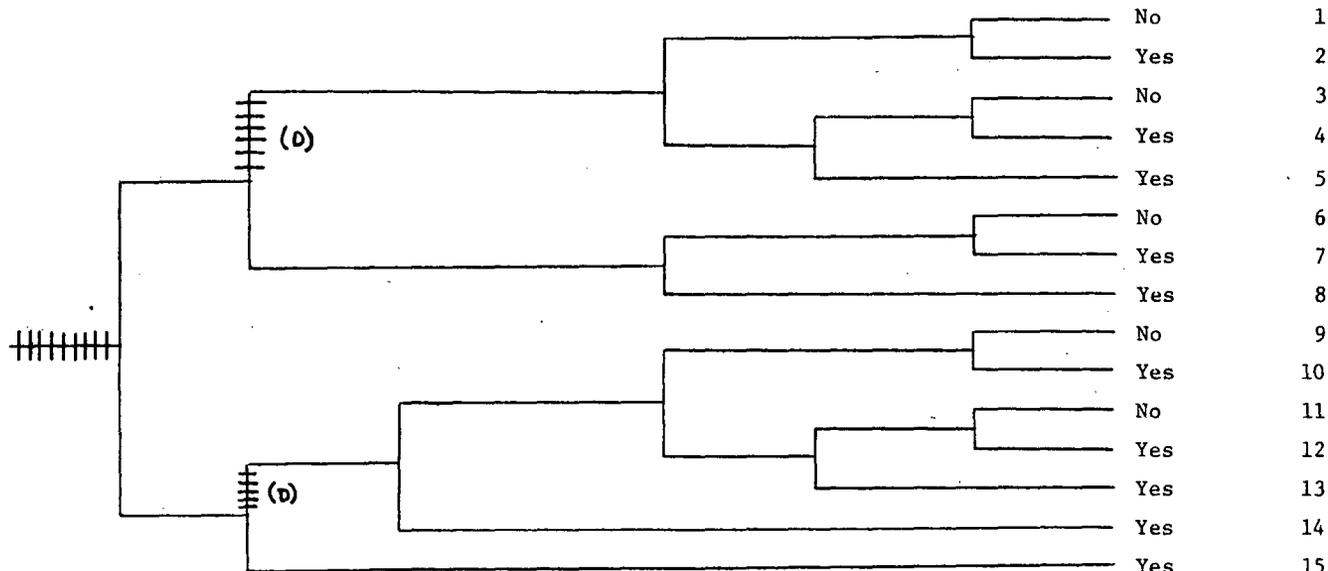
NSIC 83833 - Sequence of Interest for a Total Loss of A.C. Power at Oyster Creek

¹Diesel had initiated earlier in the transient but was locked out after being secured. The total loss of a.c. power lost approximately 15 sec.

²Oyster Creek utilizes isolation condenser rather than RCIC.
