PRECURSOR DESCRIPTION AND DATA

NSIC Accession Number: 149450

Date: May 2, 1979

Title: Loss of Feedwater Transient at Oyster Creek

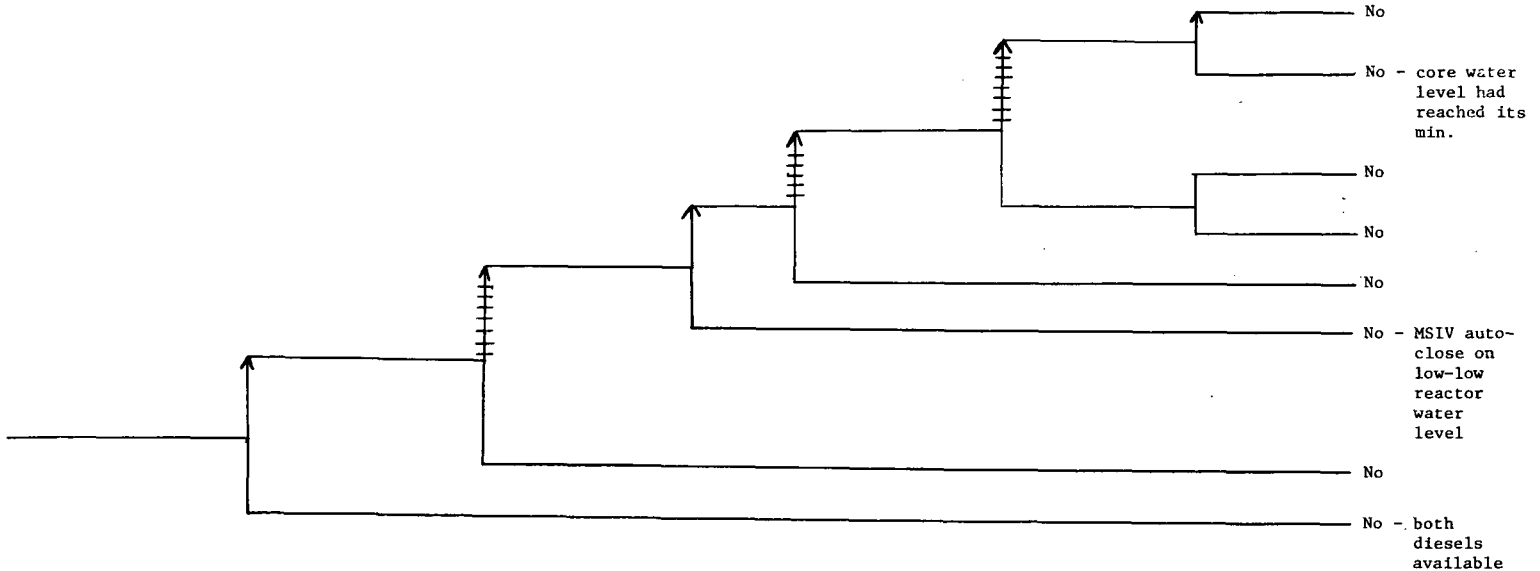
NSIC 149450 - Actual Occurrence of a Loss of Feedwater Flow at Oyster Creek

A reactor/recirculation pump trip results in a turbine/generator trip which results in a loss of feedwater	An autotransfer to transformer "5A" loaded buses "1A" & "1C". "5B" was down for maintenance thus essential bus "1D" was loaded from the diesel	An attempt to start feed pump 1A failed (pumps B & C were fed from the unavailable 1B bus	Operator manually closes the MSIV	The operator initiates the isolation condenser and closes all recirc. discharge valves instead of just "A" & "E"	Operator initiates the "C" recirculate pump but shut it off due to rapid water drop in annulus	Feed pump "A" successfully started followed by recirculation pump "A"	Potential Severe Core Damage
--	--	---	-----------------------------------	--	--	---	------------------------------

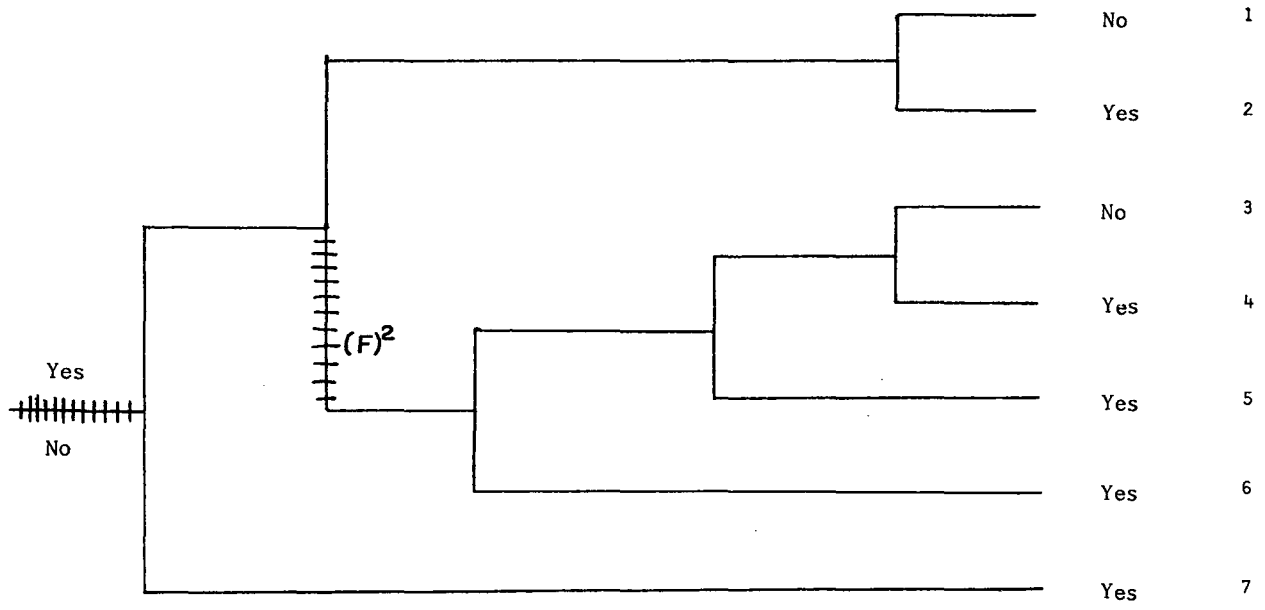
NSIC 149450 – Sequence of Interest for a Loss of Feedwater Flow at Oyster Creek

¹ Oyster Creek utilizes Isolation condensers rather than RCIC
² Success requires proper operation of either FWCT or IC.
