PRECURSOR DESCRIPTION AND DATA

NSIC Accession Number: 106616

Title: Loss of Offsite Power and a Relief Valve Sticks Open at Pilgrim 1

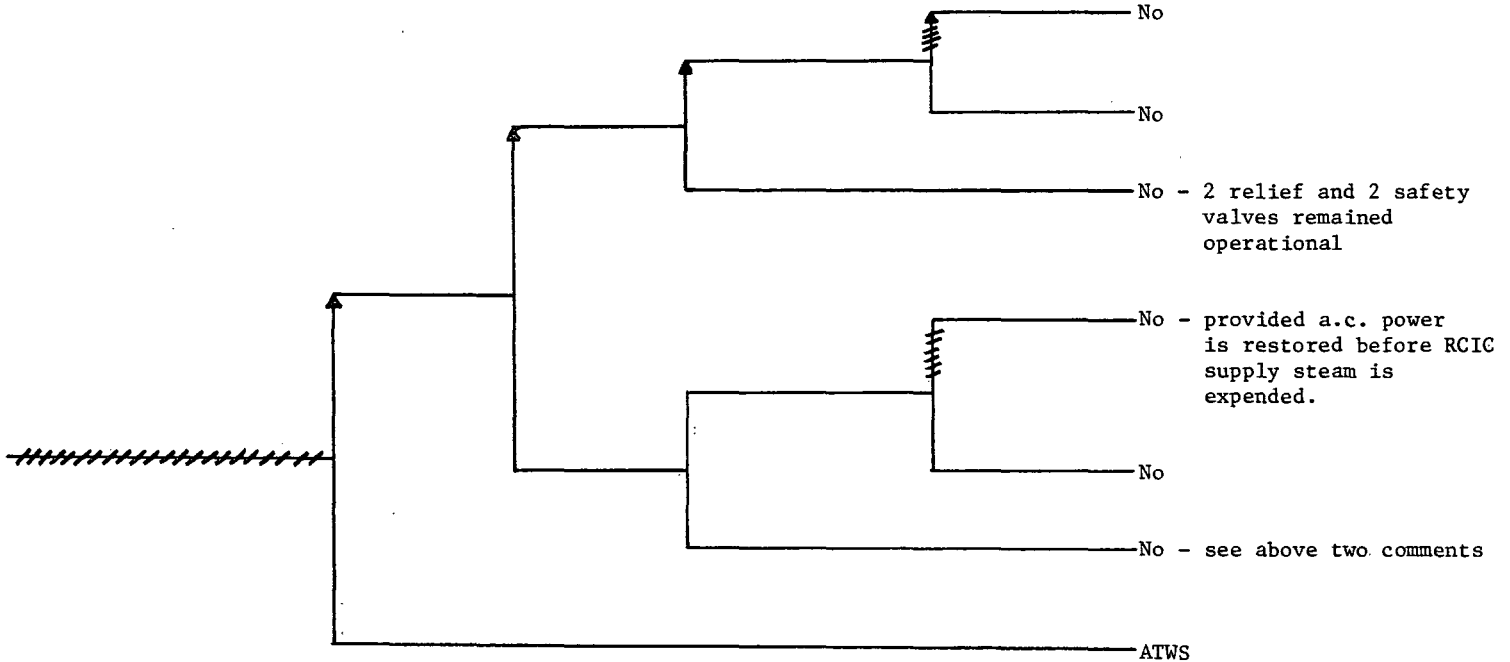
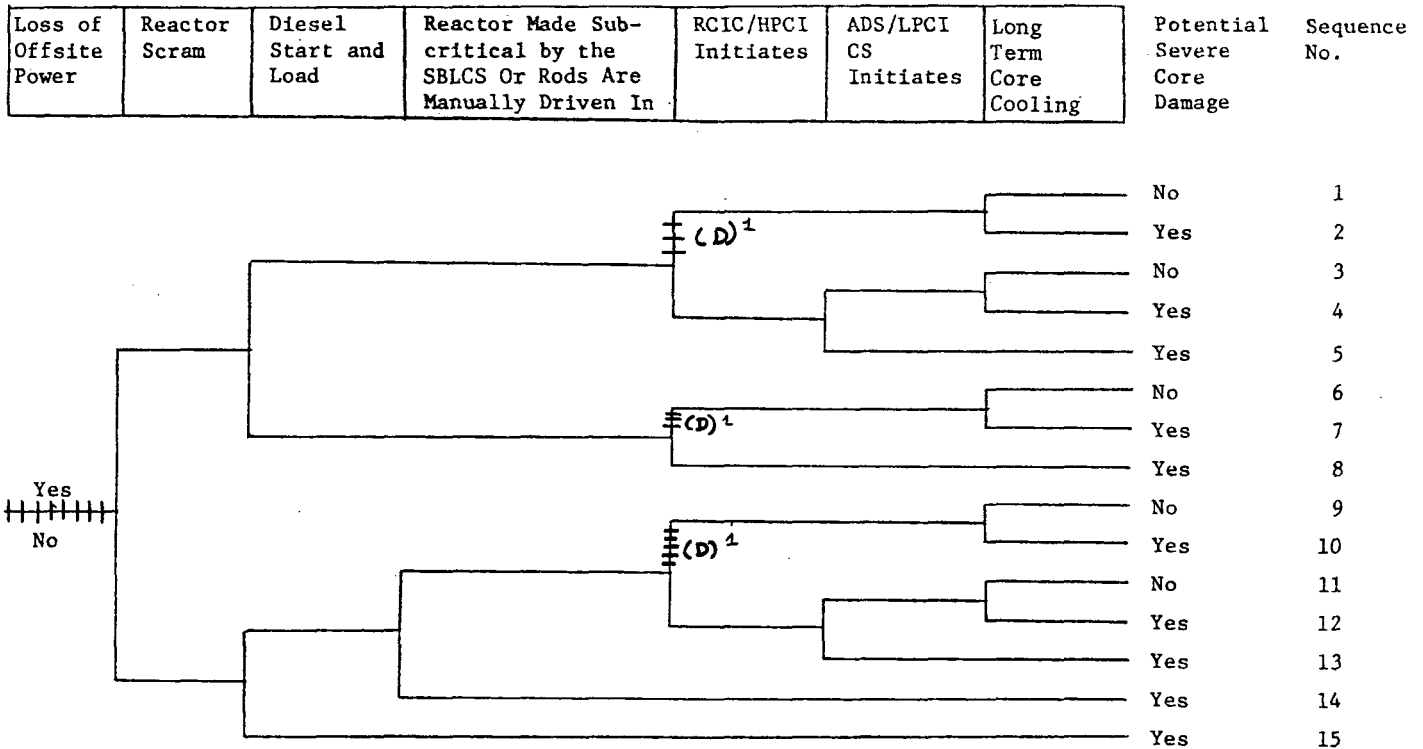
NSIC 106616 — Sequence of Interest for Loss of Offsite Power and a Relief Valve Sticks Open at Pilgrim 1
 1 A relief valve stuck open.

1. The reactor was undergoing a routine shutdown when a turbine trip occurred (no reason was given for the turbine trip). This caused the startup and auxiliary 345 kv fuses to de-energize (again reason unspecified resulting in a loop). and the reactor to trip.
2. The diesel generators started and re-energized the safety related buses.
3. A relief valve (203-2B) opened for pressure control.
4. This valve stuck open until the reactor pressure fell to approximately 300 psig. The failure was attributed to steam cutting the pilot valve assembly, which increased the pressure on the actuating side of the second stage piston, thereby reducing the closing forces on this piston.

As the reactor was experiencing a shutdown, a turbine trip occurred which caused the start-up and auxiliary buses to trip	The reactor scrambled	The diesel generators started and loaded	A relief valve opened for pressure control	The relief valve failed to reseat	Potential Severe Core Damage
---	-----------------------	--	--	-----------------------------------	------------------------------
