PRECURSOR DESCRIPTION AND DATA

NSIC Accession Number: 63144

Title: Both Diesels Fail to Start at Robinson 2

REACTOR NAME: Robinson 2

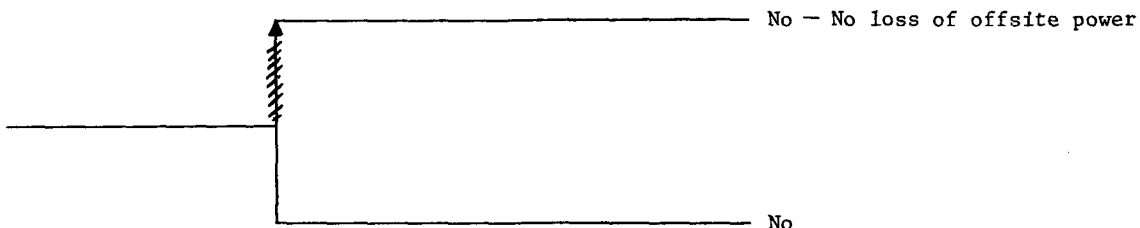
NSIC 63144 - Actual Occurrence for Both Diesel Generator
Fail to Start at Robinson 2

1. Due to a history of set point drift in the diesel generator low lube oil pressure switches, the switches were replaced with switches considered more reliable. To reduce the effects of vibration on the new switches, the switches were mounted on the room walls and connected to the diesels using approximately 15' of 1/4" copper tubing.
2. During subsequent testing, both diesels failed to run due to low indicated lube oil pressure at the pressure switches; a result of trapped air and high viscosity cold lube oil in the small tubing, which prevented transmission of the correct oil pressure to the pressure switches.

Reactor at Power and Diesel Generator Testing in Progress	Both Diesel Generators Fail to Start Due to Improperly Sized and Vented Hydraulic Lines Between the Diesel Lube Oil System and Low Lube Oil Pressure Switches
--	---

Potential
Severe
Core
Damage

The pressure switch lines were replaced with 3/8" tubing which included a vent connection.

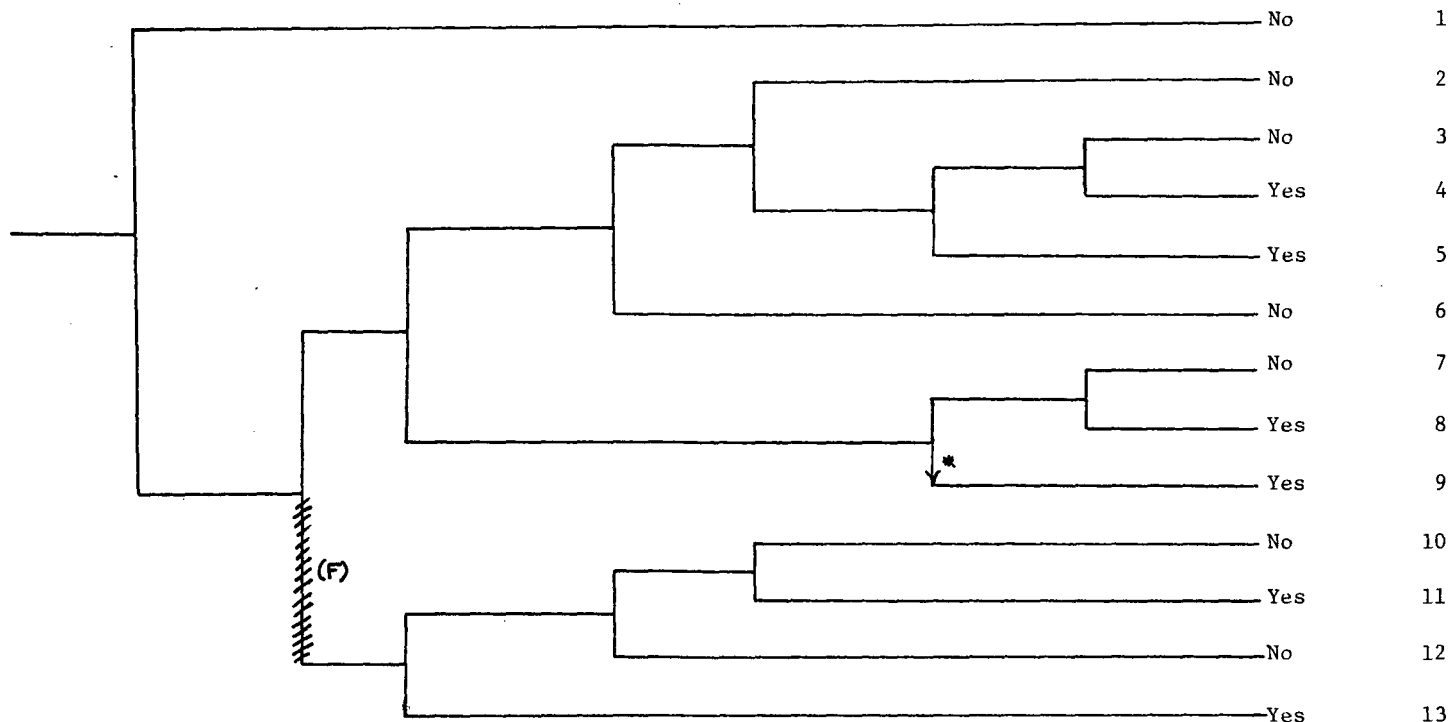
NSIC 63144 - Sequence of Interest for Both Diesel Generators Fail to Start at Robinson 2

Loss of Offsite Power	Turbine Generator Runs Back and Assumes House Loads	Emergency Power	Auxiliary Feedwater and Secondary Heat Removal	PORV Demanded	PORV or PORV Isolation Valve Closure	High Pressure Injection	Long Term Core Cooling	Potential Severe Core Damage	Sequence No.
-----------------------	---	-----------------	--	---------------	--------------------------------------	-------------------------	------------------------	------------------------------	--------------
