PRECURSOR DESCRIPTION AND DATA

NSIC Accession Number: 103077

Title: Reactor Coolant Pump Seal System Fails at Robinson 2

NSIC 103077 - Actual Occurrence for Reactor Coolant Pump Seal System fails at Robinson 2

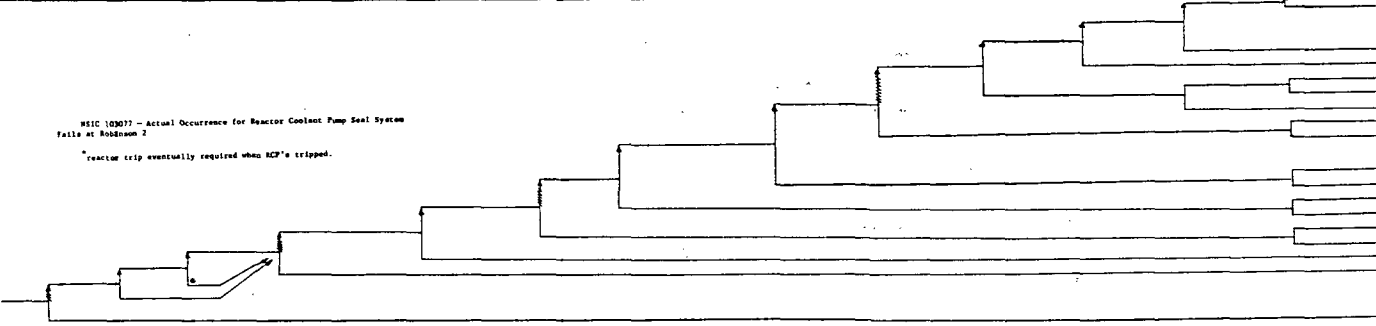
Reactor at full power	RCP "C" No. 1 seal fails with high seal flow	Plant load reduced to 36% and RCP "C" idled	Reactor trip/turbine trip due to high S.G. level resulting from the rapid load reduction	Thermal barrier cooling to all three RCPs fails due to closure of combined return line control valve on high cooling water return flow caused by cooling water flashing in RCP "C" thermal barrier	RCPs "A" and "B" stopped due to potential loss of seal flow because of pressure surges in seal return line due to seal flow flashing in RCP "C"	Seal flow lost on RCP "A" and "B"	Thermal barrier cooling water combined return line flow control valve opened to restore thermal barrier cooling to all three RCPs	RCP "C" started and RCS cooldown started using main condenser	RCP "C" stopped on high stand-pipe level; RCP "C" No. 2 and No. 3 seals fail	Rapidly decreasing pressurizer level	Safety injection pumps "A", "B", and "C" provide RCS coolant injection	RCS depressurized using auxiliary spray	RCS cooldown to cold shutdown via BHR system

- No - natural circulation cool-down using SI system/ recirculation from sump for makeup available
- No - (same as above)
- Yes
- No
- No - (same as above)
- No - (same as above)
- No - cooldown using auxiliary feedwater available to >240°F
- No
- No - (same as above)
- No
- No - (same as above)
- No
- No
- No
- No

* reactor trip eventually required when RCP's tripped.

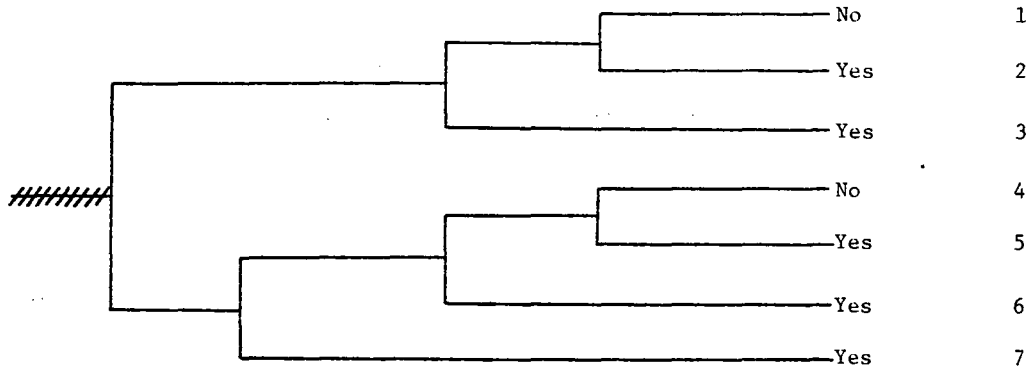
NSIC 103077 - Sequence of Interest for Reactor Coolant Pump Seal System
Fails at Robinson 2

Small LOCA	Reactor Trip	Auxiliary Feedwater and Secondary Heat Removal	High Pressure Injection	Low Pressure Recirculation and LPR/HPI Cross-Connect	Potential Severe Core Damage	Sequence No.
---------------	-----------------	---	-------------------------------	---	---------------------------------------	-----------------
