PRECURSOR DESCRIPTION AND DATA

NSIC Accession Number: 141097

Title: Safety Injection Occurs at TMI-2

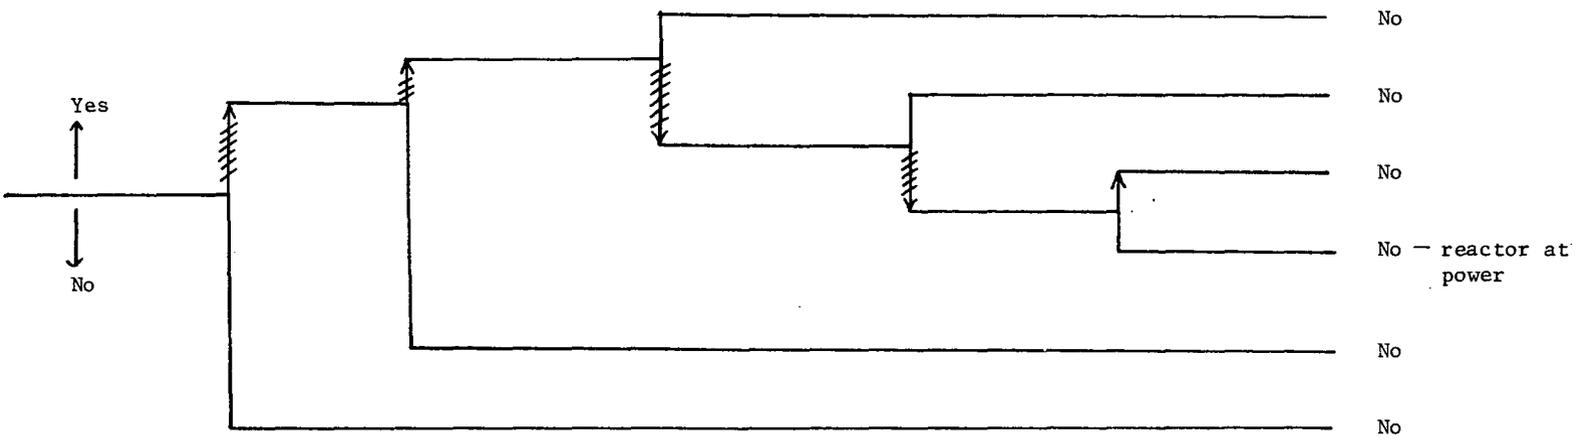
NSIC 141097 - Actual Occurrence for Loss of Vital Bus and Relief Valve Opening at Three Mile Island 2

1. Alternate power source feeder breakers to vital bus 2-IV (120 V a-c) were tripped for test.
2. Frequency control module failed resulting in blown fuses in the DC input to inverter.
3. Vital bus 2-IV tripped on inverter failure, resulting in the PORV failing open.
4. Because of the reactor coolant pump configuration at the time, a reactor trip also occurred.
5. The operators did not realize the relief valve had failed open because of lack of PORV position indication.
6. ECCS was initiated at 1650 psig.
7. Four minutes into the transient, vital bus 2-IV was re-energized, which closed the relief valve and terminated the transient.

Testing with reactor at zero power	Invertor failure & vital bus 2-IV trip & reactor trip	Pressure switch failed closed opening relief valve	Pressure indication powered from vital bus 2-IV available to operator	Operator intervention successful	Vital bus 2-IV reenergized closing relief valve & terminating RCS blowdown
------------------------------------	---	--	---	----------------------------------	--

Potential
Severe
Core
Damage

1. A design change was initiated to change the failure position of the relief valve upon loss of power to closed in lieu of open.
2. Relief valve position indication was provided in the control room.

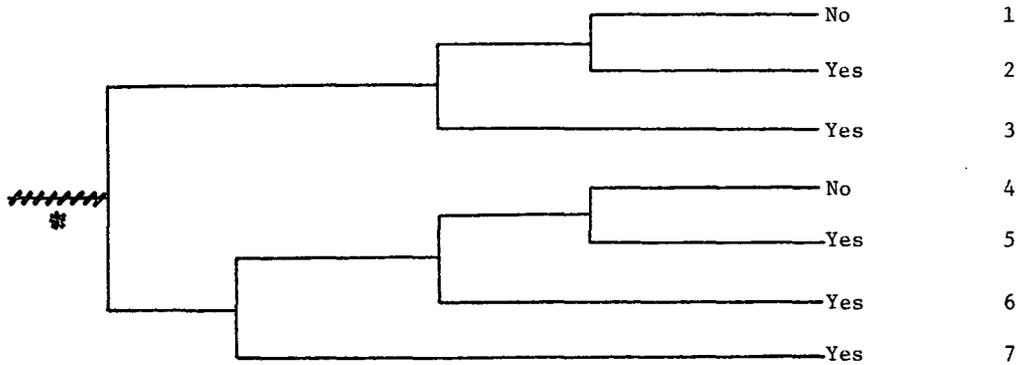
NSIC 141097 - Sequence of Interest for Safety Injection Occurs at Three Mile Island 2

Small LOCA	Reactor Trip	Auxiliary Feedwater and Secondary Heat Removal	High Pressure Injection	Low Pressure Recirculation and LPR/HPI Cross-Connect	Potential Severe Core Damage	Sequence No.
------------	--------------	--	-------------------------	--	------------------------------	--------------

* failure requires operator error of failing to close the PORV isolation valve.
